**IMPLEMENTATION
OF
BUJAGALI
INTERCONNECTION
PROJECT**

**UGANDA ELECTRICITY
TRANSMISSION COMPANY
LIMITED**

**OFFICE OF THE
AUDITOR GENERAL
UGANDA**

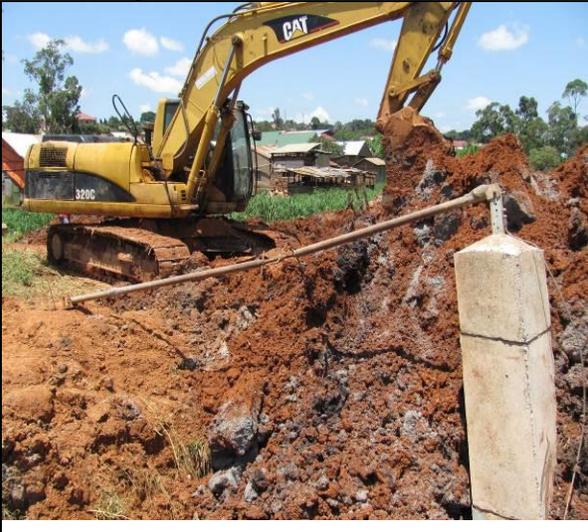
(a): Construction Work in Nansana Tower Spot

Ongoing construction of the remaining tower foundation in Nansana on the Mutundwe – Kawanda transmission line picture taken by OAG staff on 25th/10/2011

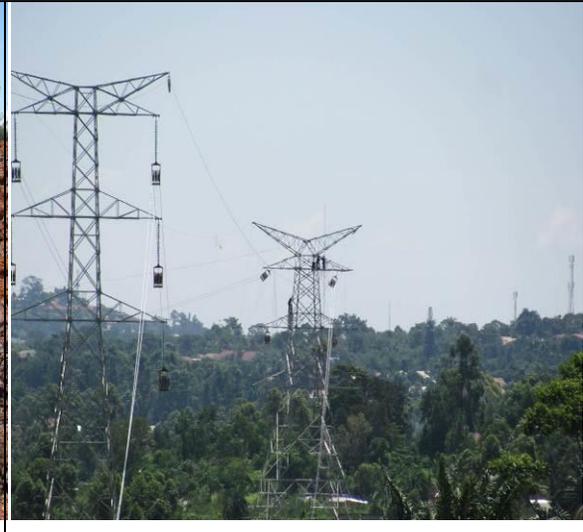
(b): Stringing Works near Kawanda Substation

Stringing going on - Kawanda – Bujagali transmission line, picture taken from Kawanda substation by OAG staff on 25th/10/2011

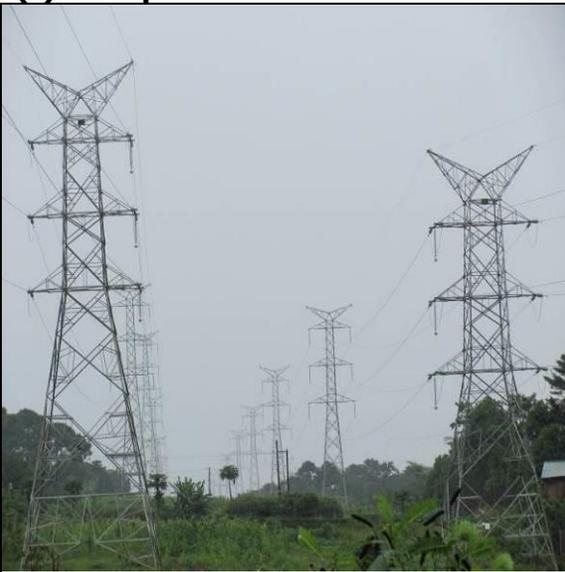
Parallel transmission lines (5 km). Right: connects to the existing Tororo line. picture taken by OAG staff on 7th/10/2011

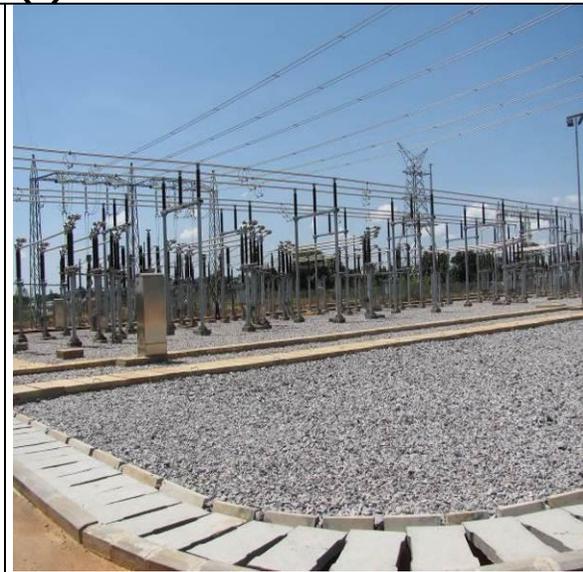
Construction works nearing completion at Kawanda Sub-station, picture taken by OAG staff on 25th/10/2011

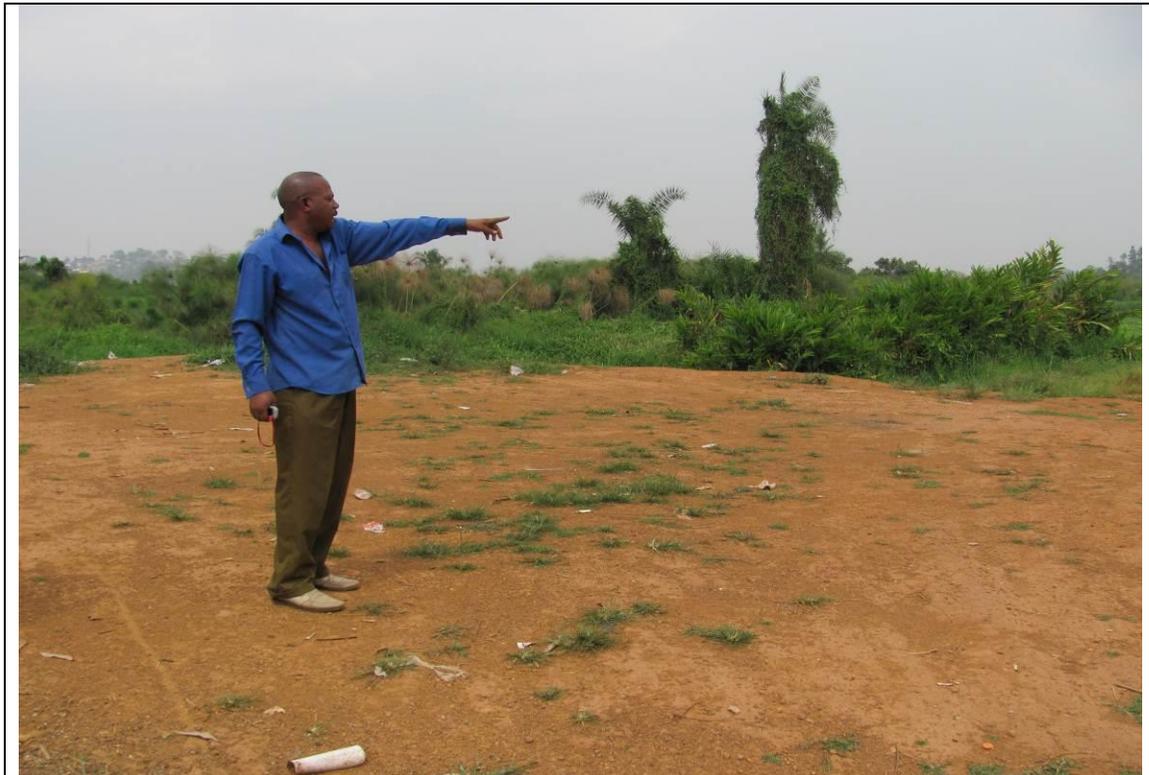
Picture 2: Disputed tower spot in Nansana Wetland

Through interviews with UETCL management and field inspections, it was noted that the delay in the construction of the Kawanda – Mutundwe transmission line was also due to the delay in solving the cases of emergence of people claiming ownership/interest in the land in the wetlands of Nansana and Ganda where the line was meant to pass. Efforts to

have NEMA evict them were futile. The construction stalled (**See Picture 2**) until the emerging claimants were paid Shs.163 million (**See Table 5**) between June and August 2011.

A claimant in Nansana wetland, standing on a tower spot where construction had stalled. The claimant was showing the audit team boundaries of his purported land.

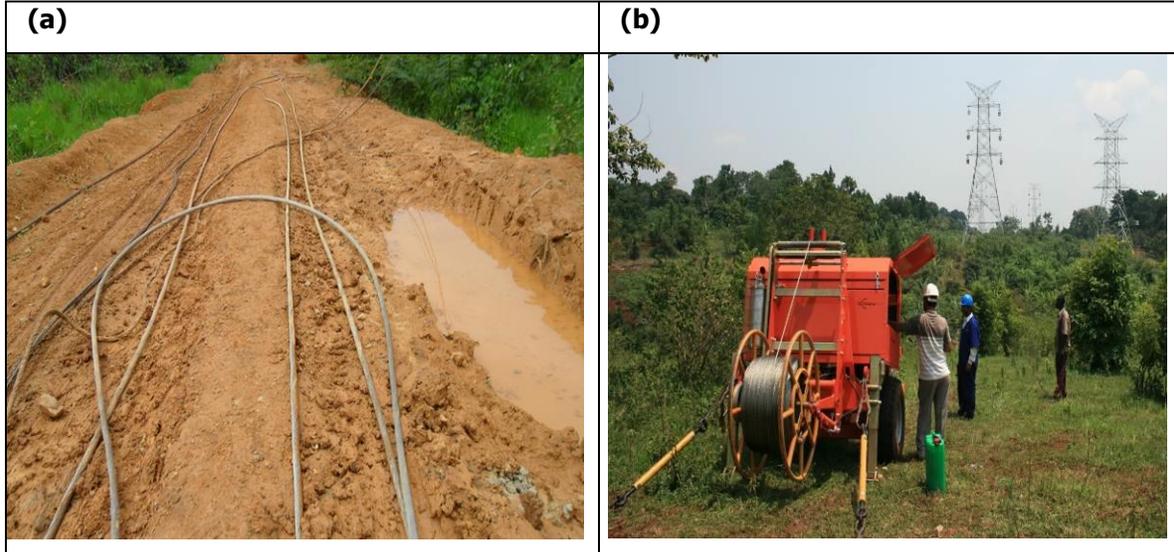
Picture 3: Stringing Process

It was noted that the insulator strings were sometimes pulled on the ground during stringing as showed in **picture 3(a)** as opposed to the recommended way of stringing as shown in **picture 3(b)**. BEL, the supervisors of the contractor, acknowledged the occurrence of the anomaly and stated that the contractor was asked to correct the mistake by cutting off the affected insulator strings. This could not be independently confirmed by the auditors.

This unconventional way of stringing was caused by inadequate supervision/inspection of stringing by the BEL site engineers and UETCL inspection teams. According to UETCL engineers, the anomaly may lead to unacceptable levels of corona (discharge of electrical energy) and energy loss.

Un-conventional way of stringing

Recommended way of stringing (Picture courtesy of BEL)

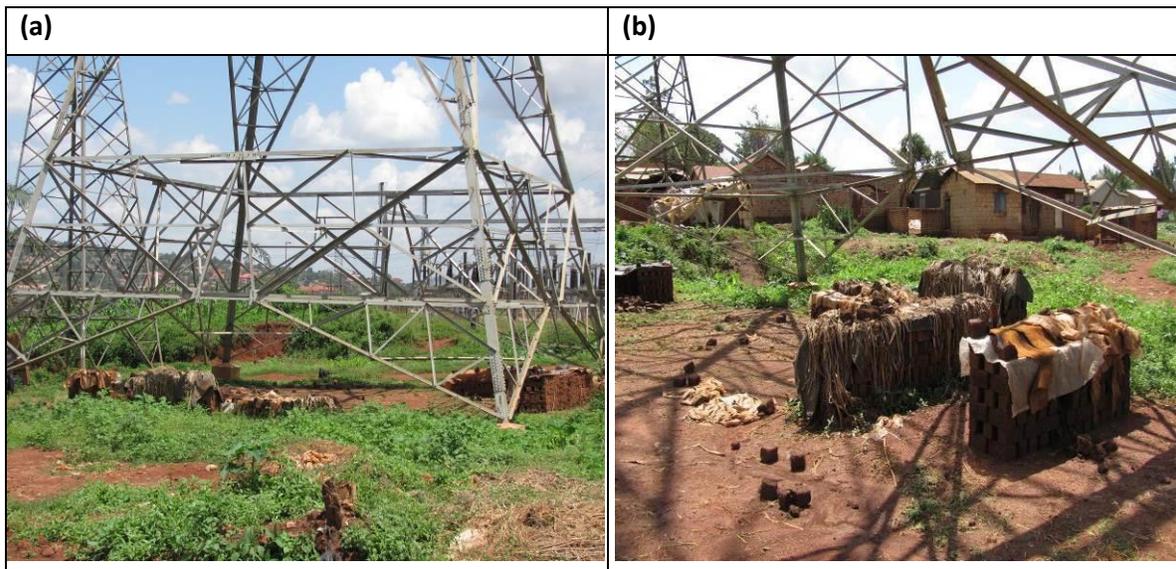
Picture 4: Brick making under a tower

During the inspection of the Kawanda – Mutundwe transmission line, it was noted that brick laying was taking place on the right of way right below the towers as seen in **Picture 4**. This was caused by failure by UETCL to monitor the right of way to ensure that no activities are taking place on the secured right of way.

These activities will in future jeopardize the safety of the installations by weakening the tower footings and also endanger the lives of the people engaged in the illegal activities.

Brick making below a transmission tower line in Mutundwe, photo taken on 25th/ Oct /2011

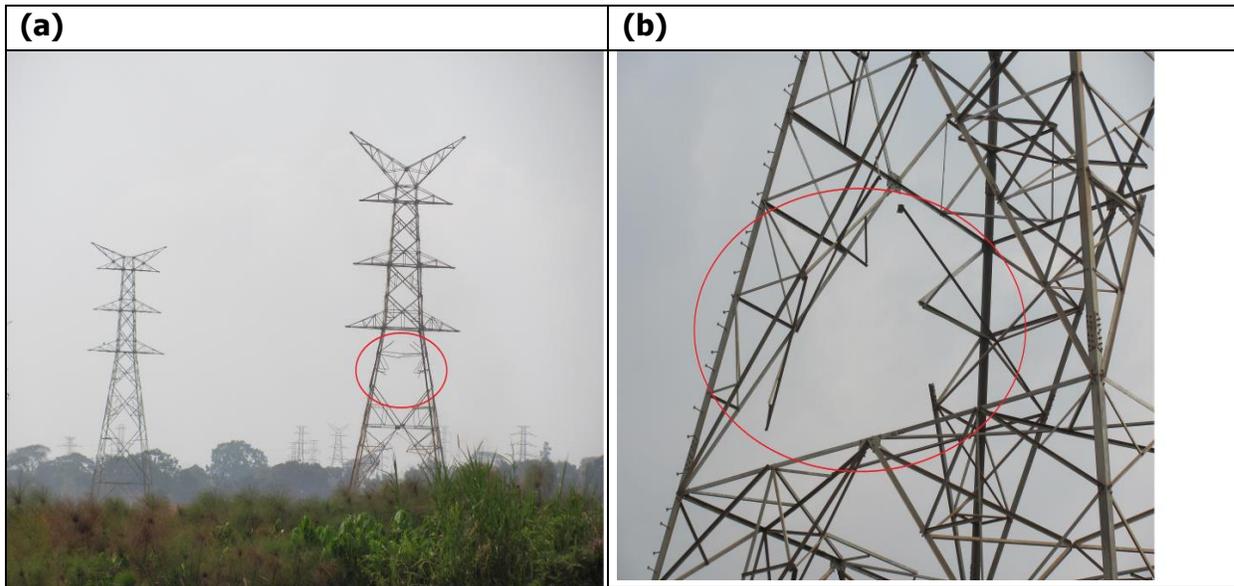
Picture 5: Vandalized Tower Members

UETCL provided for special anti-theft bolts on the towers constructed (up-to 3m above the foundation cap) and anti-climbing devices in the EPC contract. During the field visits it was noted that the anti-theft bolts and anti-climbing devices had been installed on towers on the completed sections of the transmission lines while the un-completed sections did not have. It was however found that these measures were not effective in protecting tower members from theft as noted in the Kawanda – Mutundwe and Bujagali - Kawanda transmission lines, as shown in **Picture 5**. By the time of audit, 53 cases of material thefts had been reported to different police stations but values had not yet been attached to them.

Pictures taken by OAG staff showing vandalized tower members (encircled in red)

The theft of tower members was mainly caused by the failure by UETCL to provide for welding of tower members and bolts (after erection) in the project design, which was a key intervention measure used in the earlier transmission lines in Uganda. The thefts may result into cost escalation if the contractor in future decides to bill for the replacement of stolen members and time overruns because the materials have to be imported from India. The proposed additional works (tack welding) being proposed by management, if approved, will equally lead to increased costs for the project⁹.

8. UETCL should consider tack welding of the tower members in the BIP and future projects to avert the continued vandalism of the installed structure.
9. UETCL in collaboration with security agencies should improve on surveillance to deter continued thefts of tower members.

10. UETCL may also in future projects consider the use of monopole towers which are not prone to thefts as is the case with lattice towers.
11. UETCL in future projects should ensure that the environmental audits are carried out at the intervals stipulated to ensure that negative environmental effects are detected so that mitigations are sought in time.

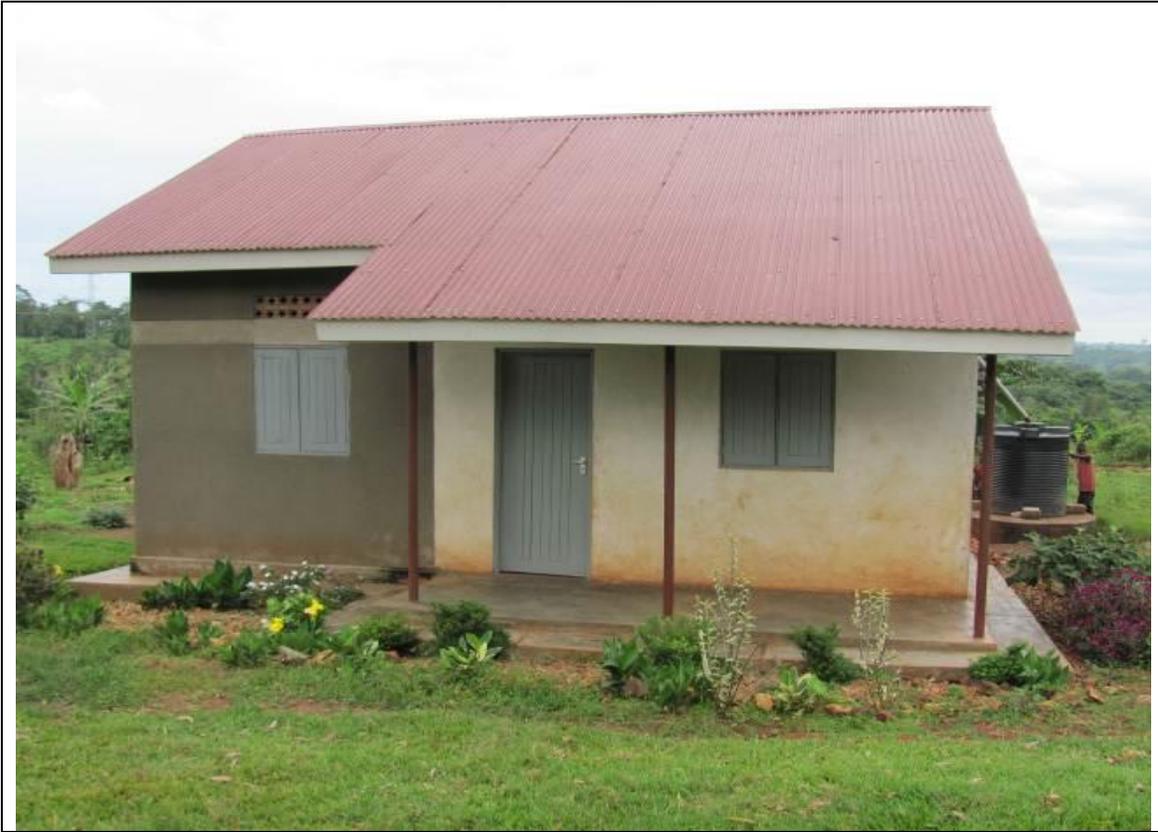
Picture 6: House Constructed by UETCL

According to the project reports, all the 44 houses in 12 resettlement sites had been completed and handed over to the project displaced persons. Inspections of the Kanyogoga and Masiko settlements sites revealed that the resettlement houses were well constructed and the specifications had been followed as seen in **Picture 6**. The households also received land for cultivation.

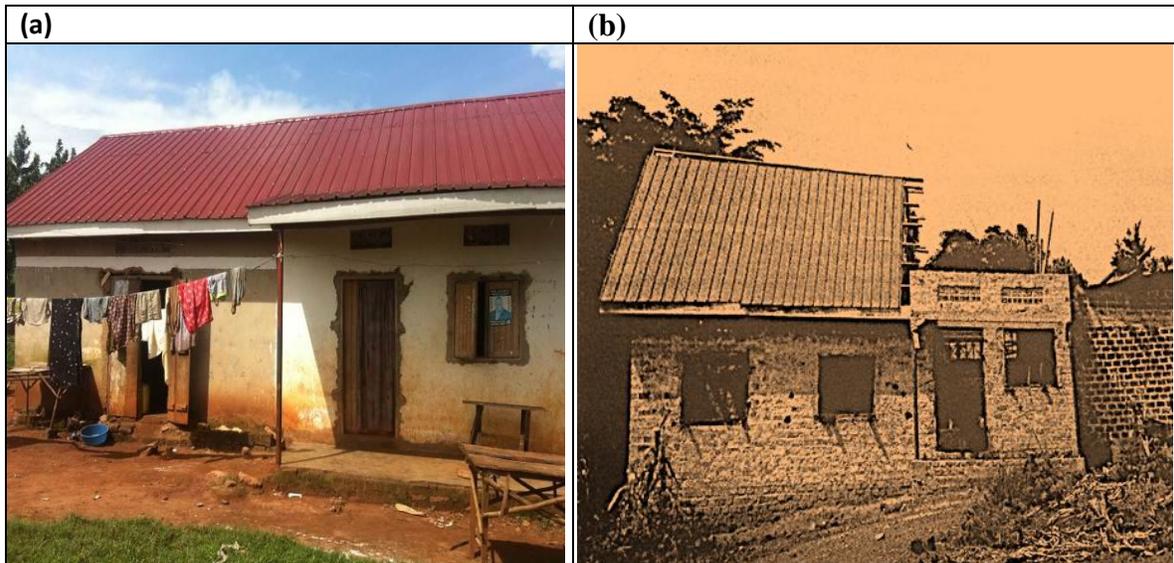
Picture 7: Poorly Constructed Resettlement Houses

As indicated in **Figure 1** above, 149 households received building materials in kind as their compensation packages. It was however noted during the inspection of the Kanyogoga settlements that some of the households who received building materials took on bigger house plans than what the materials received could accomplish as evidenced in **Picture 7**. Management estimated the completion rate of 90% for houses built by PDPs who opted for building materials.

Poorly constructed house in Kanyogoga, built by an individual PAP who received building materials

House not completed by a PAP in Bujuuko. (Picture courtesy of UETCL)

This anomaly was caused by failure by UETCL to put in place adequate safeguards to ensure that PDPs who received building materials put up houses in accordance with the agreed upon building plans. This has resulted in some PDPs putting up in ramshackled houses, as evidenced in **Picture 7 (a)** or struggling to finish the incomplete houses as seen in **Picture 7 (b)**.

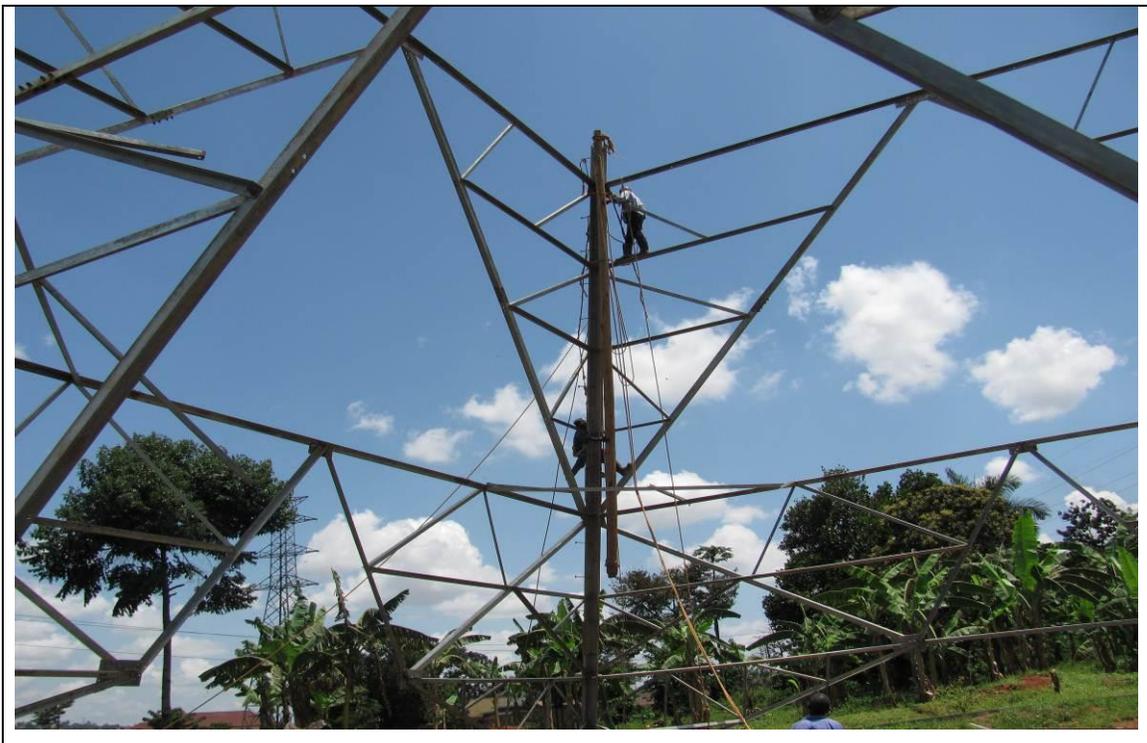
Picture 8: Ongoing erection of tower

From the field visits on the Kawanda – Mutundwe transmission line, it was observed that the workers constructing the towers did not use personal protective equipment for protection against accidents. The workers lacked the nonslip footwear, gloves, helmets, face protection and leggings as seen in **Picture No 8**.

Employees erecting a tower without using the personal protection equipment , picture taken by OAG staff on 25th/10/2011

The failure to provide protective gear to employees was attributed to non-adherence to contract provisions by the contractor. In addition, UETCL and BEL management were not vigilant enough during their supervisory and inspection visits to identify the irregularity and enforce compliance by the contractor. Lack of safety measures resulted into poor working conditions, which exposed the lives of workers to risk.
