**OFFICE OF THE AUDITOR GENERAL
OF STATE FINANCES, RWANDA**

**PERFORMANCE AUDIT REPORT ON UTILIZATION AND MAINTENANCE OF
IRRIGATION AND MECHANIZATION EQUIPMENT**

May 2015

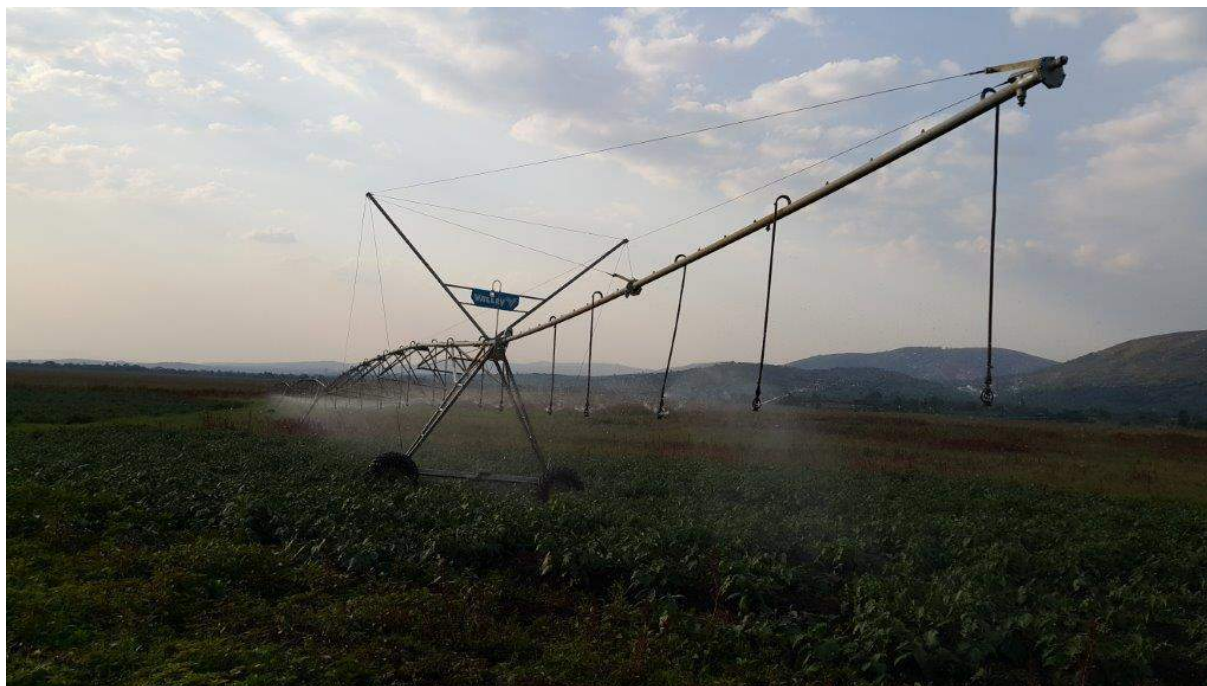
Irrigation of vegetables in Matimba with Center Pivot Equipment. Photo taken on 28th January 2015.

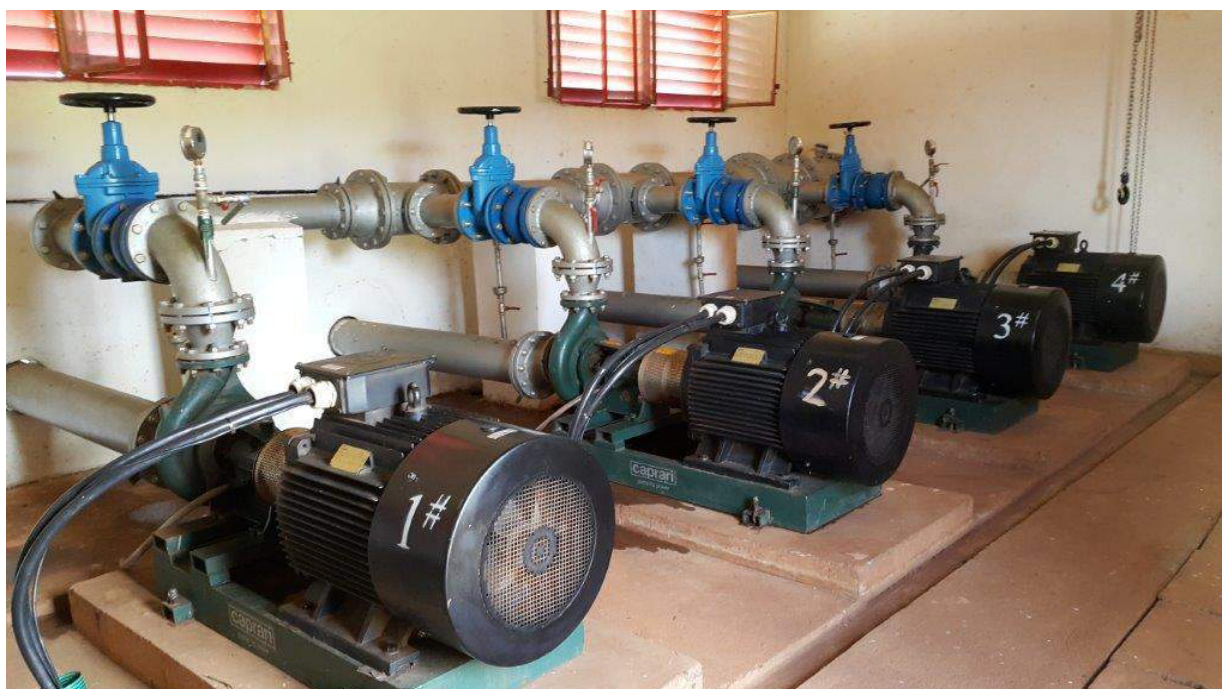
Pumping machines that enable hectares of crops to be irrigated in Nasho. Photo taken on 26th January 2015

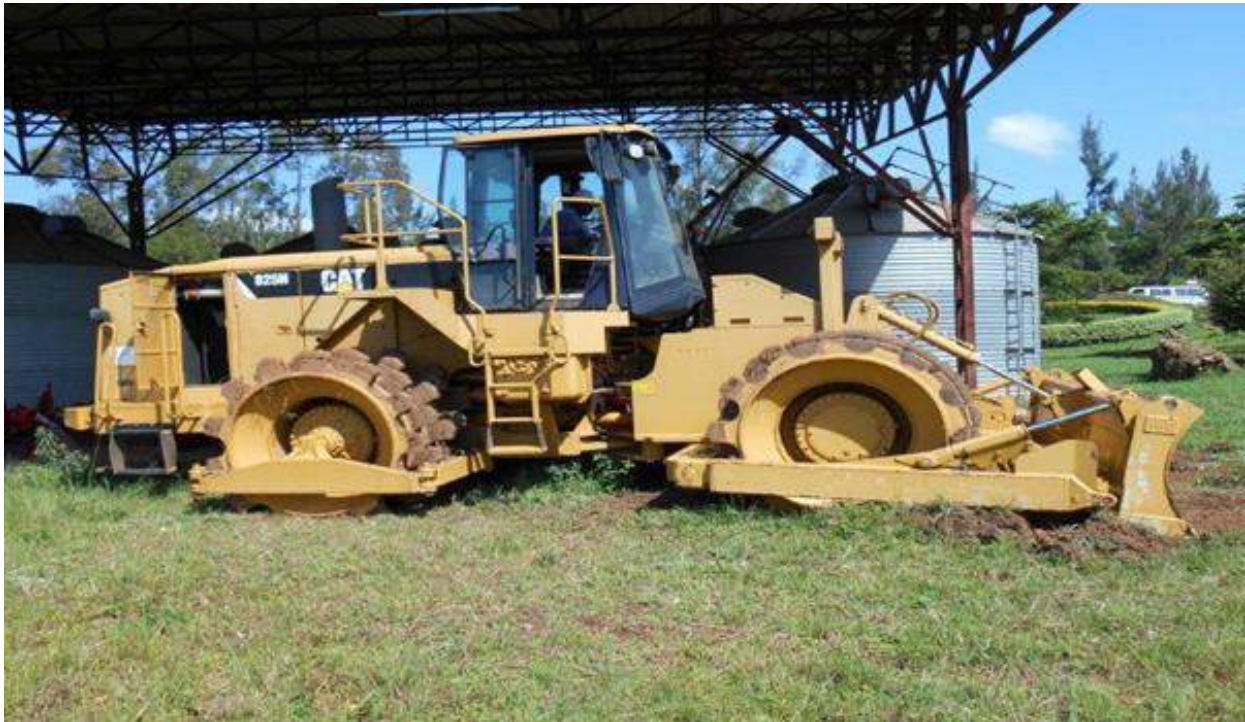
Soil compactor model CAT 825H with plate number GR 030D (side view) lying idle at Kabuye workshop. Photo taken on 6th November 2014.

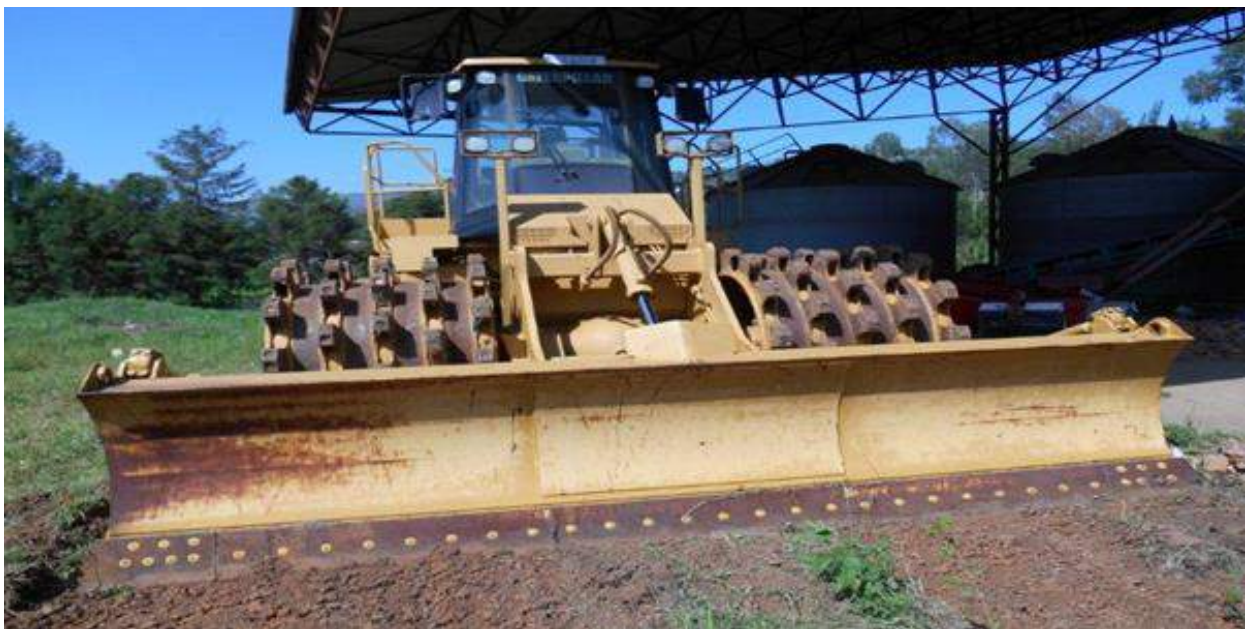
The soil compactor was acquired in 2010 at a cost of \$ 858,000 (equivalent to Frw 492,063,000⁹) and was meant to support MINAGRI in implementing irrigation activities through building of dams and other related irrigation infrastructure. However, it was found to be too big compared to the dimensions of dams that needed to be constructed. Consequently, it has not been used for irrigation related work. This soil compactor has for the most part been lying idle at Kabuye workshop since acquisition with the exception of small requests for hire by private firms. For the four years since its purchase, it has only operated for 101.7 hours. Taking an average working day of 8 hours implies that the soil compactor has only operated for 12.7 days over the four years. This gives an average of 3 days of operation for each year since its purchase.

I also noted that even with this level of underutilization, the task force still had to pay annual insurance amounting to Frw 15,071,000. See photos below for details:

Soil compactor model CAT 825H with plate number GR 030D (front view) lying idle at Kabuye workshop. Photo taken on 6th November 2014.

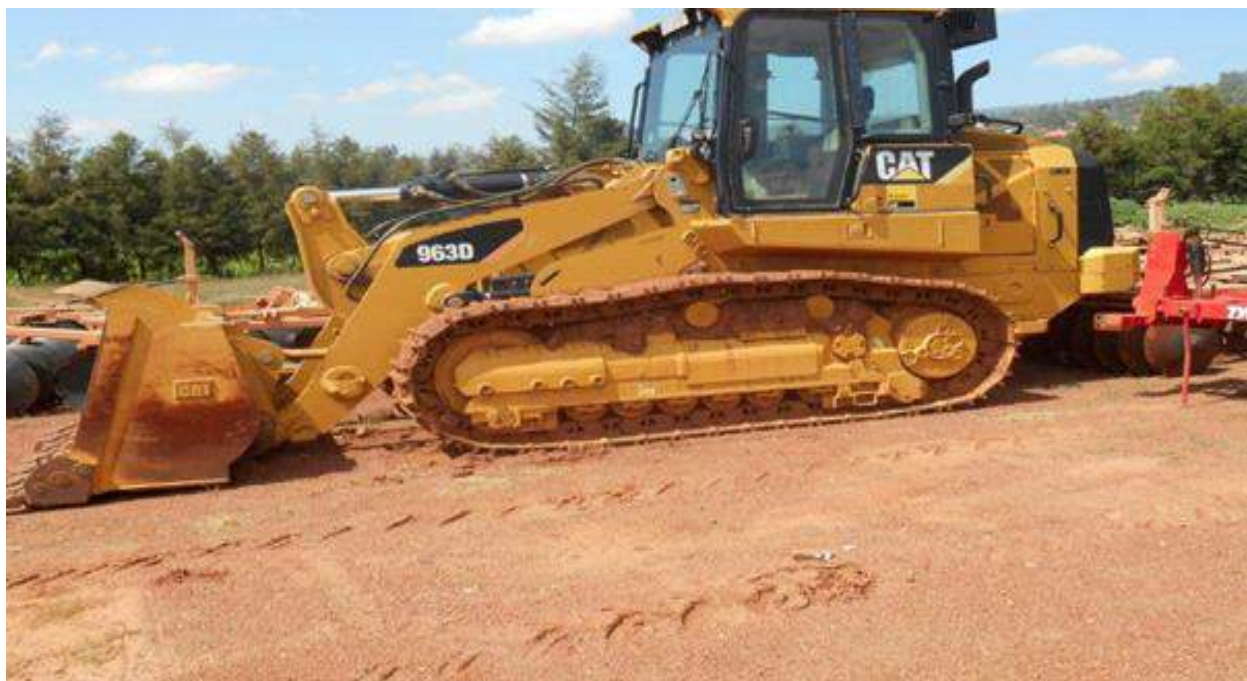
Track loader model CAT 963D with plate number GR 028D (side view) lying idle at Kabuye workshop. Photo taken on 6th November 2014.

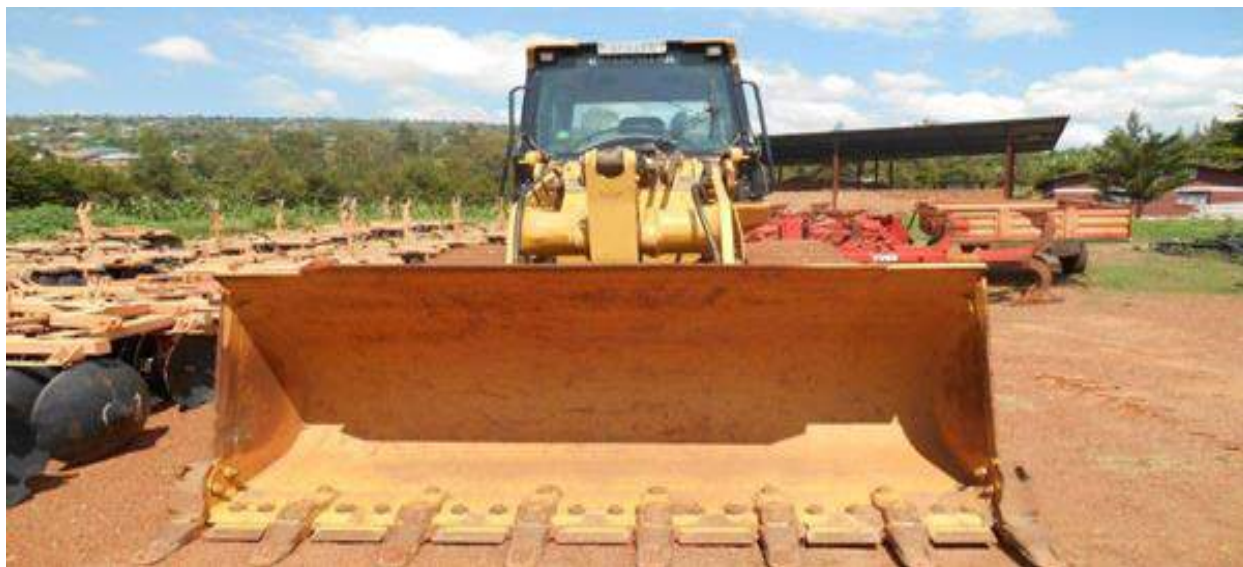
5.2.2. Track loader model CAT 963D with plate number GR 028D

(equivalent to Frw 220,224,000¹⁰) and was meant to support MINAGRI in implementing irrigation activities through building of dams and other related irrigation infrastructure. However, it was found to be too big compared to the dimensions of dams that needed to be constructed. Consequently, it has not been used and has been lying idle at Kabuye workshop since 18th March 2013.

I also noted that even with this level of underutilization, the task force still had to pay annual insurance amounting to Frw 6,825,505. See photos below for details:

Track loader model CAT 963D with plate number GR 028D (front view) lying idle at Kabuye workshop. Photo taken on 6th November 2014.

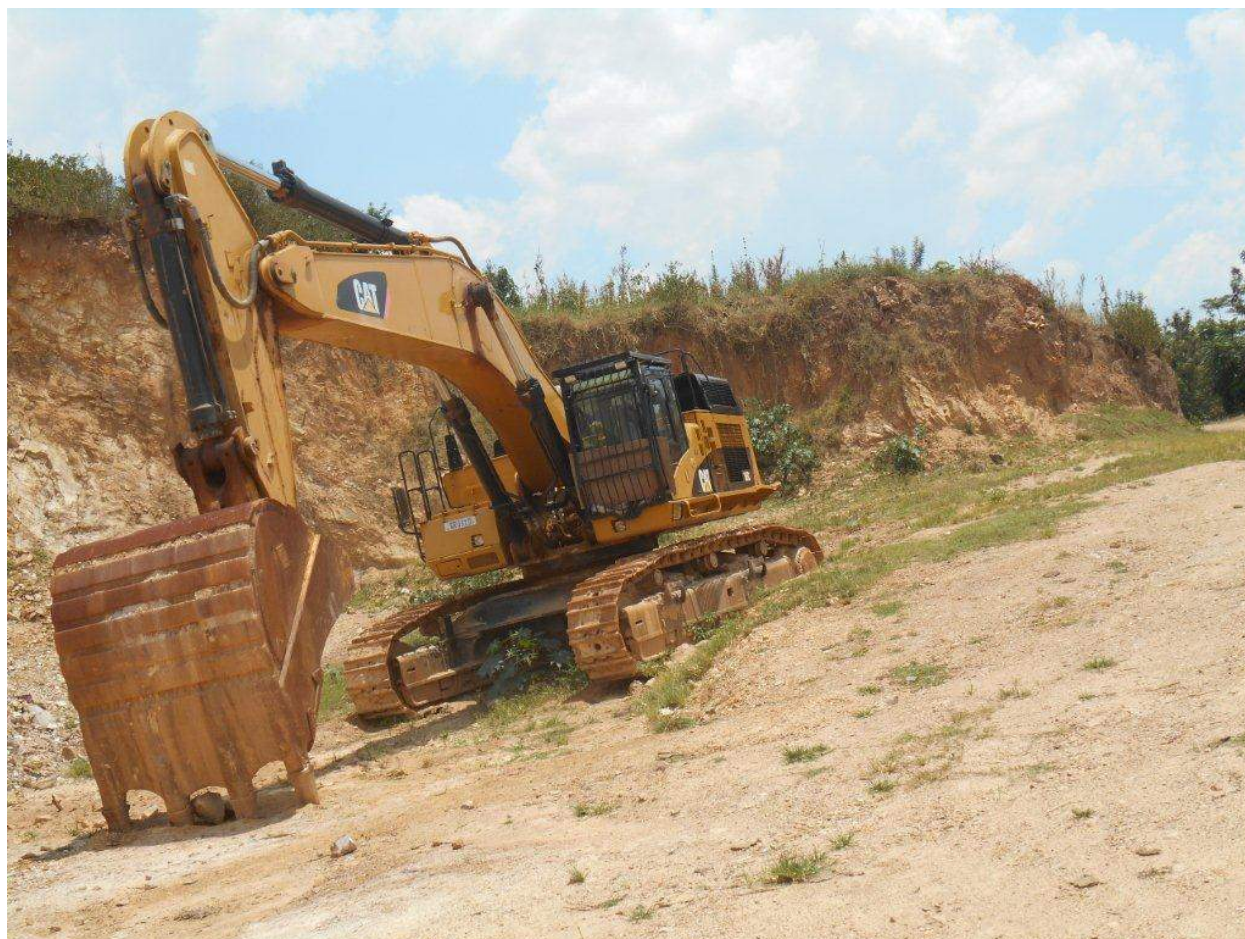
Excavator model number CAT 365CL with plate number GR 031D parked in Migina where it was on hire to a private engineering firm. By the time of the audit, the excavator had spent two weeks without work and was lying idle at the site. Photo taken on 13th February 2015.

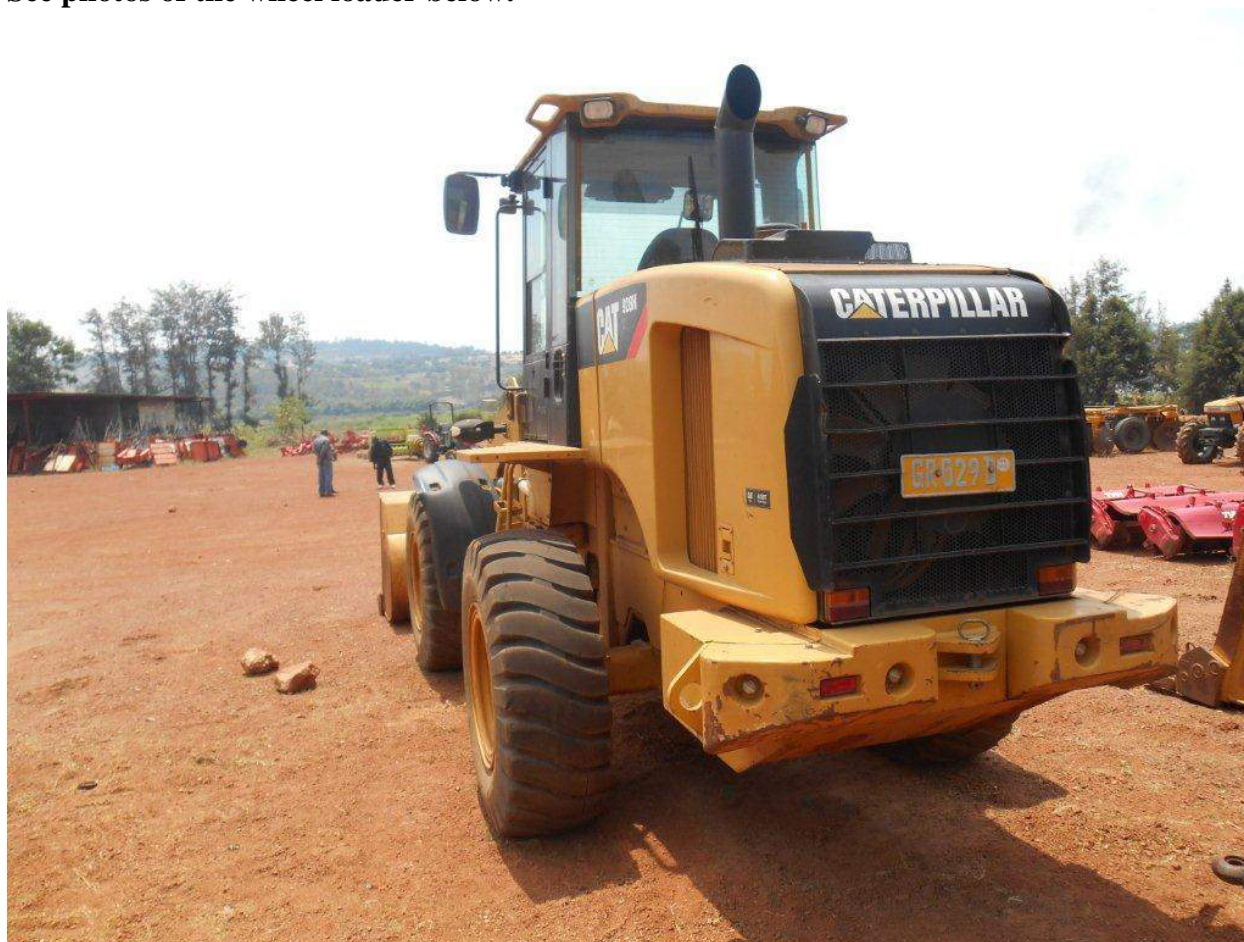
Wheel loader model number CAT 928Hz with plate number GR 029D (rear view) parked at Kabuye VMSC. Photo taken on 11th February 2015.

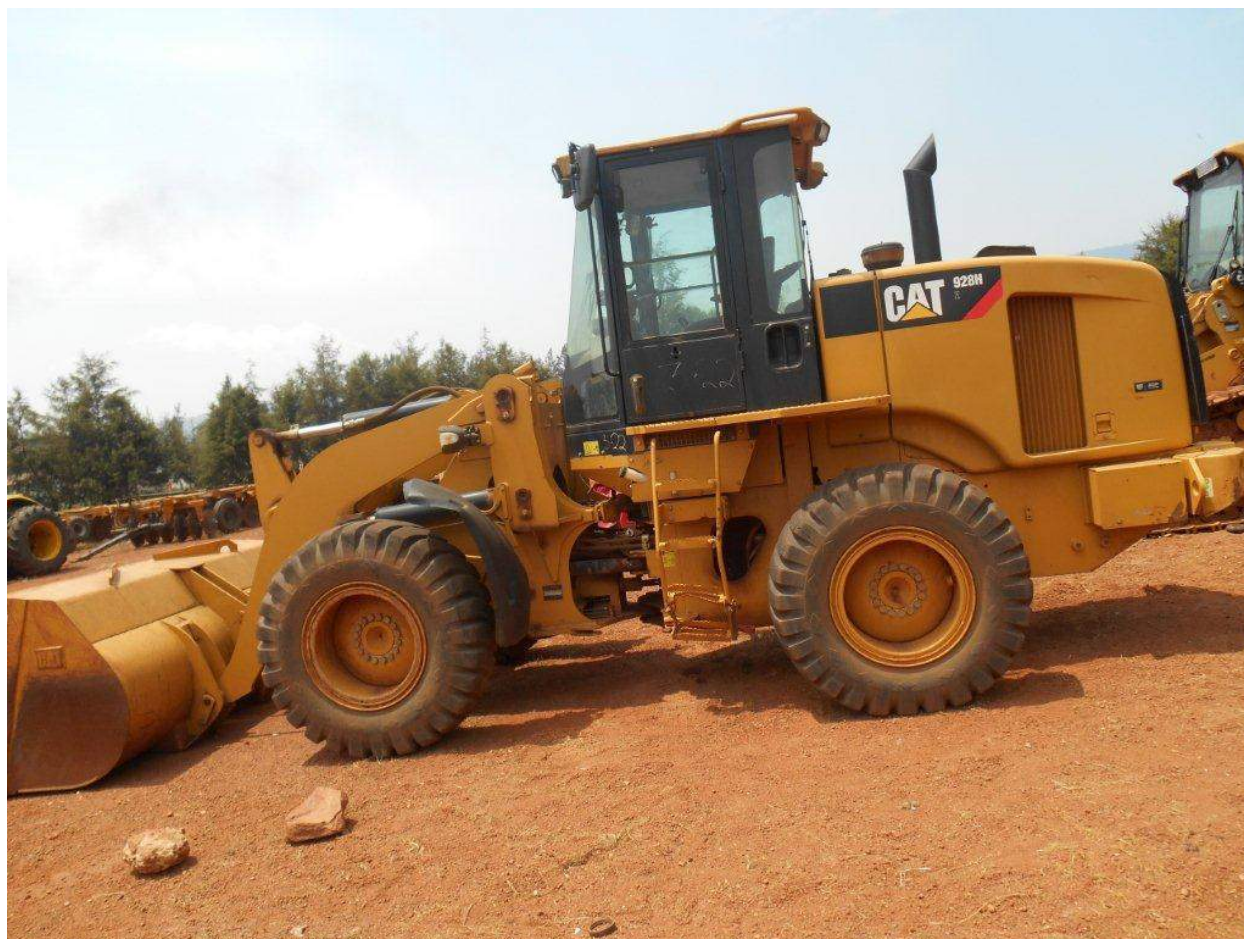
Wheel loader model number CAT 928Hz with plate number GR 029D (side view) parked at Kabuye VMSC. Photo taken on 11th February 2015.

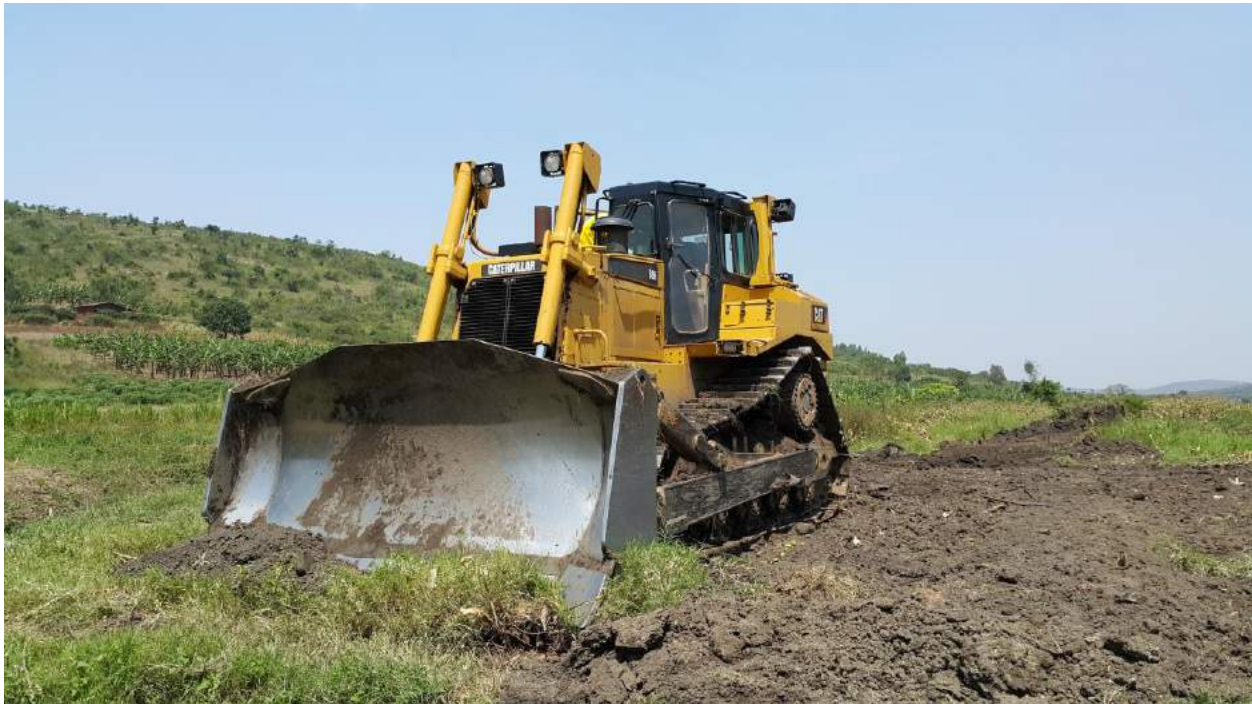
Bulldozer model CAT D8R with plate number GR 027D (front view) is in use and was found to be hired by RSSP in preparing a section of Gacaca marshland in Kayonza District. Photo taken on 28th January 2015.

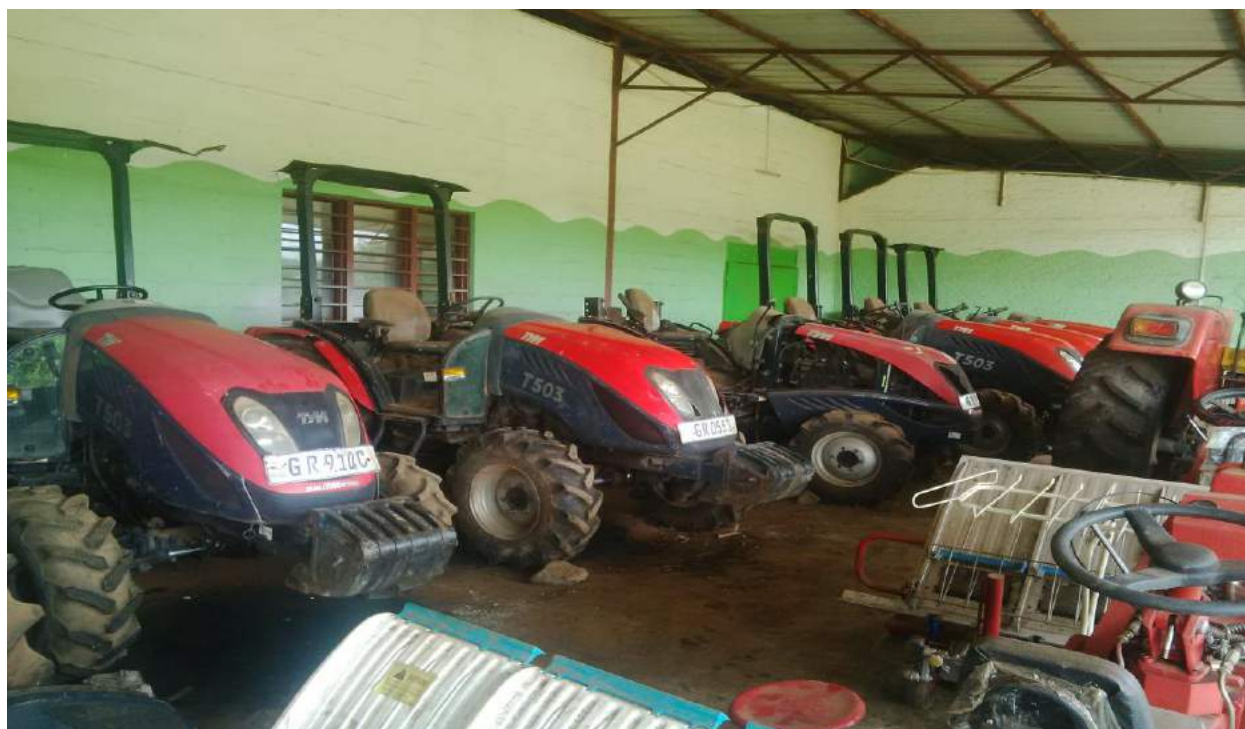
TYM tractors broken down and awaiting repair in Kabuye workshop. Photo taken on 04th November 2014.

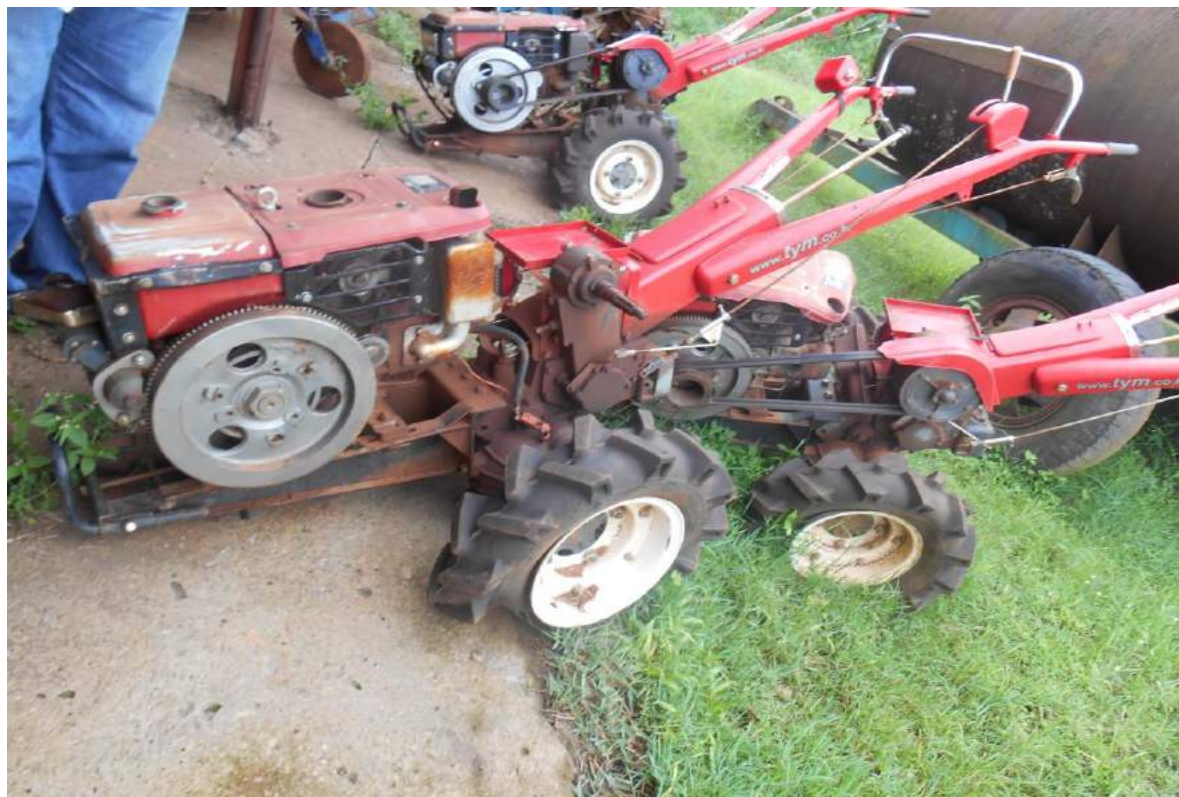
Power tillers broken down and awaiting repair in Kabuye workshop. Photo taken on 6th November 2014.

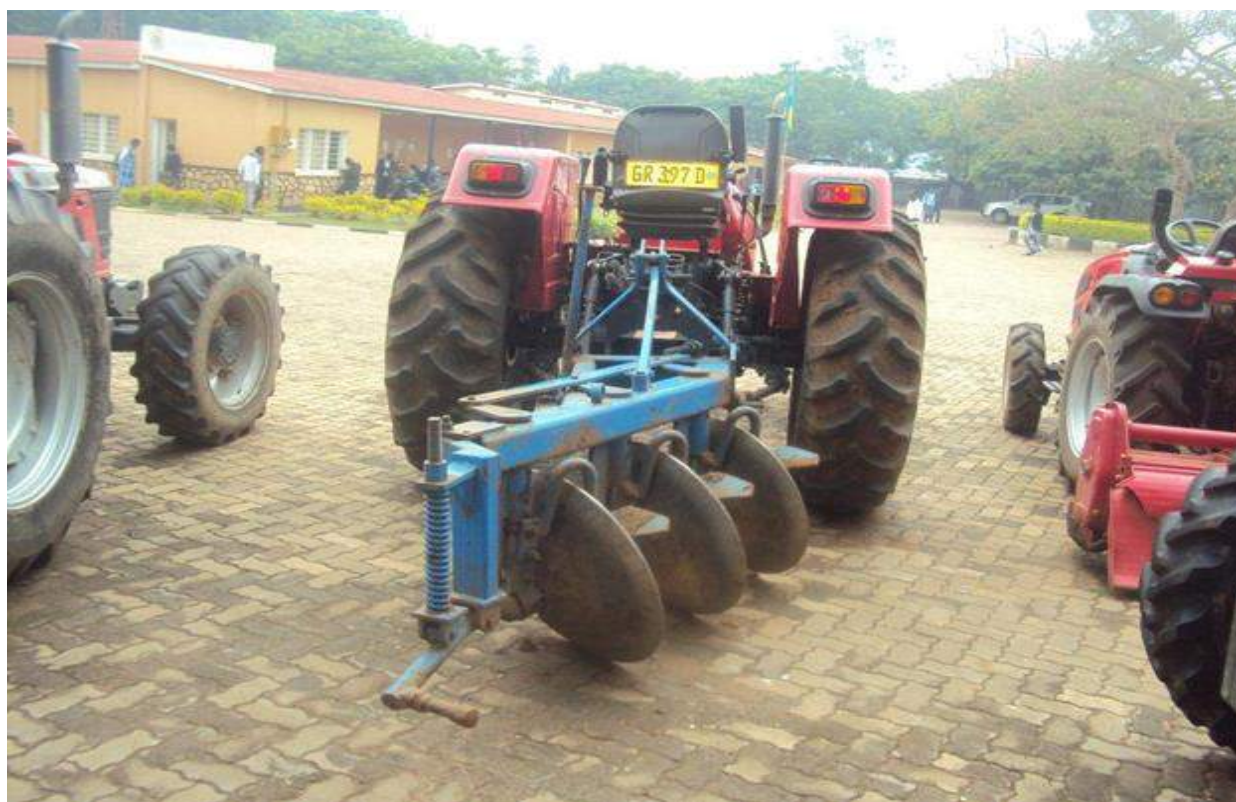
Tractors operating without ROPS. Photo taken at Bugesera VMSC on 26th January 2015.

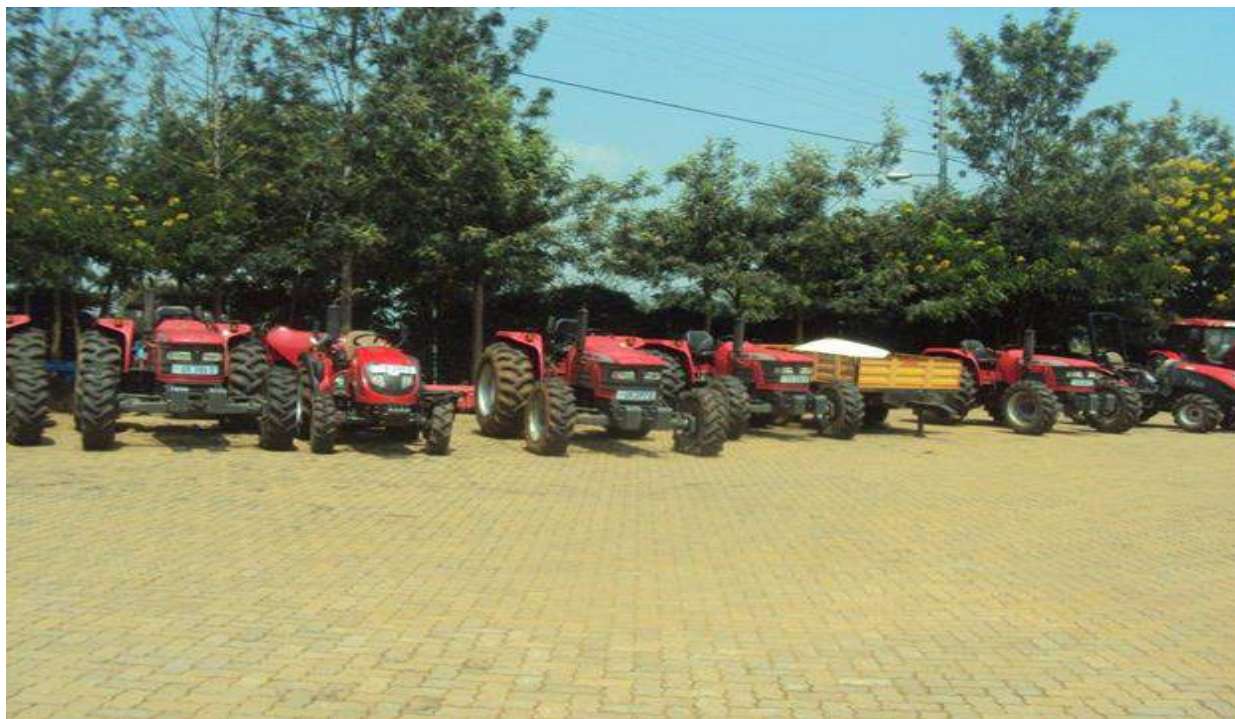
Tractors operating without ROPS. Photo taken at Bugesera VMSC on 26th January 2015.

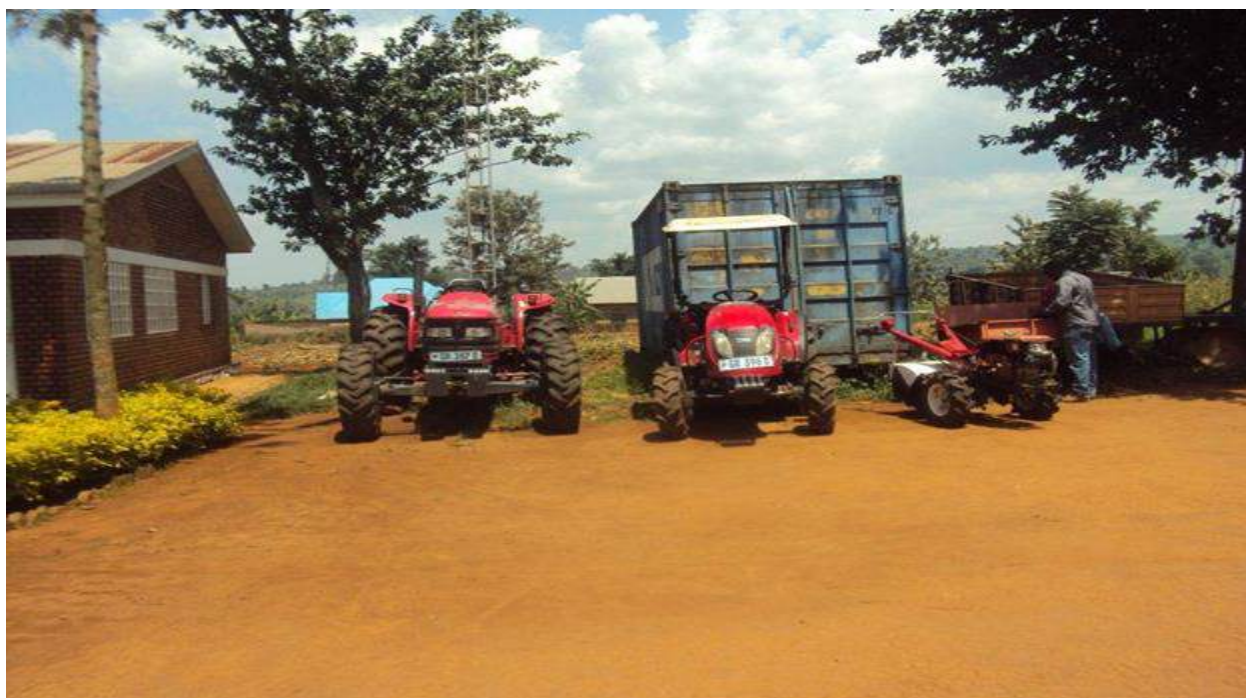
A Mahindra tractor on the left is not equipped with ROPS while a TYM tractor in the middle is equipped with it. Photo taken at Ngoma VMSC on 26th January 2015.

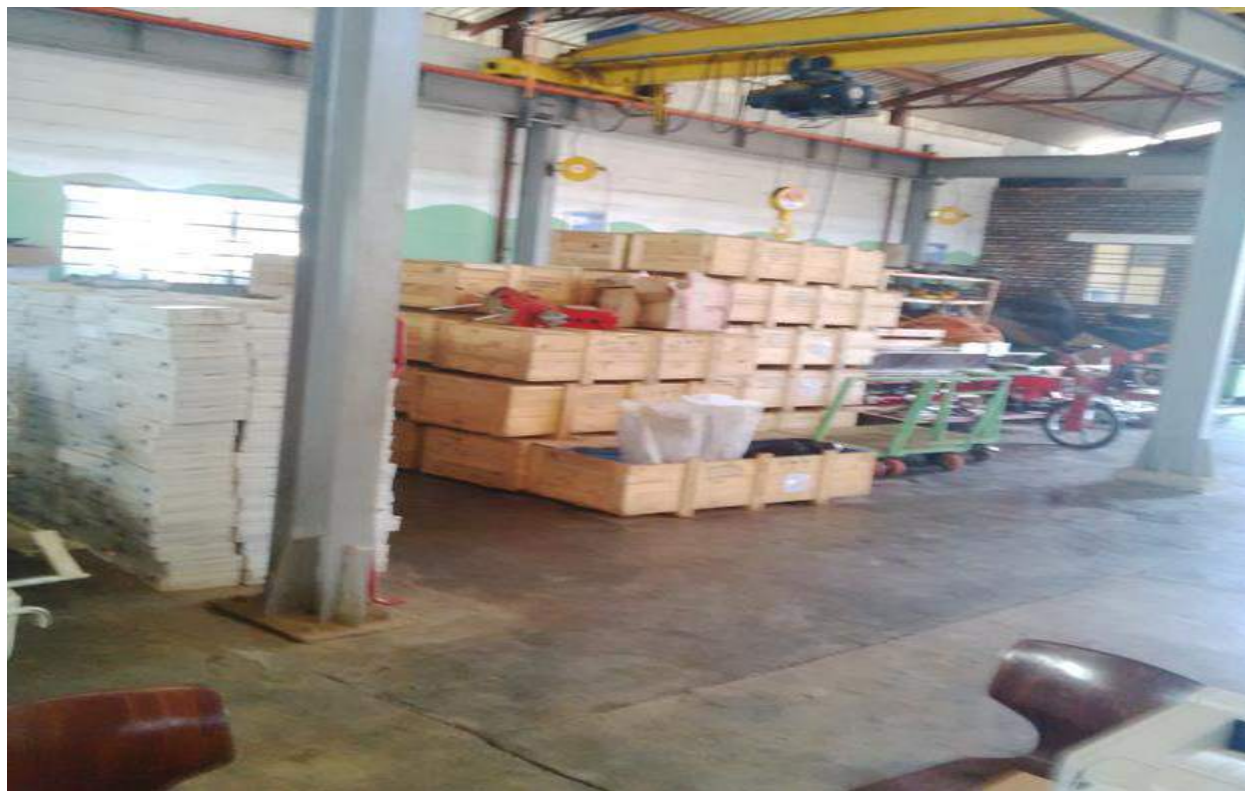
Brand new ROPS still packed in their wooden boxes remain unused at Kabuye workshop yet tractor operators are operating tractors in the field without adequate protection. Photo taken at Kabuye workshop on 6th November 2014.

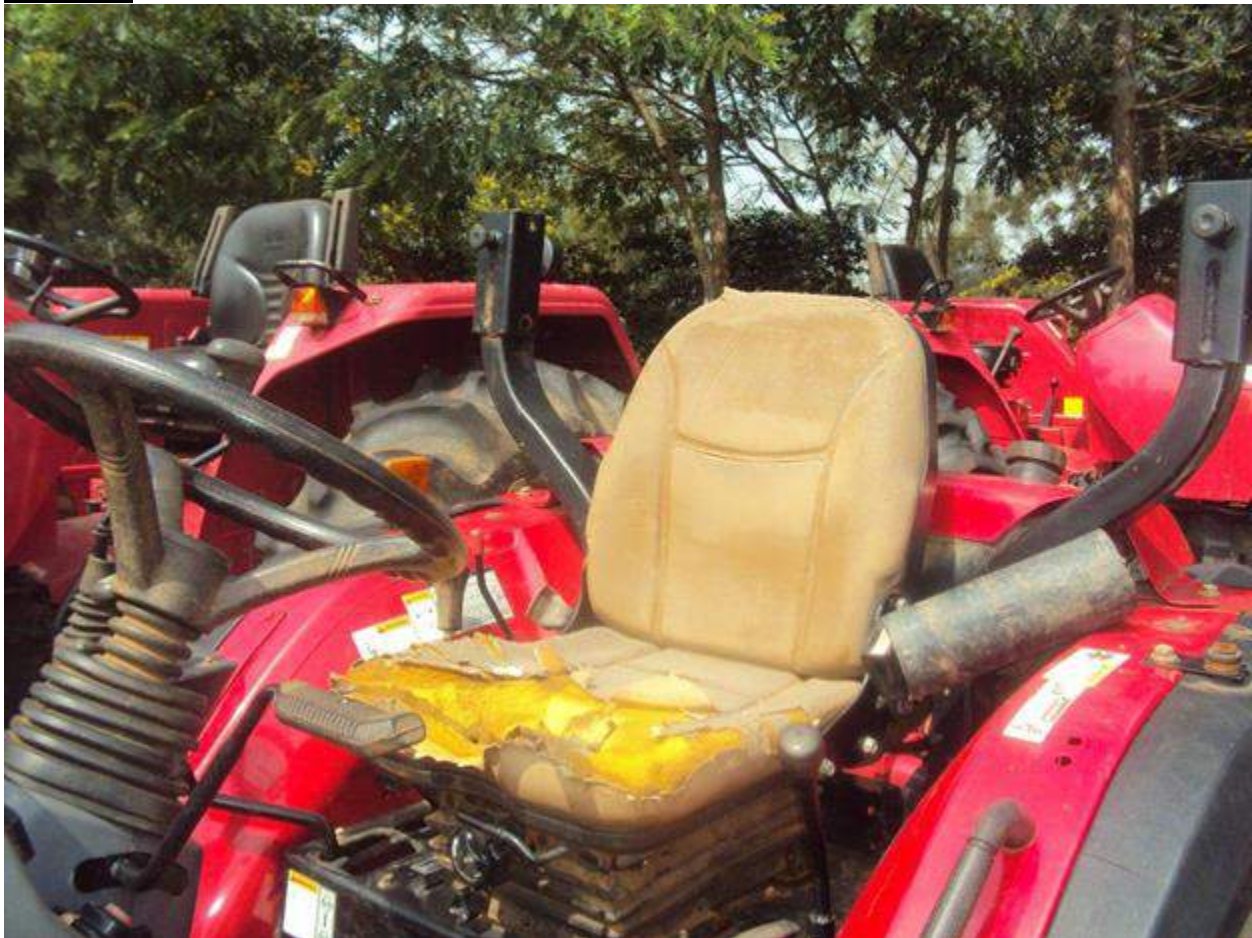
Tractor seats are worn out due to continued exposure to rain and humidity. Metal components below the seat have also started getting corroded yet the tractor has been operation for only one and a half years²⁴. Normally, a tractor can last 8 years when well maintained. Photo taken at Bugesera VMSC on 26th January 2015.

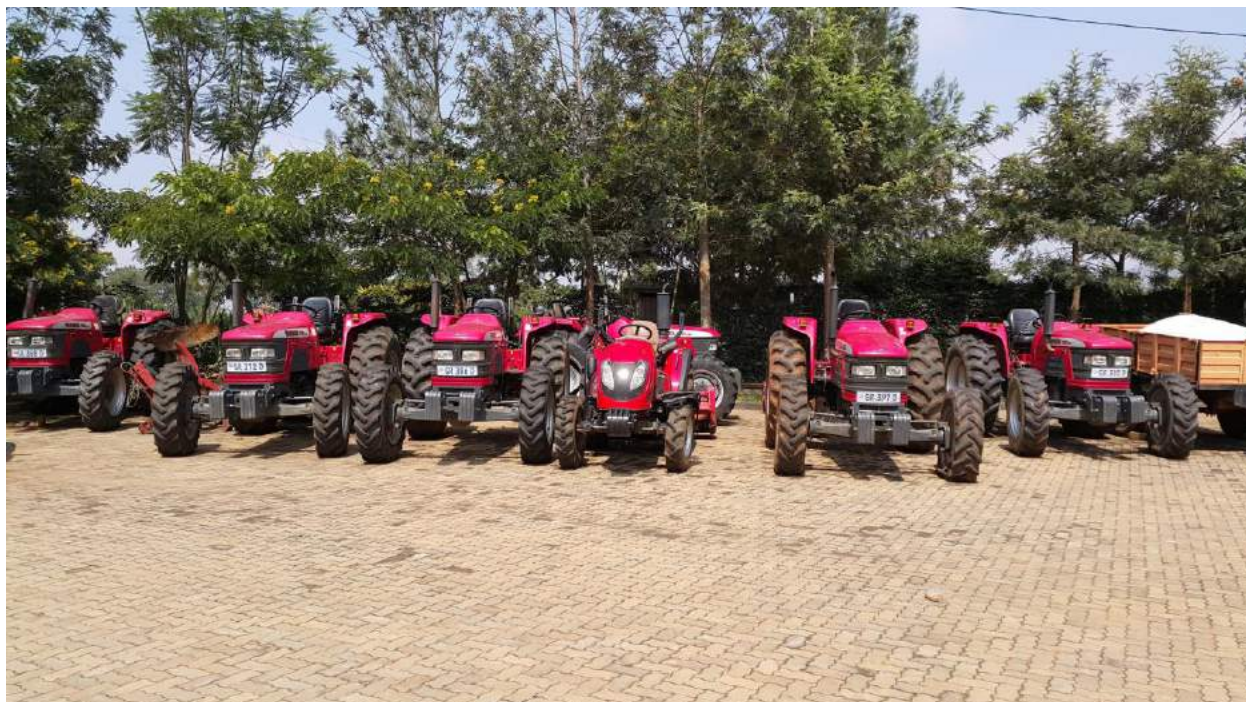
Tractors are parked in an exposed area without a protective shade. Photo taken at Bugesera VMSC on 26th January 2015.

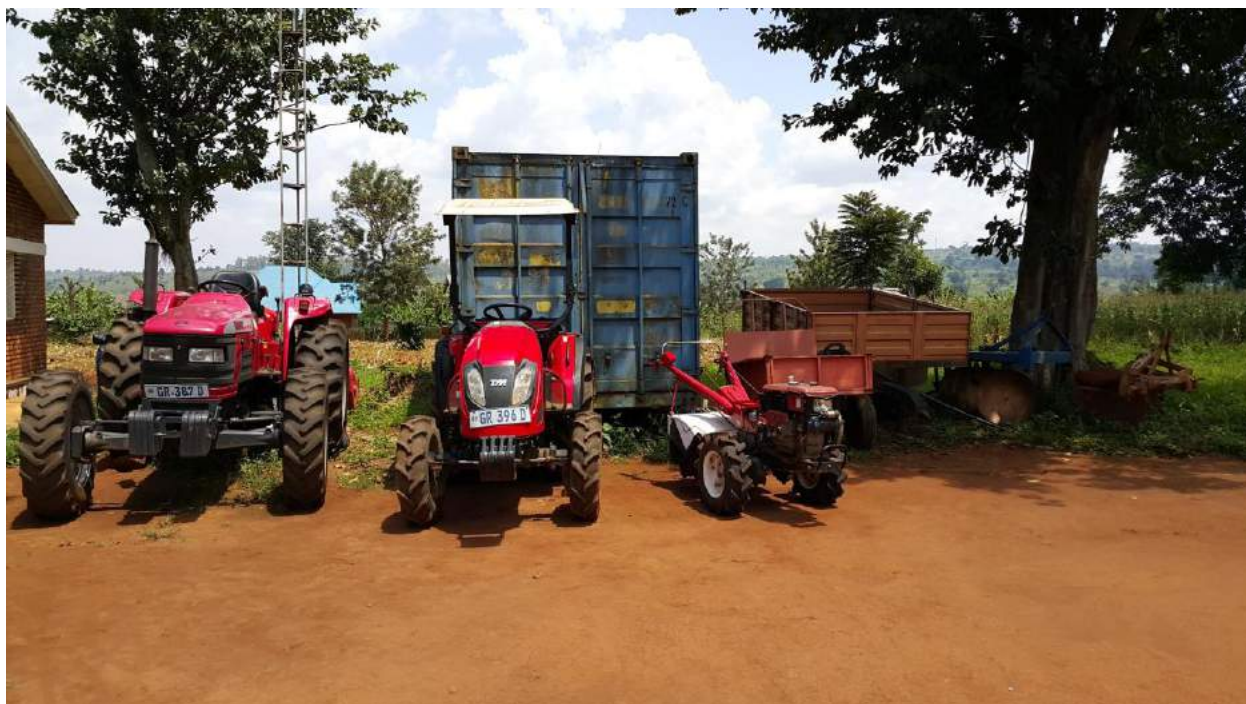
Tractors are parked in an exposed area without a protective shade. Photo taken at Ngoma VMSC on 26th January 2015.

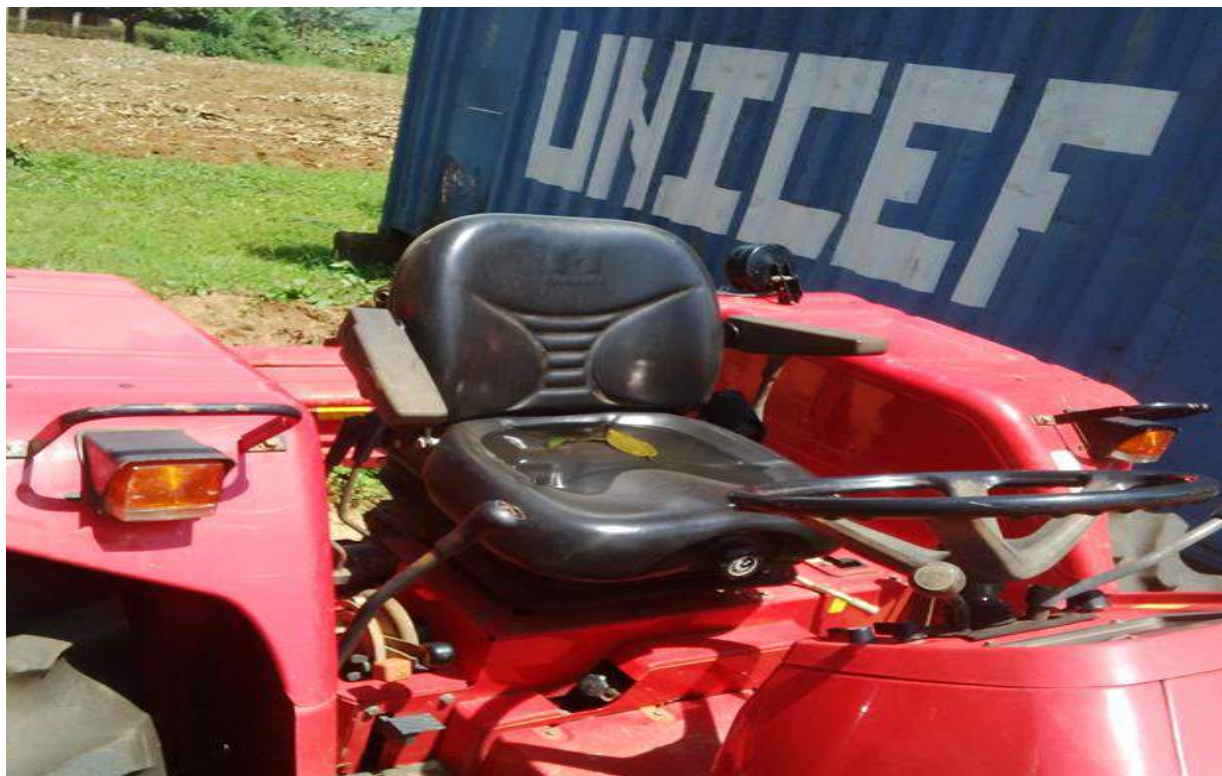
on tractor components leads to accelerated depreciation of these parts. Photo taken at Sake sector in Ngoma district on 26th January 2015.

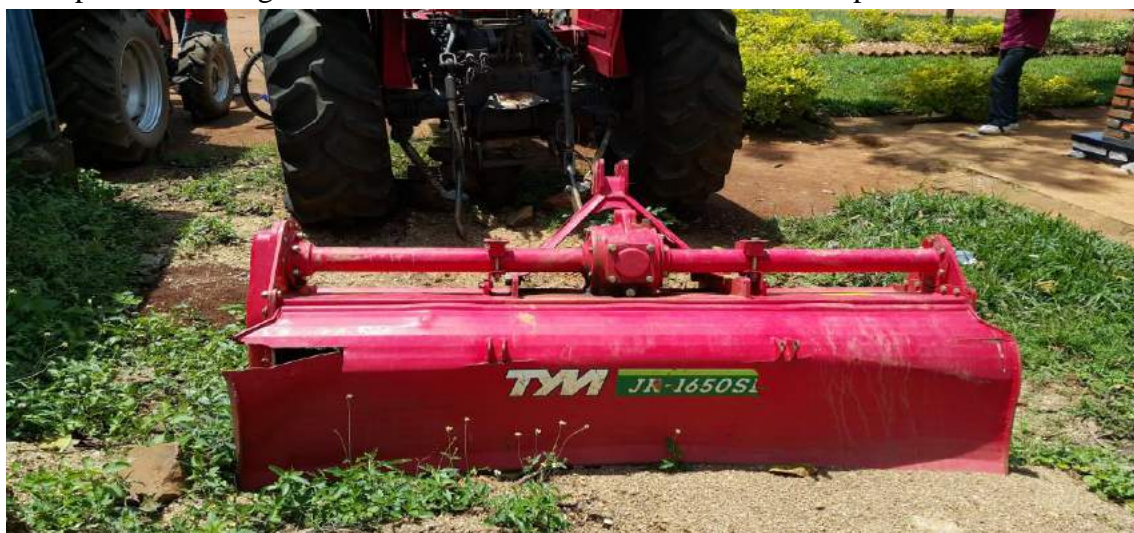
Ploughs are stored in the open where they are exposed to continuous sunlight and rain. This one was damaged but not repaired. Photo taken at Sake sector in Ngoma VMSC on 26th January 2015.

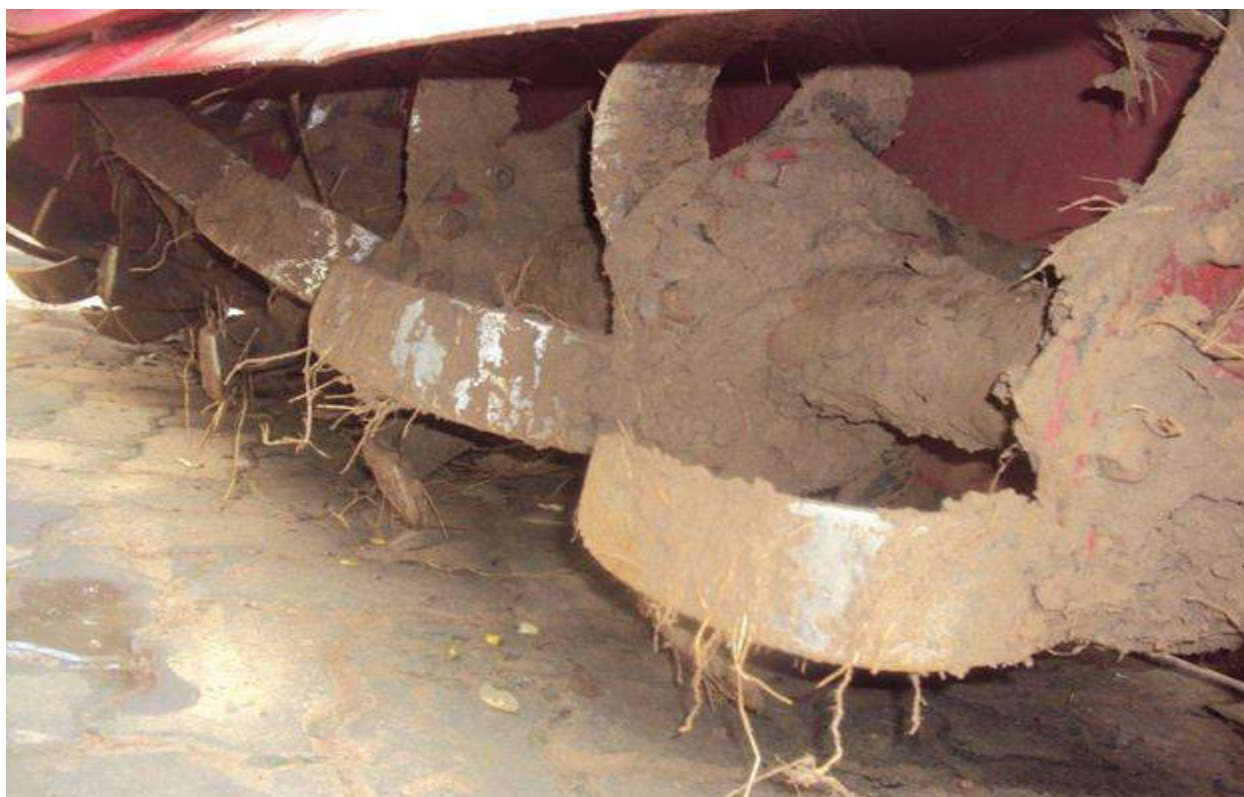
On removing the plough cover plate, it shows the extent to which they are poorly maintained. The ploughs are not cleaned on completion of each task from the garden and yet they are continuously exposed to humidity. This poor handling exposes the ploughs to rusting within a very short period. Photo taken at Bugesera VMSC on 26th January 2015.

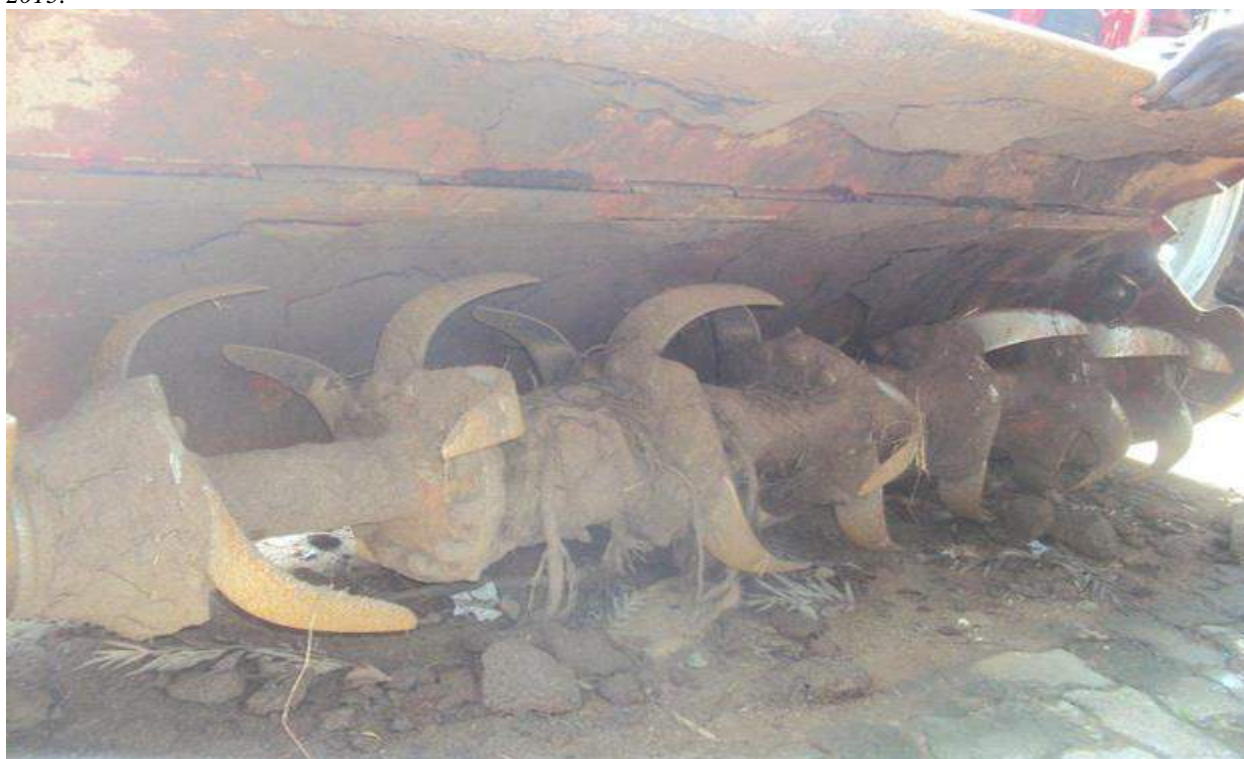
Rotary ploughs are found scattered outside Bugesera district headquarter grounds. They are corroded and worn out and are susceptible to breakdown on return to service. Photo taken on 26th January 2015.
