**OFFICE OF THE AUDITOR GENERAL
OF STATE FINANCES, RWANDA**

**PERFORMANCE AUDIT REPORT ON UTILIZATION AND MAINTENANCE OF
IRRIGATION AND MECHANIZATION EQUIPMENT**

May 2015

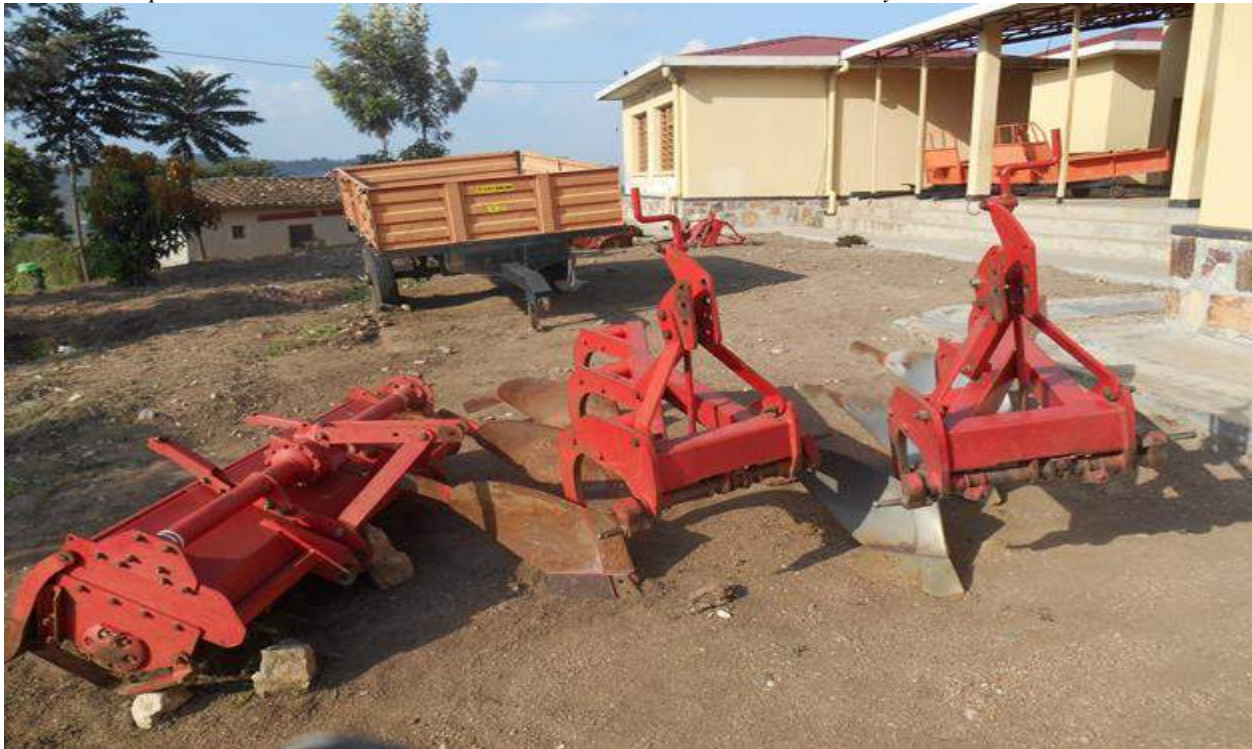
Ploughs are left outside on the ground. They are continuously exposed to the sun and rain in Nyanza VMSC. Photo taken on 12th January 2015

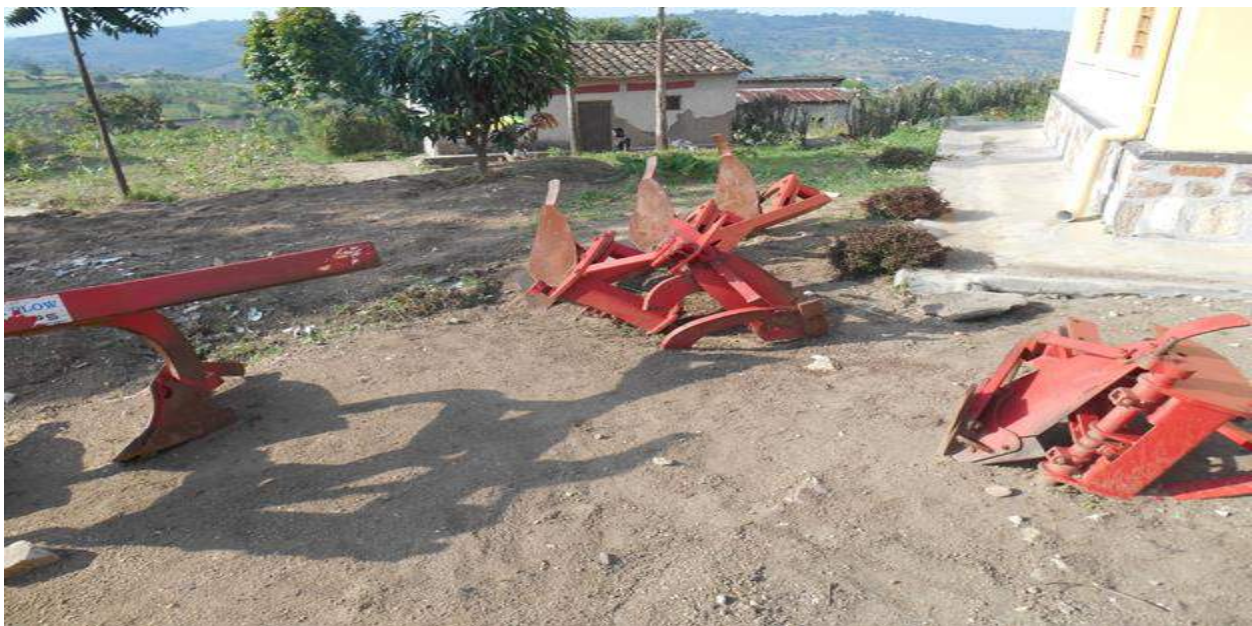
Additional disc ploughs that were damaged and left unrepaired outside Nyanza VMSC. Photo taken on 12th January 2015

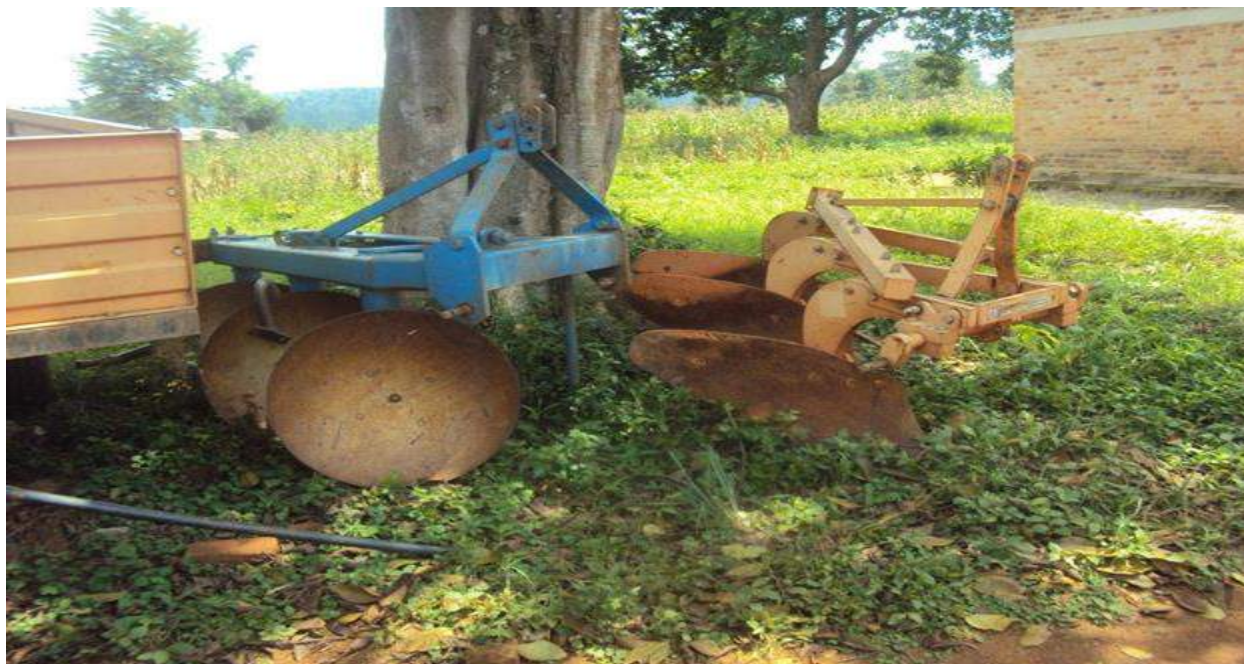
Ploughs are scattered in the grounds of Sake sector in Ngoma district. Both ploughs have started to rust and their future use is in doubt. Photo taken on 26th January 2015.

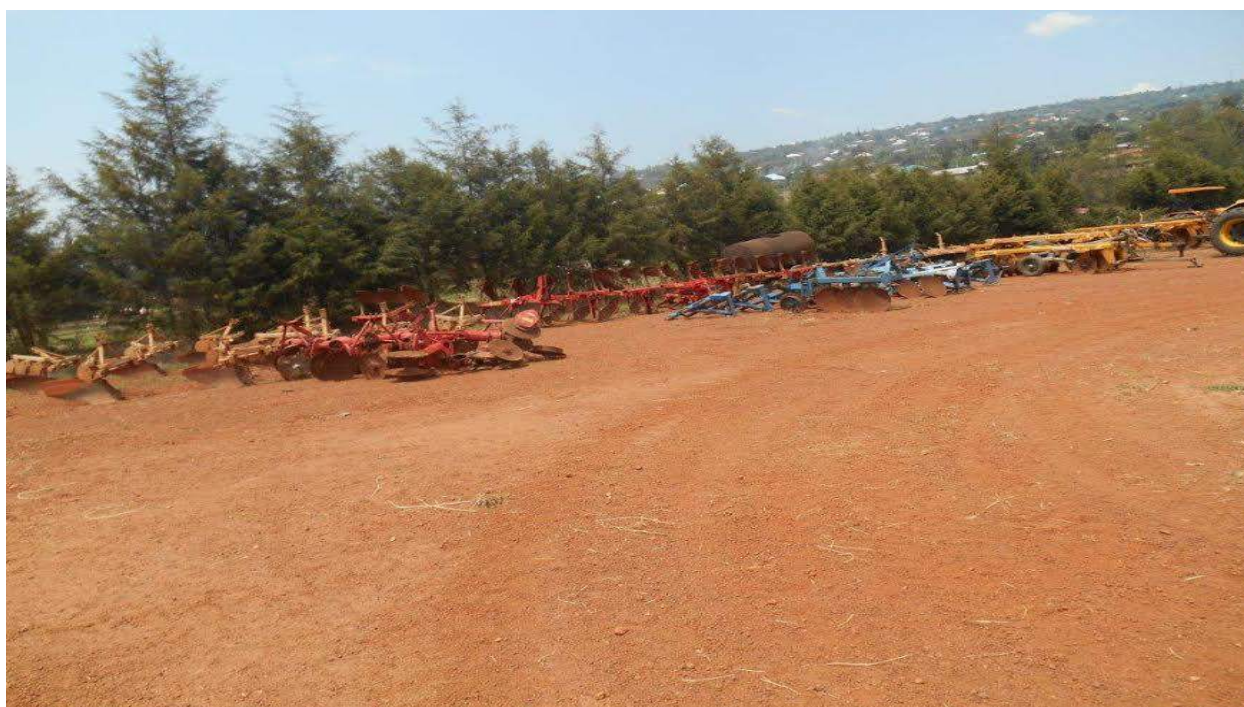
Tractor attachments kept in the open at Kabuye VMSC. They are continuously exposed to rain and humidity making them susceptible to rust. Photo taken on 10th January 2015.

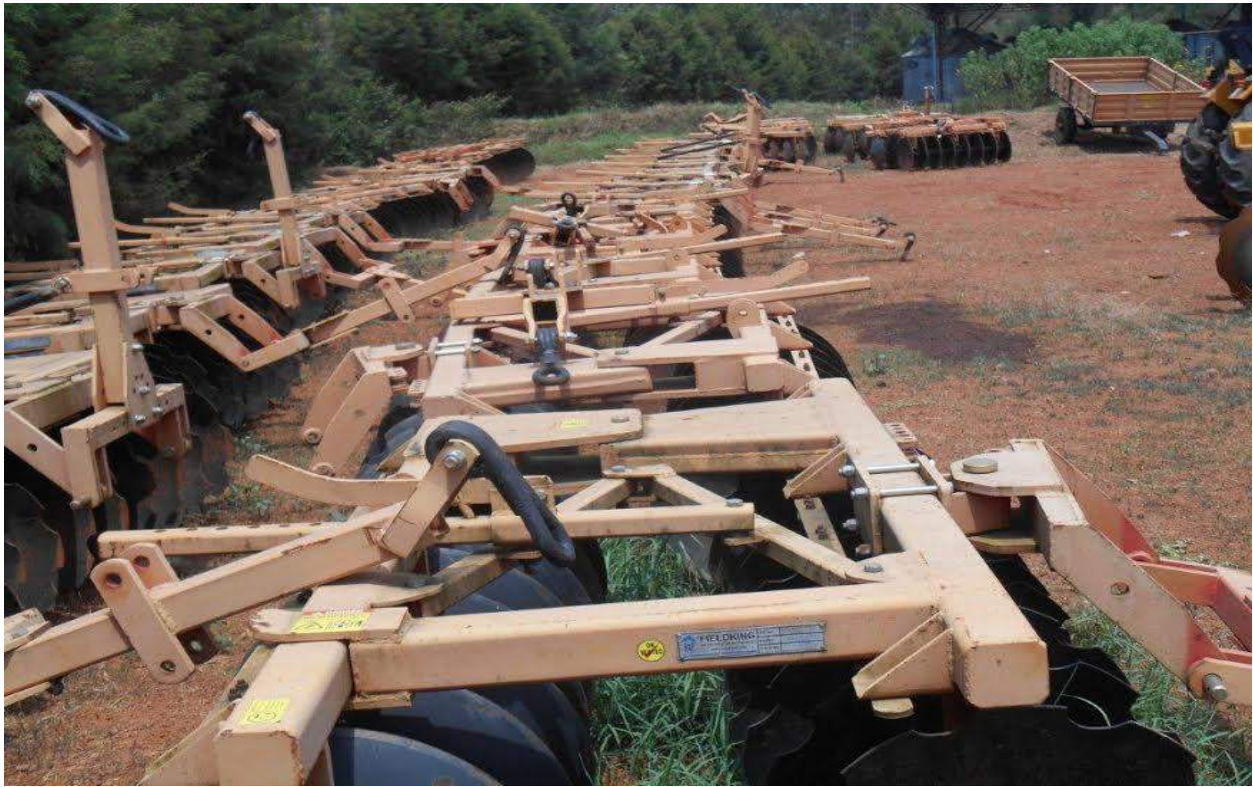
Additional tractor attachments kept in the open at Kabuye VMSC. They are continuously exposed to rain and humidity making them susceptible to rust. Photo taken on 10th January 2015.

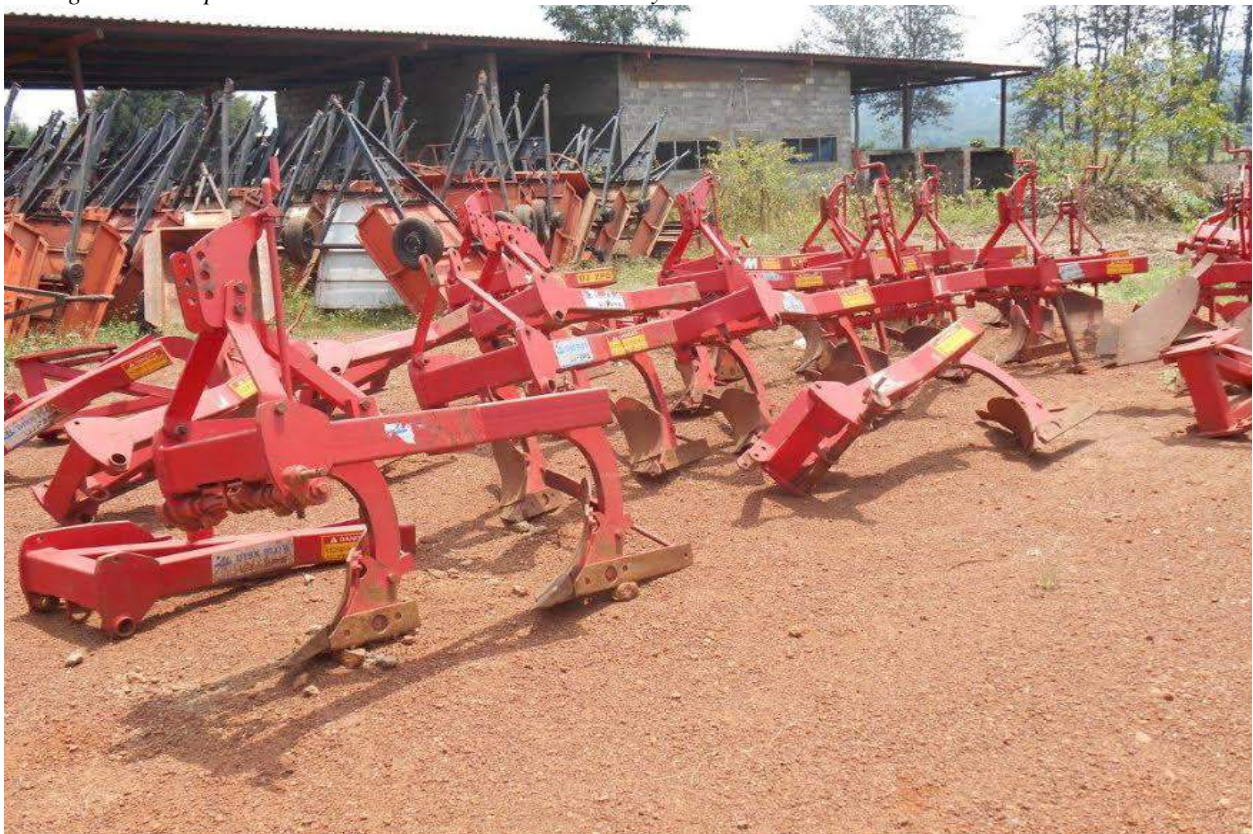
Tractor ploughs kept in the open at Kabuye VMSC. They are continuously exposed to rain and humidity making them

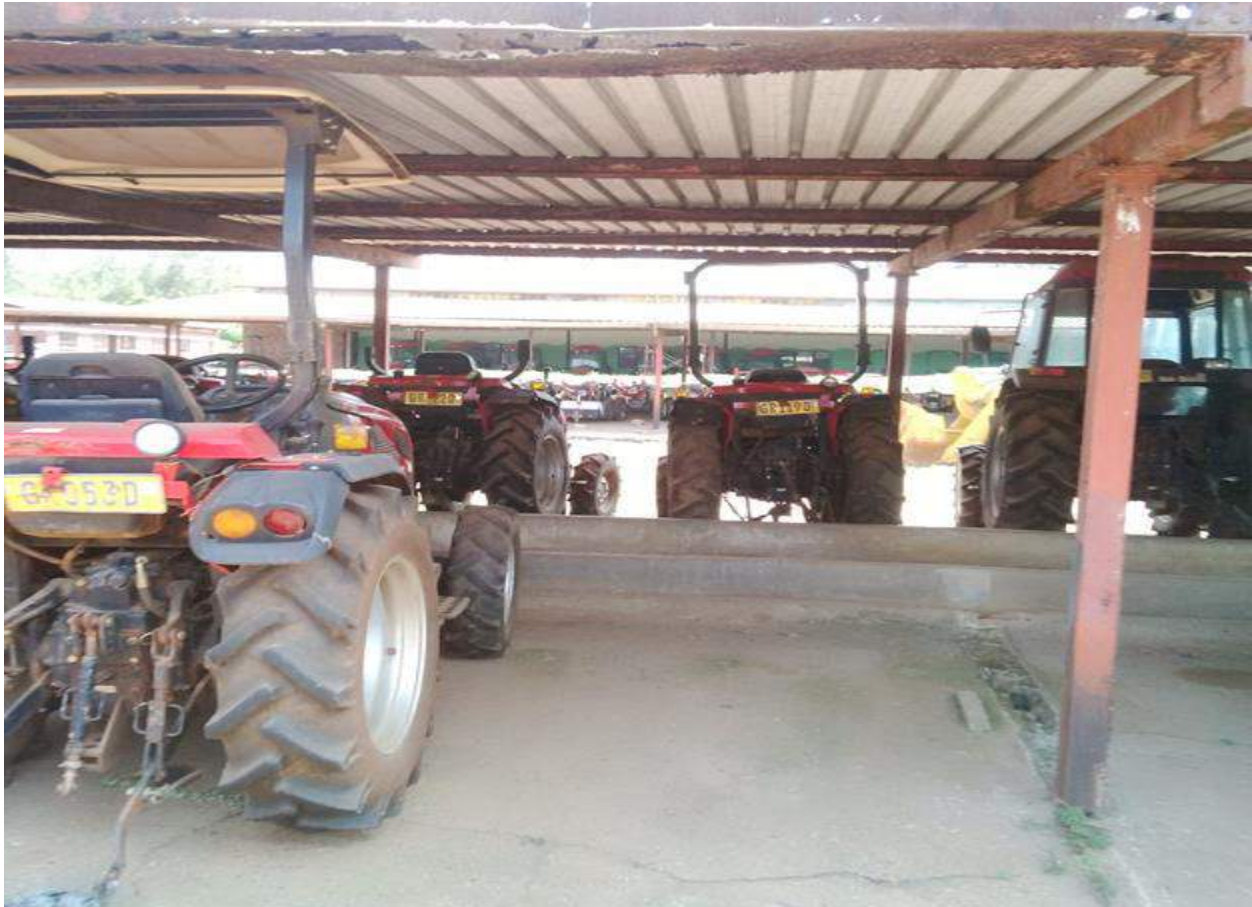
According to best practice, it is expected that machines with metal components should be safely stored under a protective shed. An example is depicted in the photo below where tractors are appropriately parked in a simple shed at the central workshop in Kabuye. This protects the machinery against rain and humidity and ensures a longer and productive life of the asset.

Tractors in Kabuye workshop appropriately parked in a protected area. Photo taken on 6th November 2014.

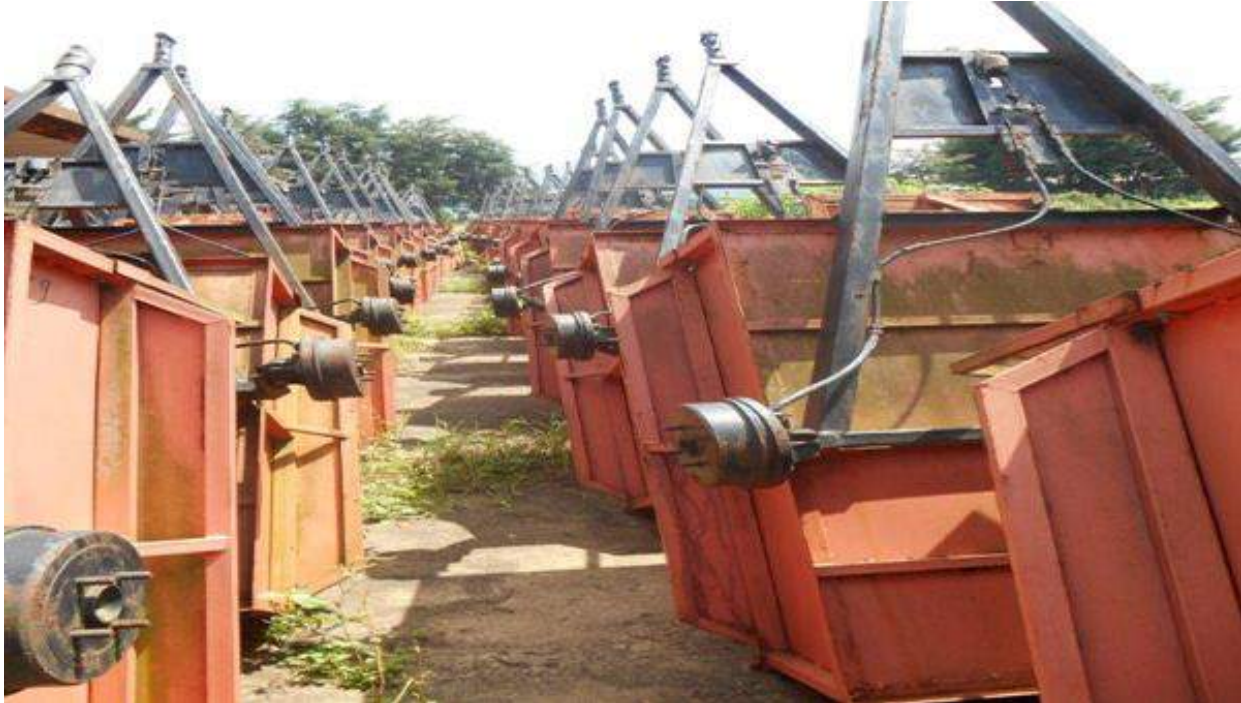
The trailer bodies are continuously exposed to direct sunlight and rain water leading to rapid degradation through rusting. Photo taken at Kabuye workshop on 6th November 2014.

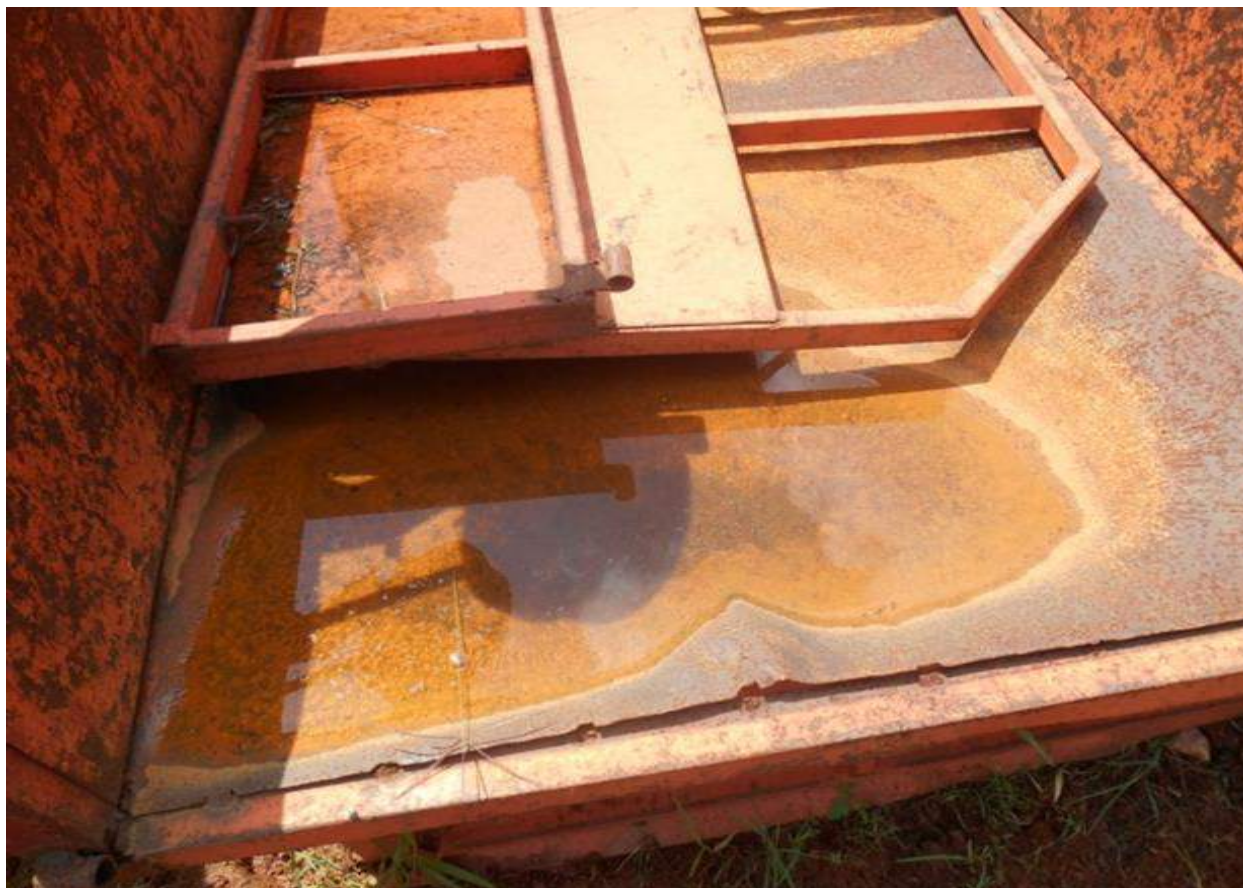
A combination of rainwater and sunlight has resulted in rusting of the trailer bodies. Photo taken at Kabuye workshop on 6th November 2014.

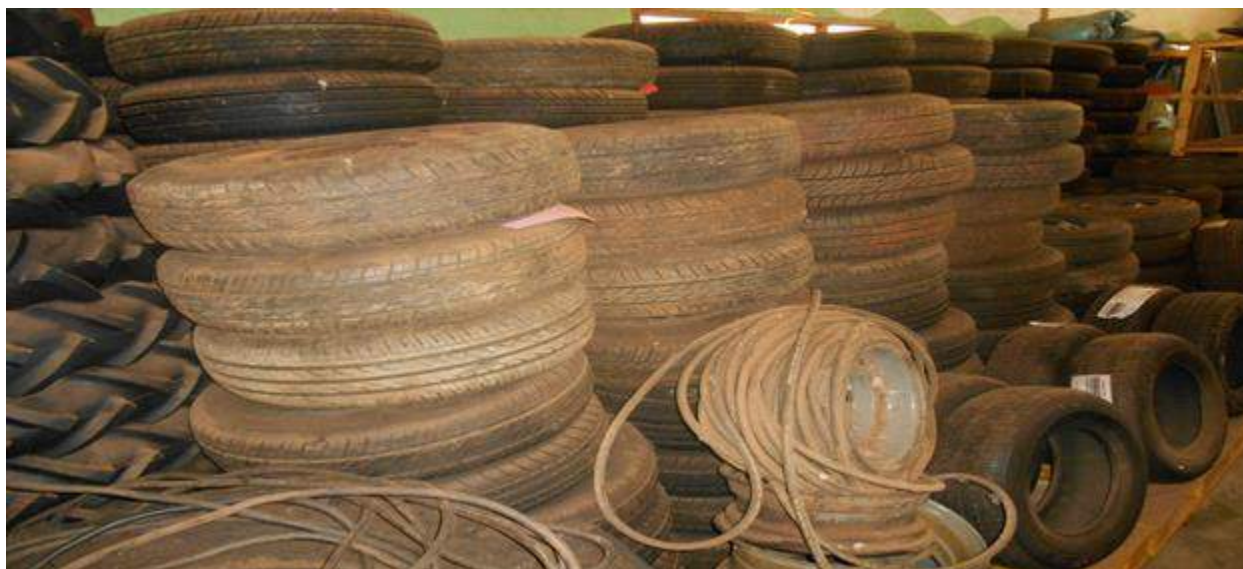
Trailer tyres have been kept unused inside the workshop since October 2011. Photo taken at Kabuye workshop on 6th November 2014.

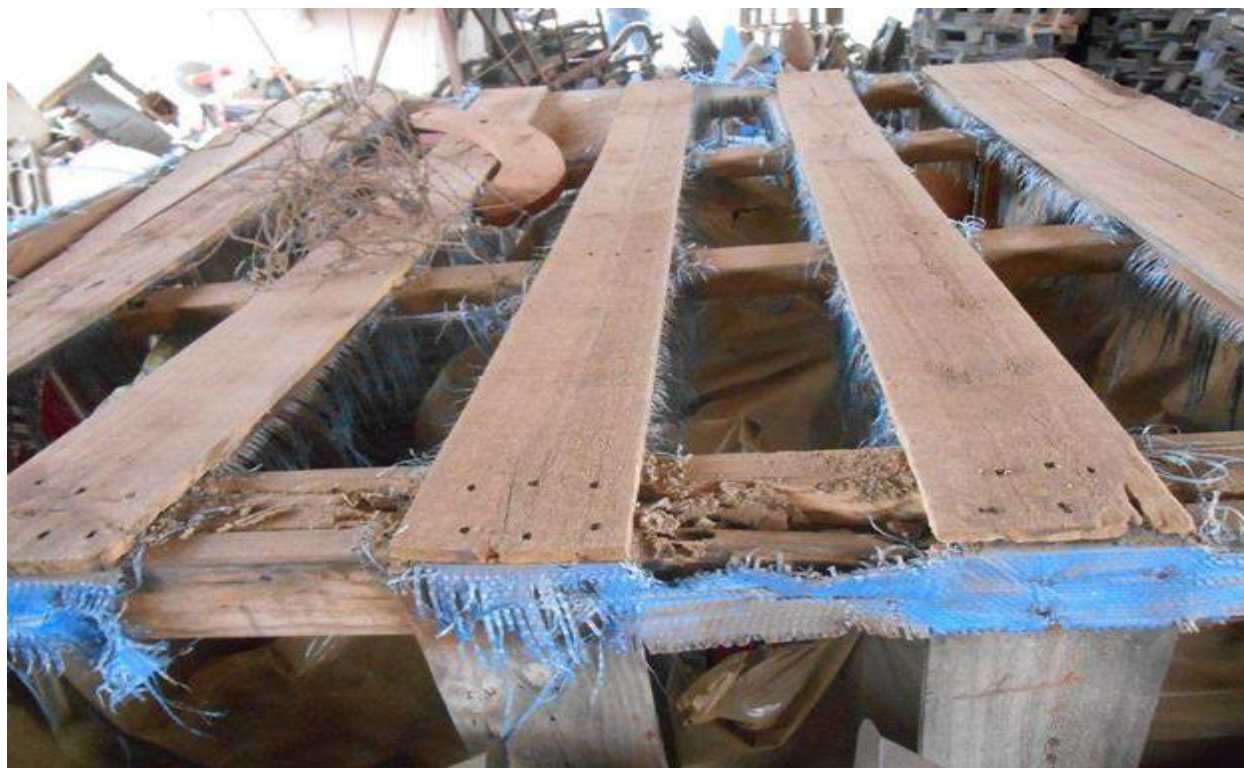
New potato harvesters still wrapped in their delivery packaging. Photo taken at Kabuye workshop on 6th November 2014.

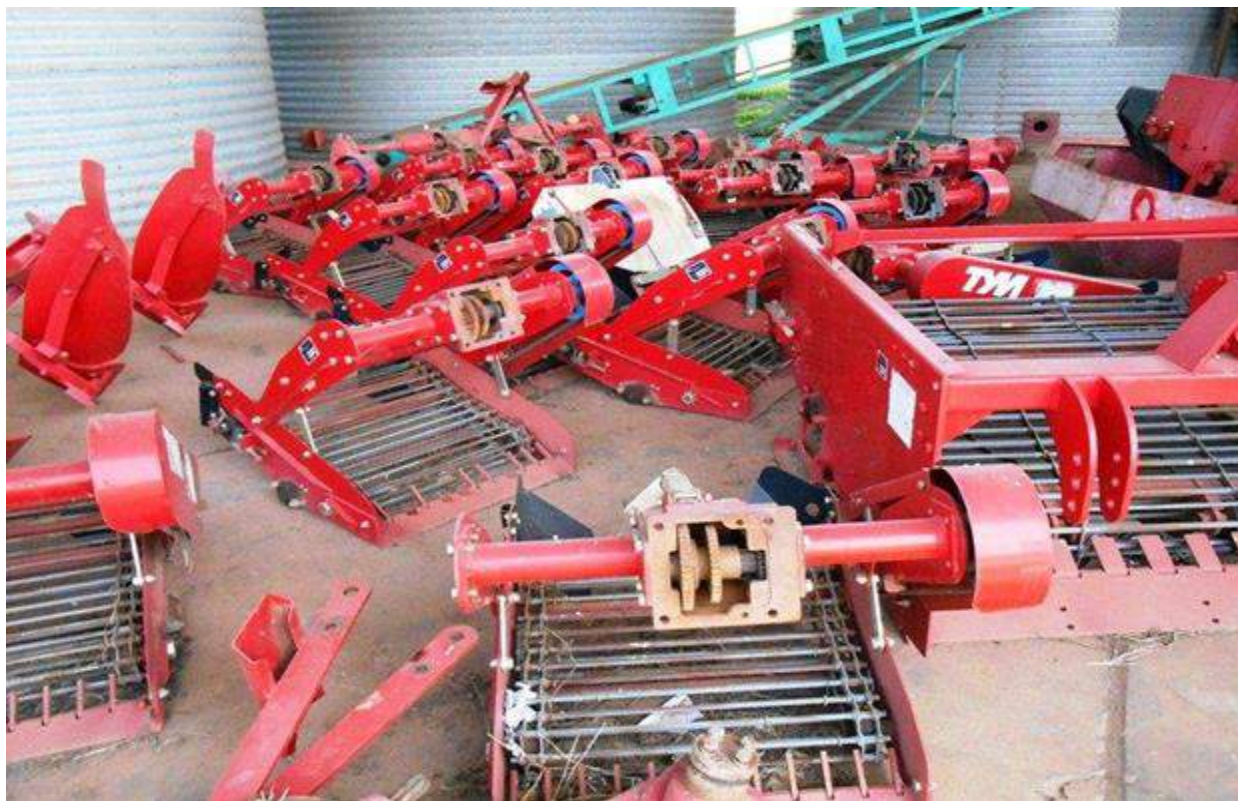
Potato harvesters lying idle at Kabuye workshop. Photo taken on 6th November 2014.

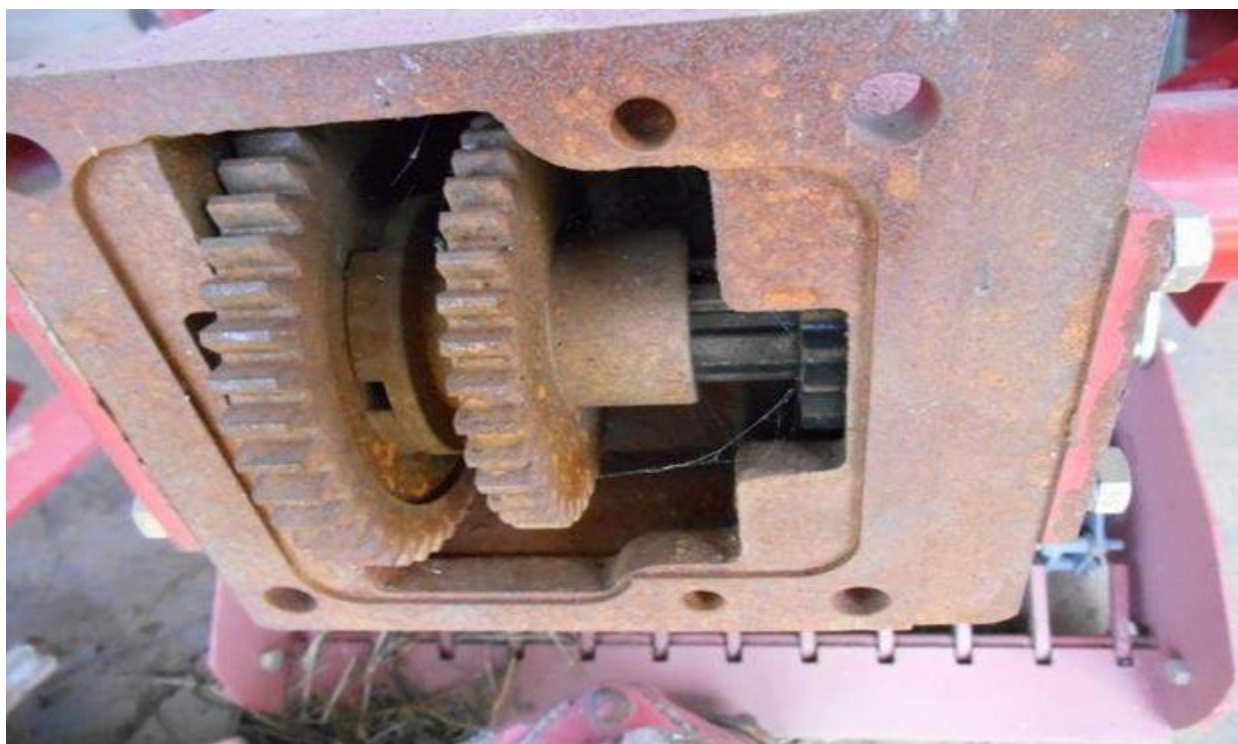
Potato harvester parts are not protected against moisture in the workshop leading to degradation through rusting. Photo taken at Kabuye workshop on 6th November 2014.

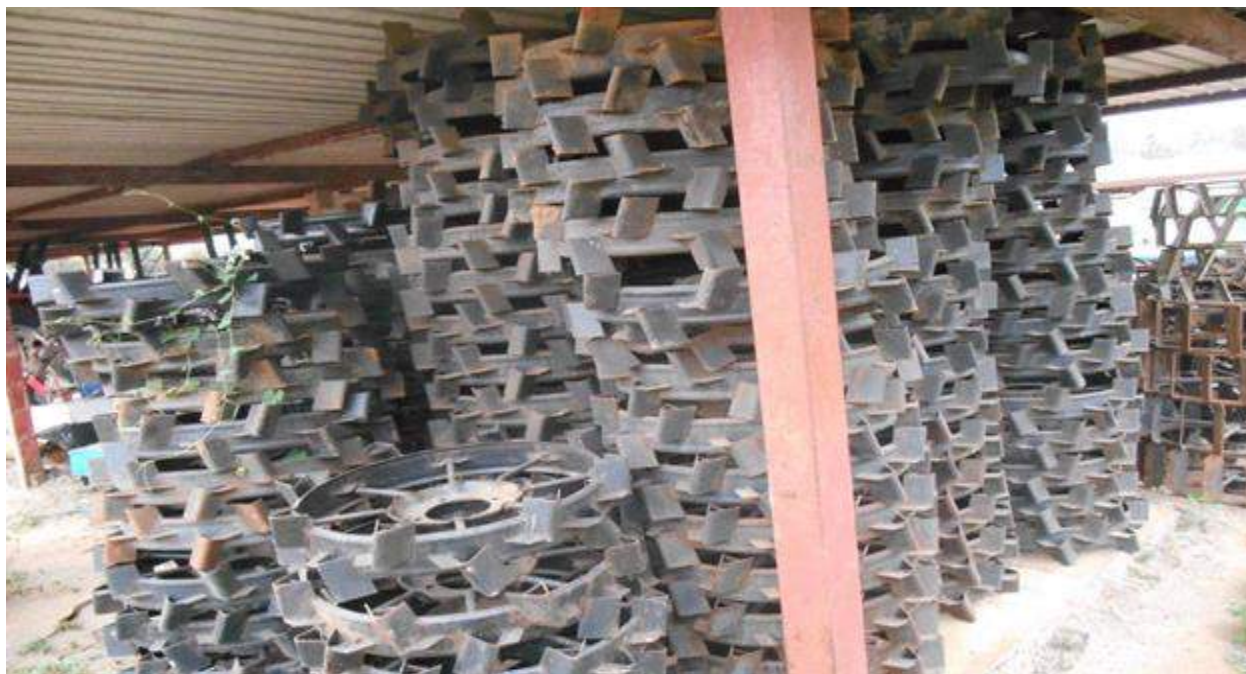
Apart from potato harvesters and power tiller trailers, the task force acquired other tractor and power tiller attachments such as; mould board, rotary plough, disc harrow, iron wheel and disc plough. Based on the fact that the tractors and power tillers were used inefficiently, these corresponding attachments were consequently not utilized as well. Therefore a large number of these attachments is lying idle in Kabuye workshop as shown in the photos below.

Iron wheels for both Power tiller 12HP and 15 HP lying idle in Kabuye VMSC premises. Photo taken on 6th November 2014.

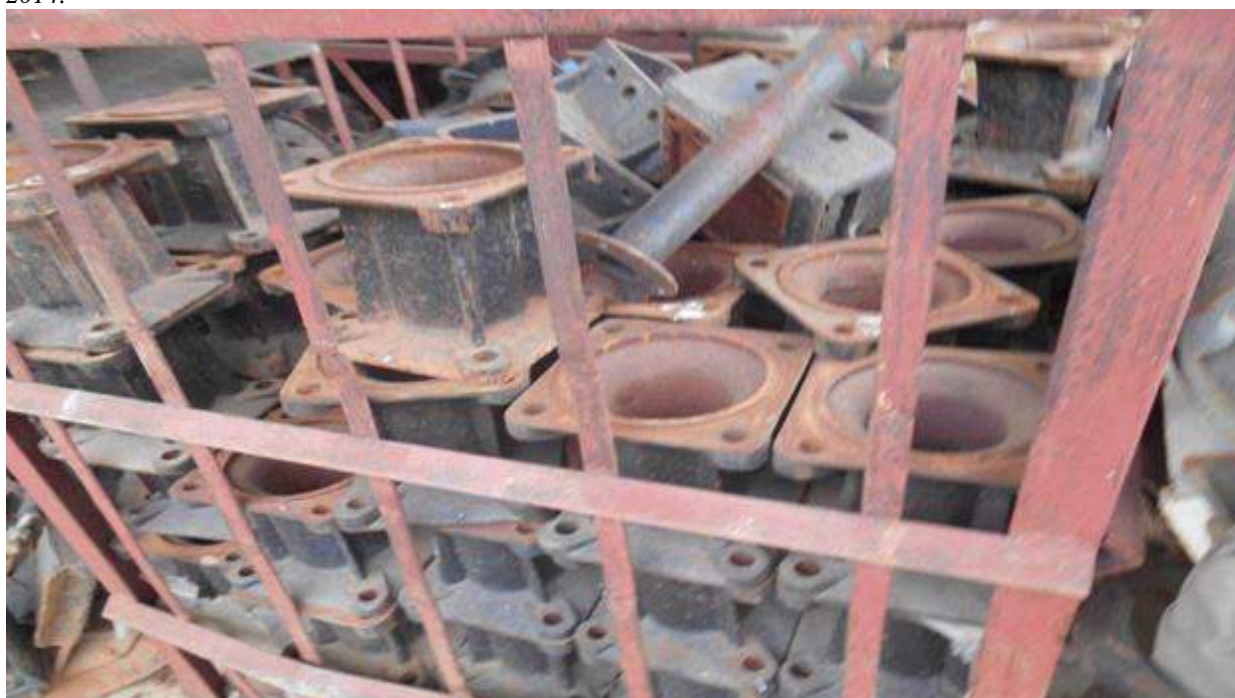
Power tiller iron wheel attachments have started to wear out while still packed. Photo taken 6th November 2014.

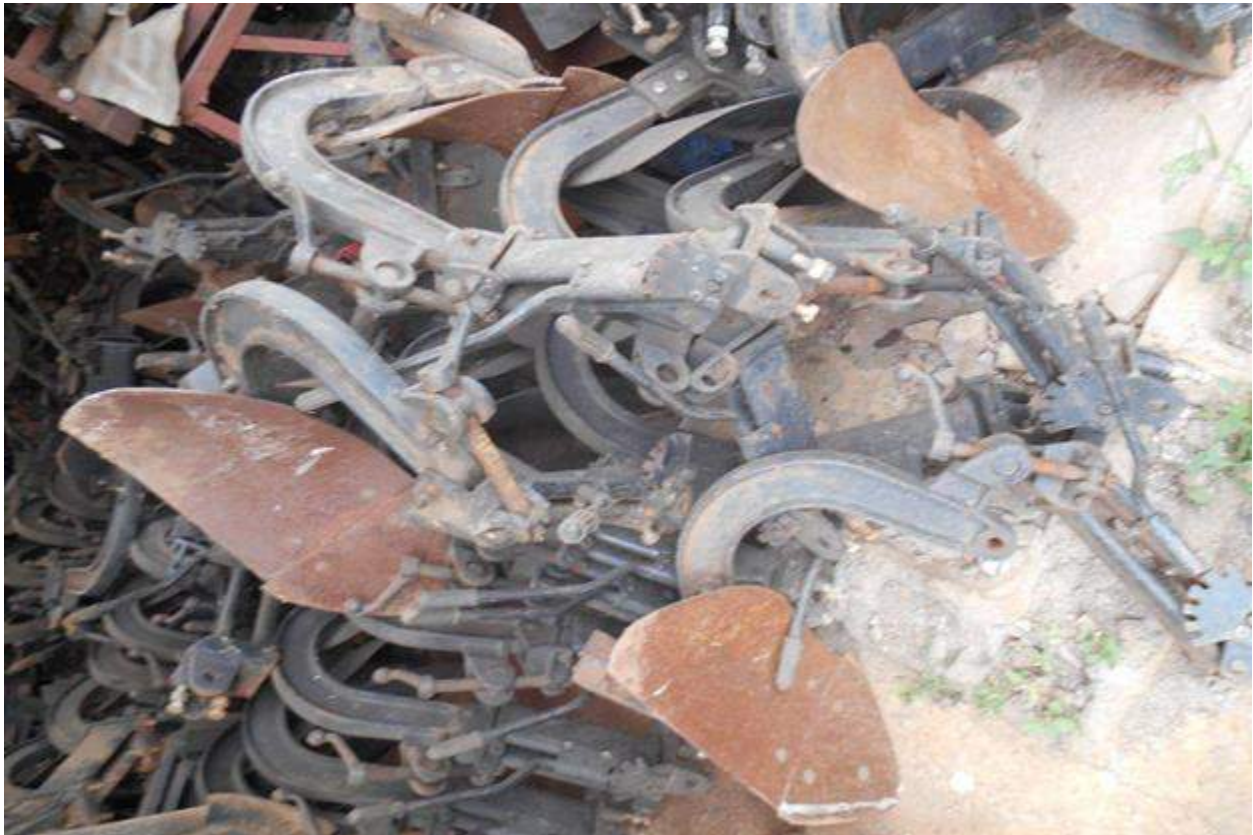
Mold board parts scattered in the storage area. They are lying idle and already worn out. Photo taken 6th November 2014 in Kabuye VMSC.

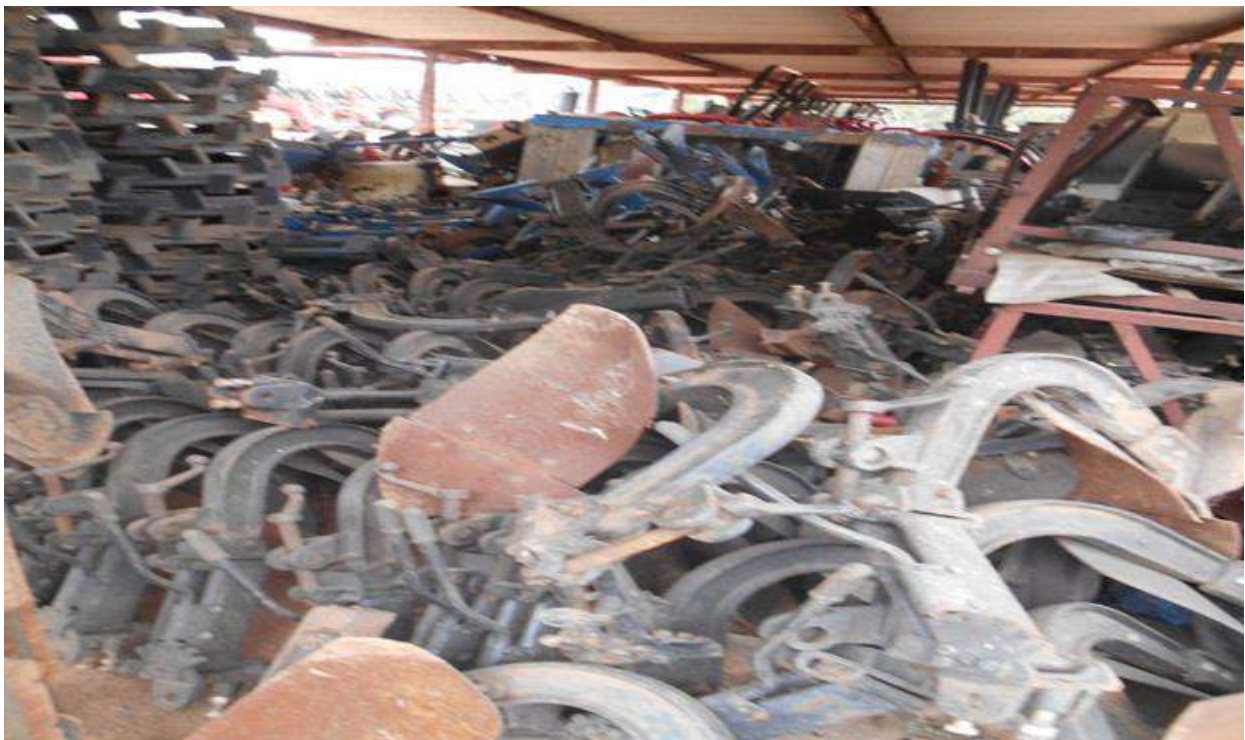
Combination of iron wheels and mold boards lying idle in Kabuye VMSC. Photo taken 6th November 2014.

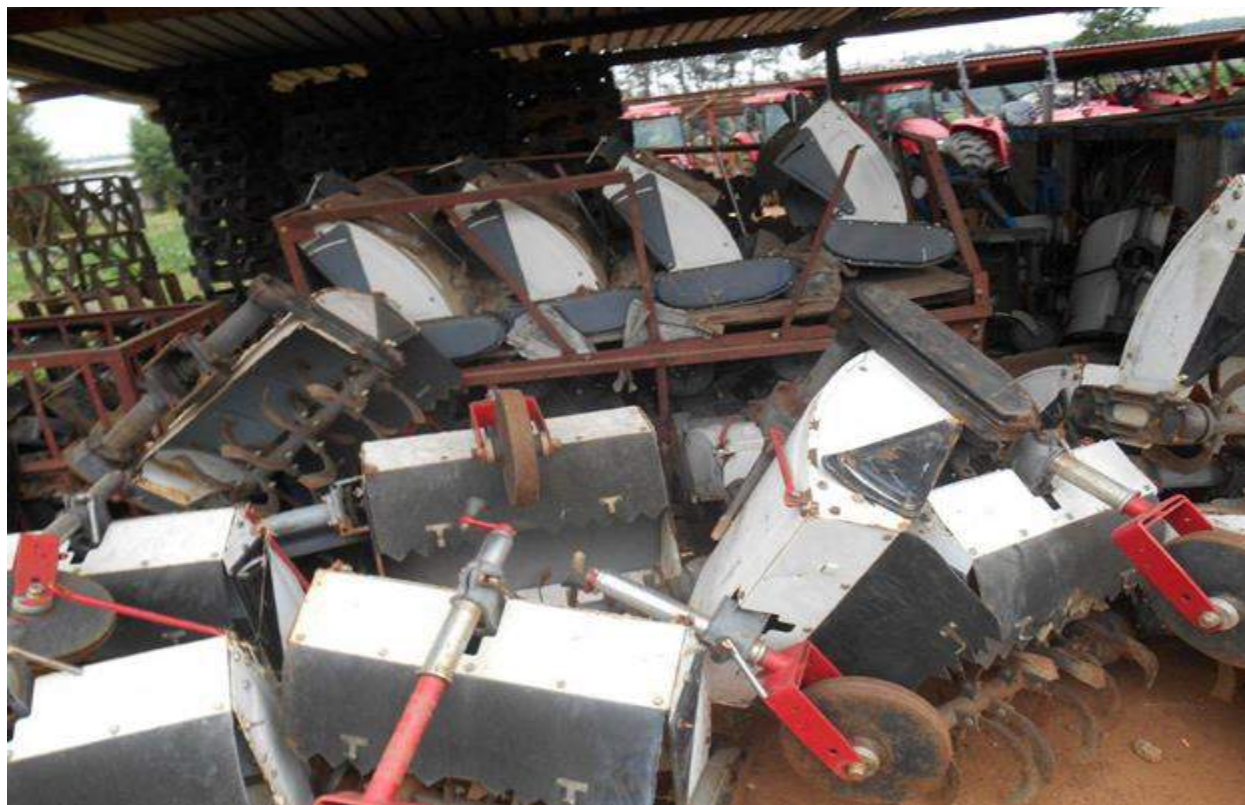
Combination of power tillers and other related attachments. They are stored like scrap in Kabuye VMSC. Photo taken 6th November 2014.

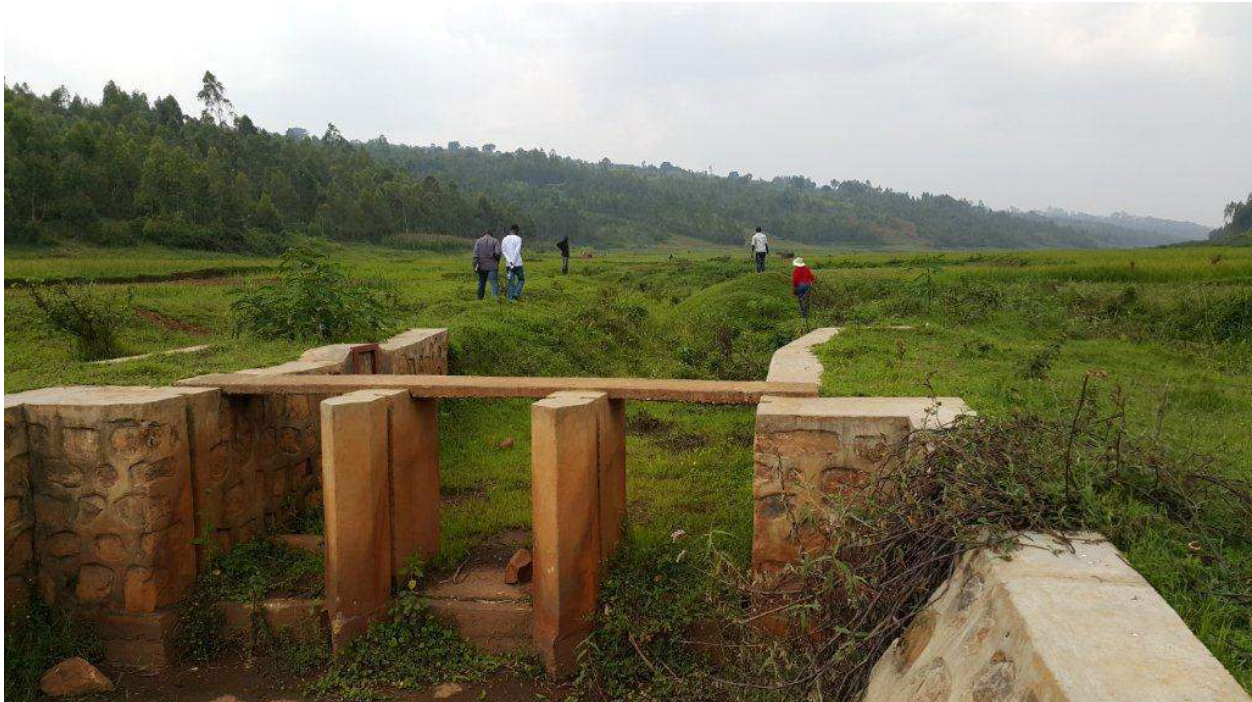
Headwork Diversion Structure that cannot serve water to surrounding areas in Mukura Marshland because it is situated above the water level of the river intended to feed it. Photo taken at Mukura marshland on 13th January 2015.

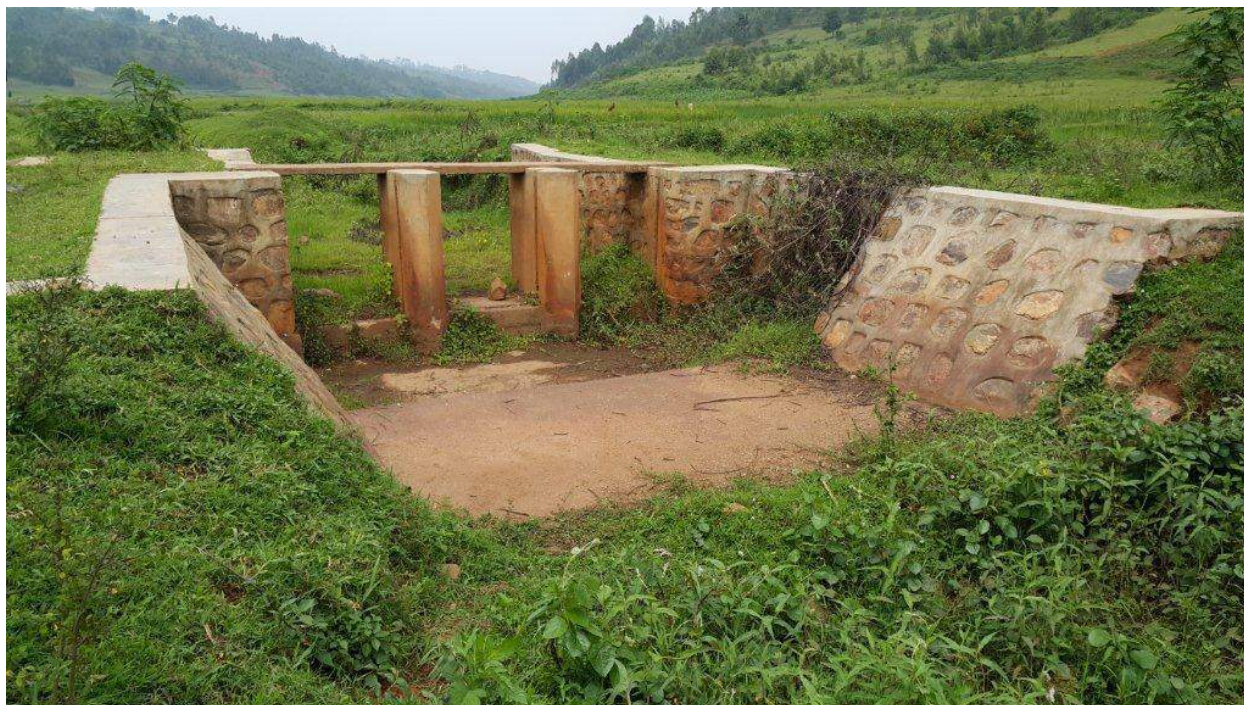
There is no value for money of irrigation infrastructure built but is not in use. Photo taken at Mukura marshland on 13th January 2015.

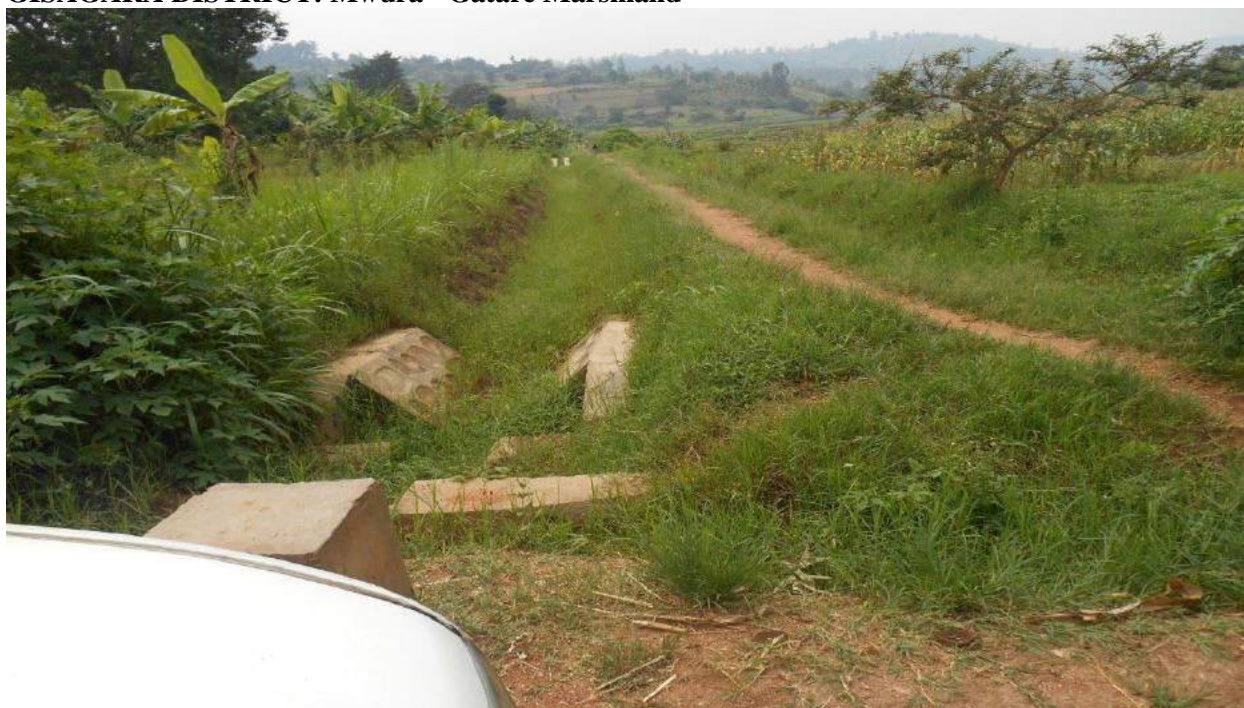
The water canal and the infrastructure built on- are not in use since it was built at a level above the water intake stream. Photo taken at Mwura - Gatara marshland on 15th January 2015.

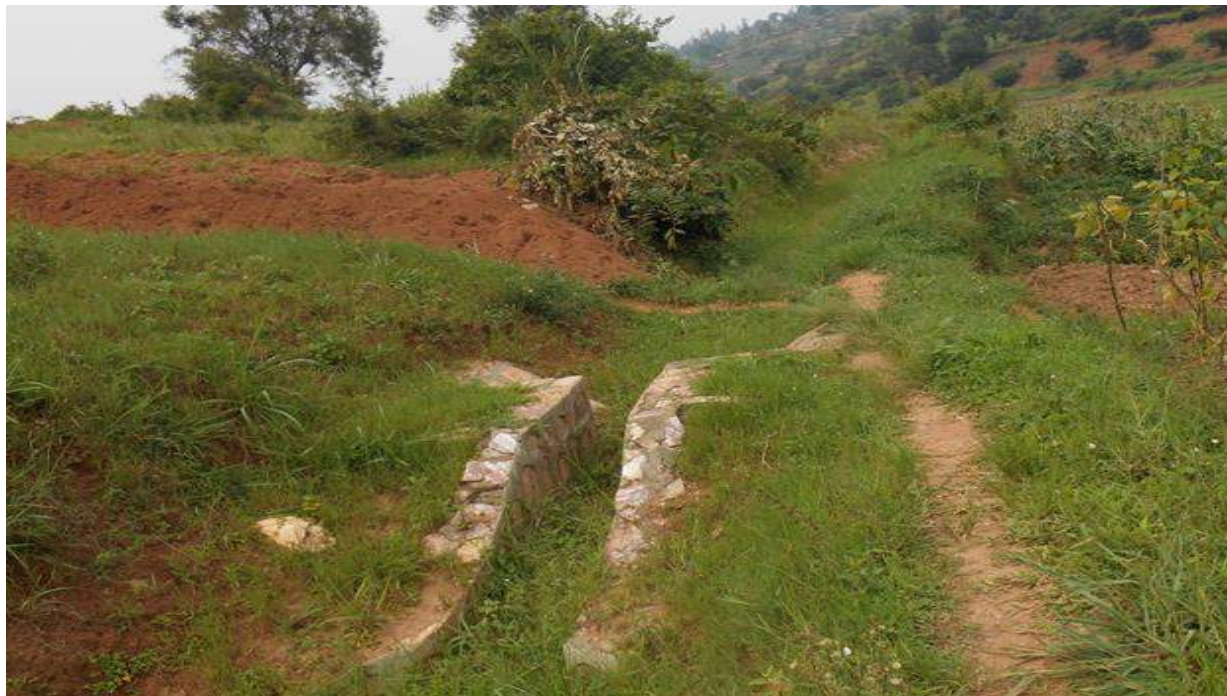
GISAGARA DISTRICT: Mwura - Gatare Marshland

The infrastructure became useless due to the water that can't reach the level the structure was built. Photo taken on 15th January 2015

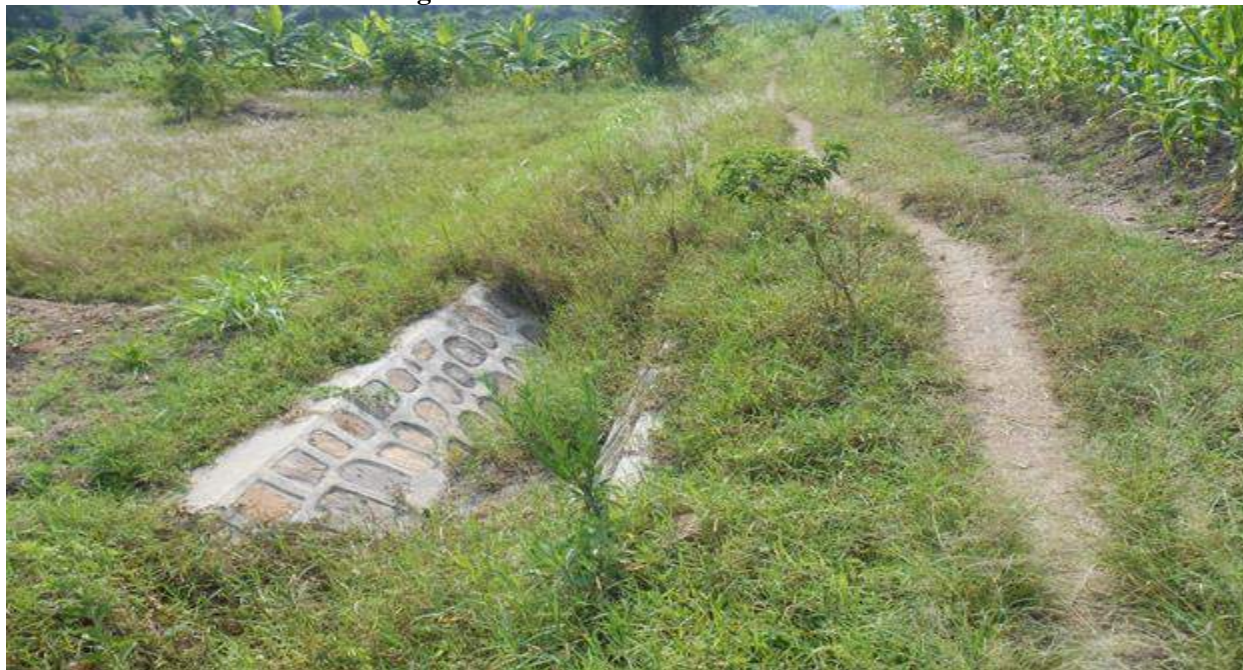
KAMONYI DISTRICT: Ruboroga marshland

More irrigation infrastructure that is unfunctional and is blocked by overgrowth of grasses. Irrigation water does not reach this part of the marshland. Photo taken at Ruboroga marshland on 7th January 2015.
