**OFFICE OF THE AUDITOR GENERAL
OF STATE FINANCES, RWANDA**

**PERFORMANCE AUDIT REPORT ON UTILIZATION AND MAINTENANCE OF
IRRIGATION AND MECHANIZATION EQUIPMENT**

May 2015

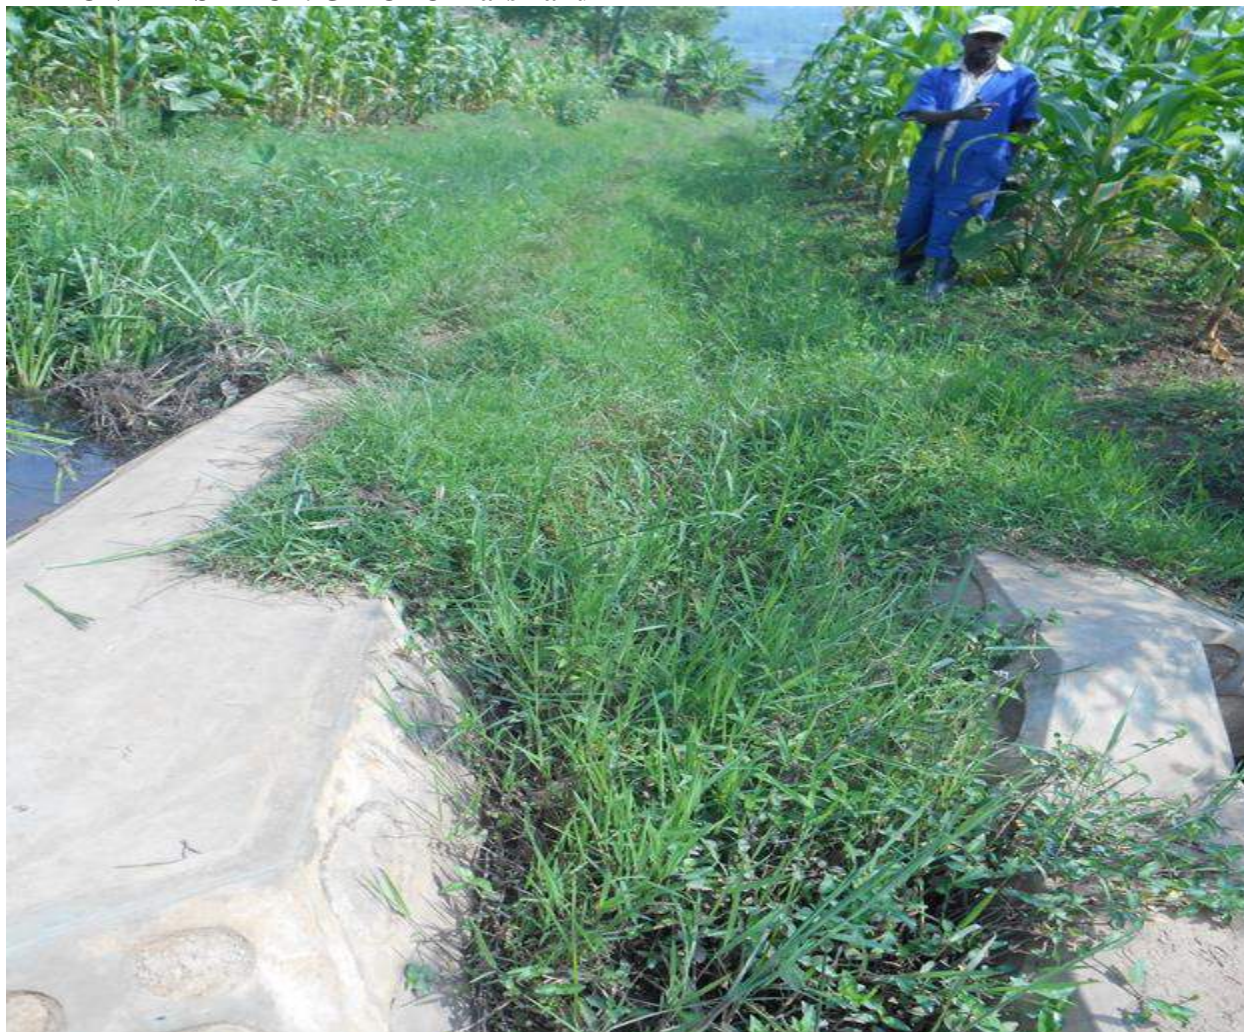
More irrigation infrastructure that is unfunctional and is blocked by overgrowth of grasses. Irrigation water does not reach this part of the marshland. Photo taken at Gikoro marshland on 9th January 2015.

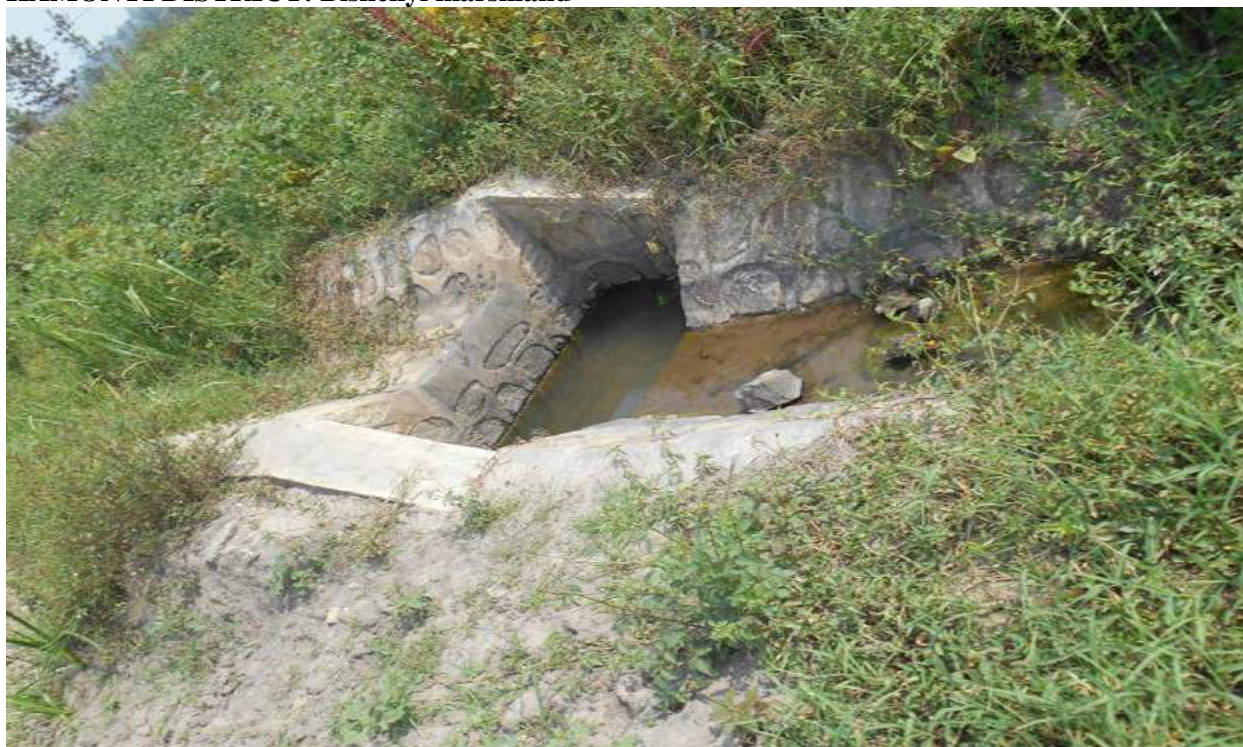
Some canal parts are built in such a way that they cannot supply water to the next part of the canal. Farmland along subsequent parts of the canal do not get access to irrigation water because they are on a raised surface relative to the canal supplying the area. Photo taken at Bishenyi marshland on 14 January 2015.

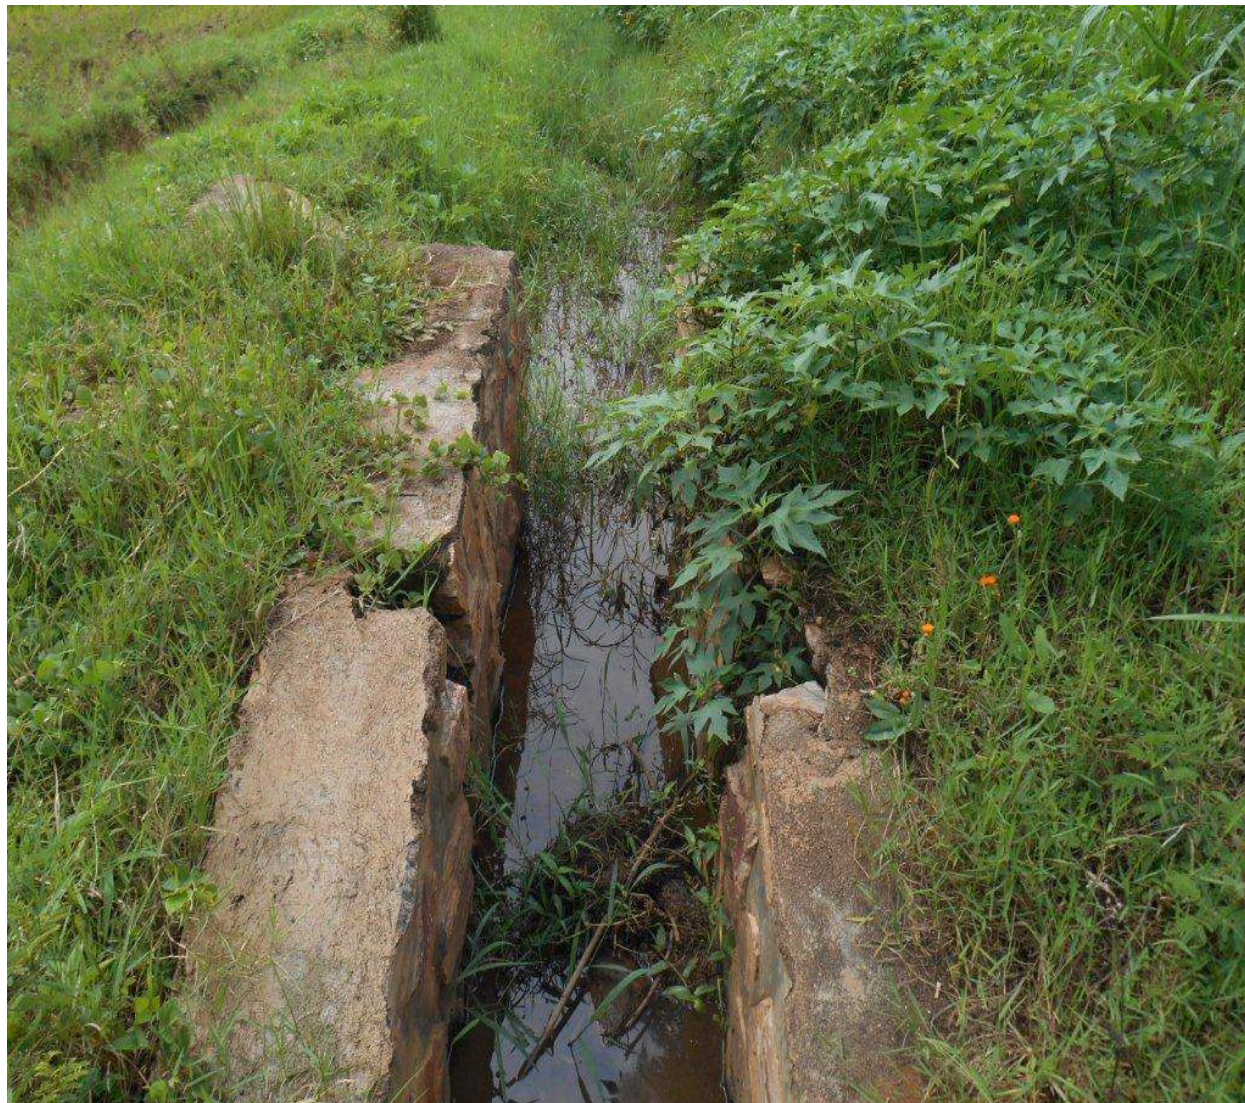
The infrastructure was left incomplete. Photo taken at Mwura-Gatare marshland on 15th January 2015.

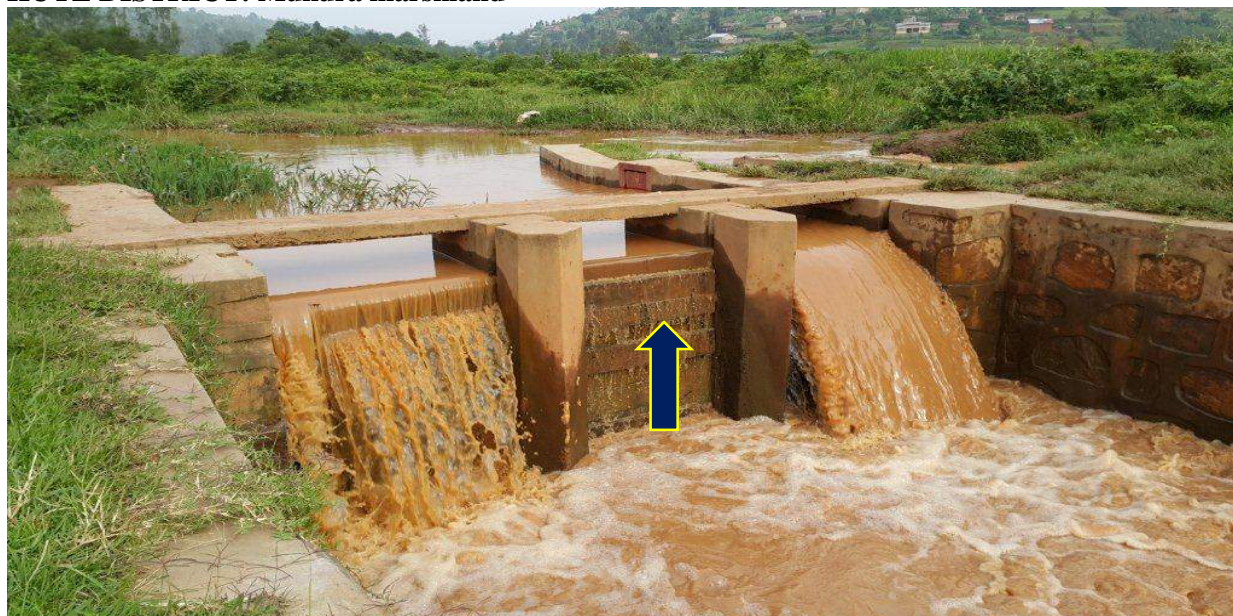
HUYE DISTRICT: Mukura marshland

In cases where over flooding occurred, this led to bursting of the river banks and hence flooding of farmland and destruction of crops. In cases of very low water levels, this meant that farmers' crops were not irrigated resulting into poor crop yields. There is no value for money derived from expensive infrastructure that is not operated as intended and hence not of benefit to users. For illustration of the above, refer to the photos below.

Water flowing uncontrollably through the intake dam. The wooden planks were not removed (see blue arrow) to allow a drop in the water level. This led to over flooding and bursting of the river bank (see the following photo) and consequently led to flooding of surrounding farmland. Photo taken on 13th January 2015

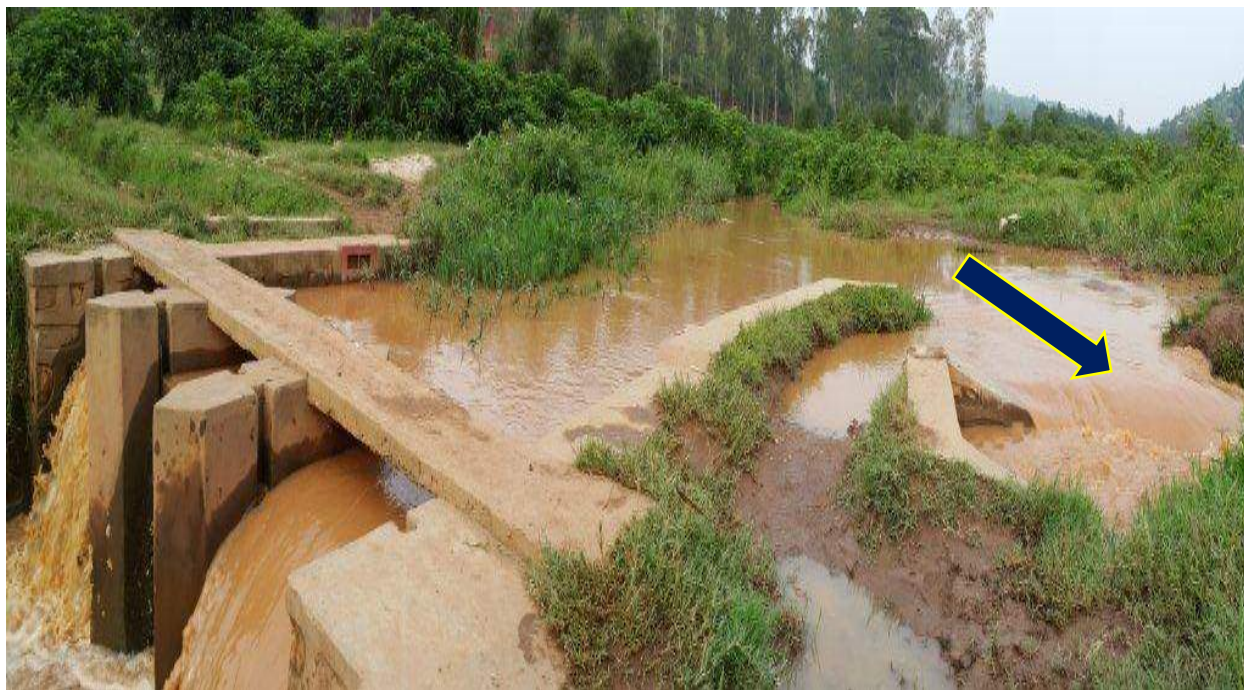
Water flowing uncontrollably through the intake dam. The wooden planks were not removed (as explained above) to allow a drop in the water level. This led to over flooding and bursting of the river bank (see blue arrow) and consequently led to flooding of surrounding farmland. Photo taken on 13th January 2015

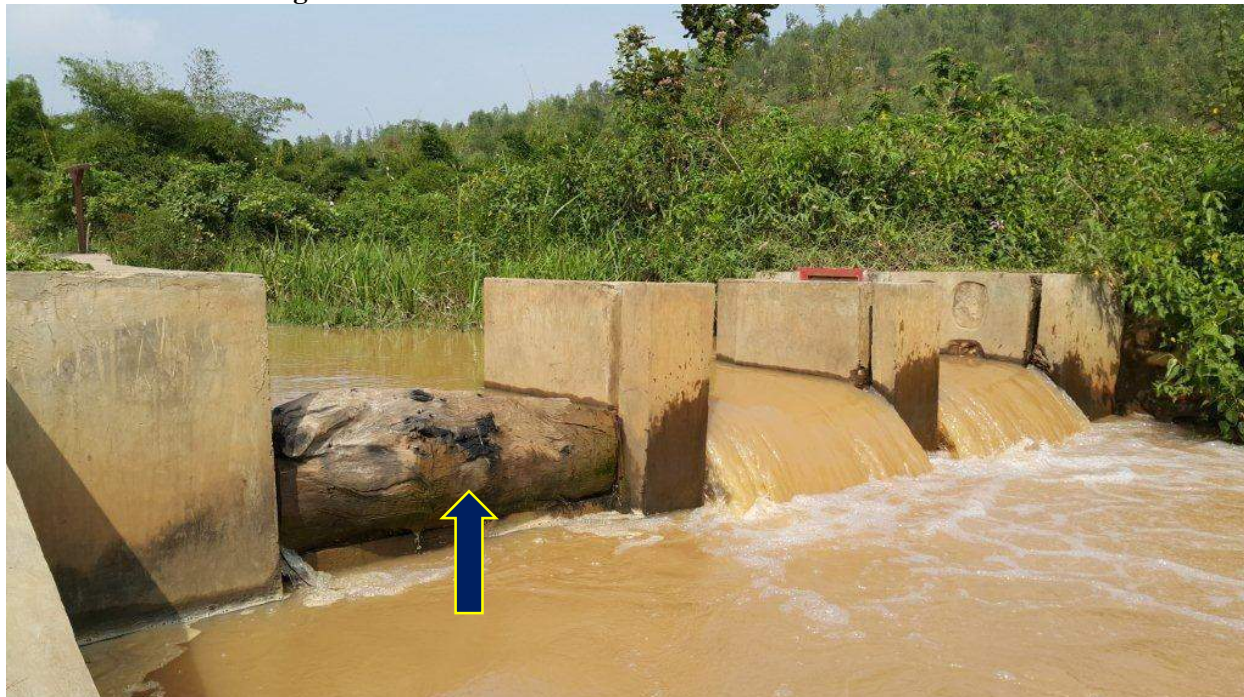
HUYE DISTRICT: Migina marshland

Water flowing uncontrollably through the intake dam. The wooden planks were not removed (see blue arrow) to allow a drop in the water level. This led to over flooding and bursting of the river bank and consequently led to flooding of surrounding farmland (see photo below). Photo taken on 12th January 2015.

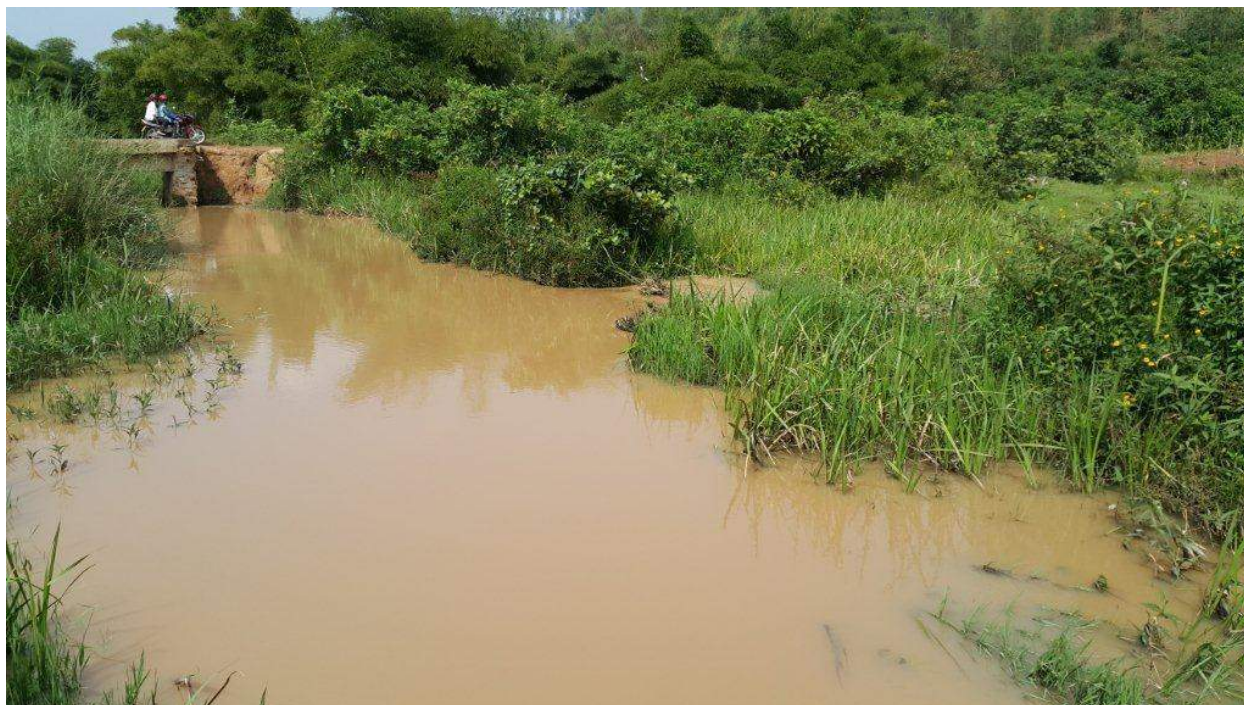
Over flooding and bursting of the river bank led to flooding of surrounding farmland. Photo taken on 12th January 2015.

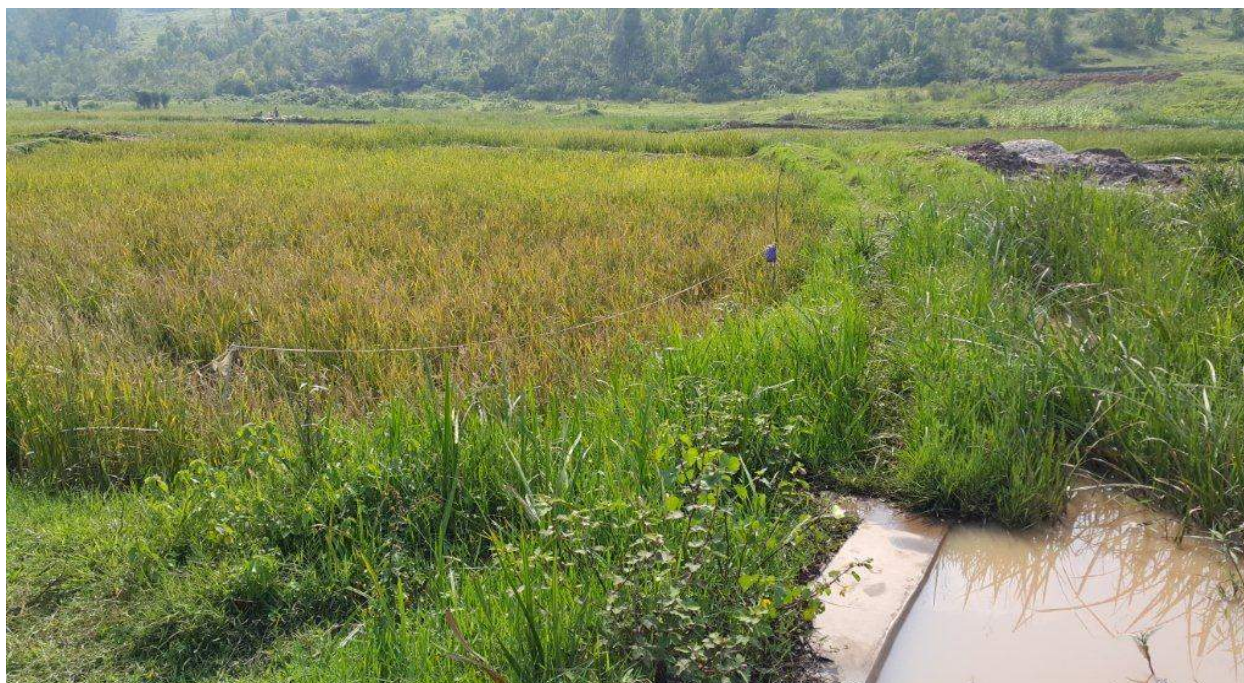
Flooding of farmland led to destruction of crops. Photo taken on 12th January 2015

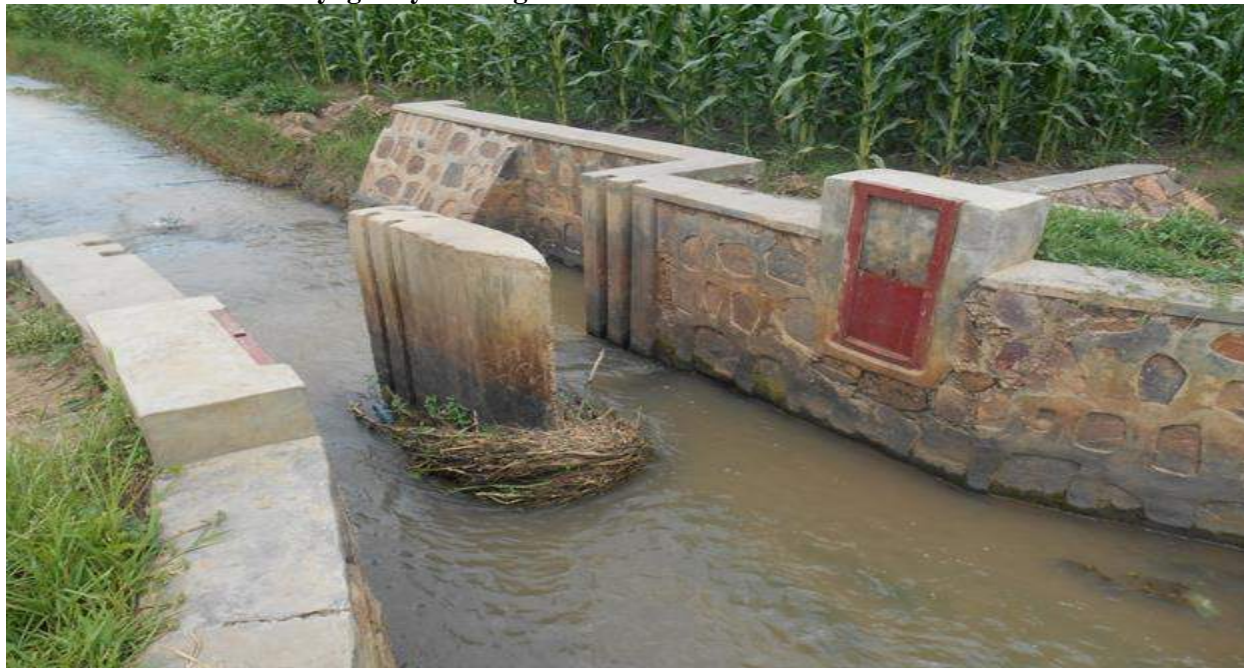
GASABO DISTRICT: Nyagisenyi - Rufigiza marshland

Wooden planks were not inserted in the dam at all. The water level dropped significantly to a level below the red sluice gates. Consequently water could not go through the irrigation canals to the farmland. Photo taken 18th November 2014.

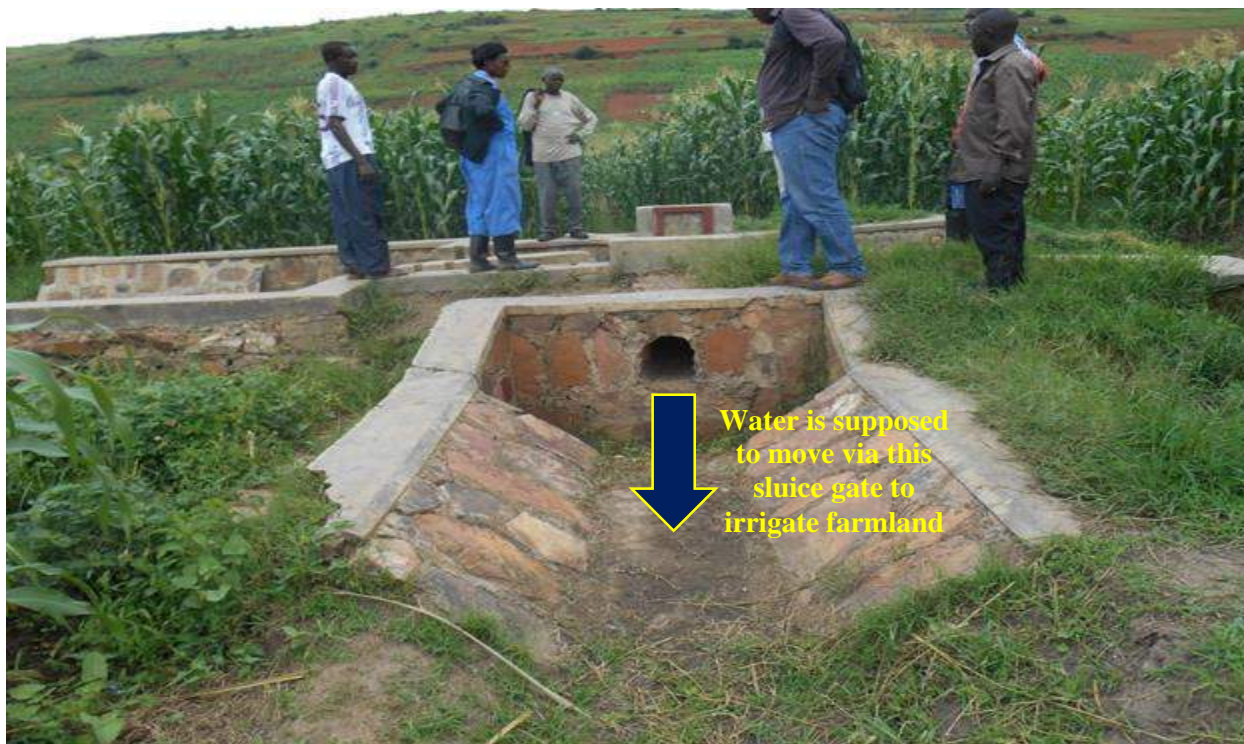
Wooden planks were not inserted in the dam at all. The water level dropped significantly to a level below the red sluice gates. Consequently water could not go through the irrigation canals to the farmland. Photo taken 18th November 2014.

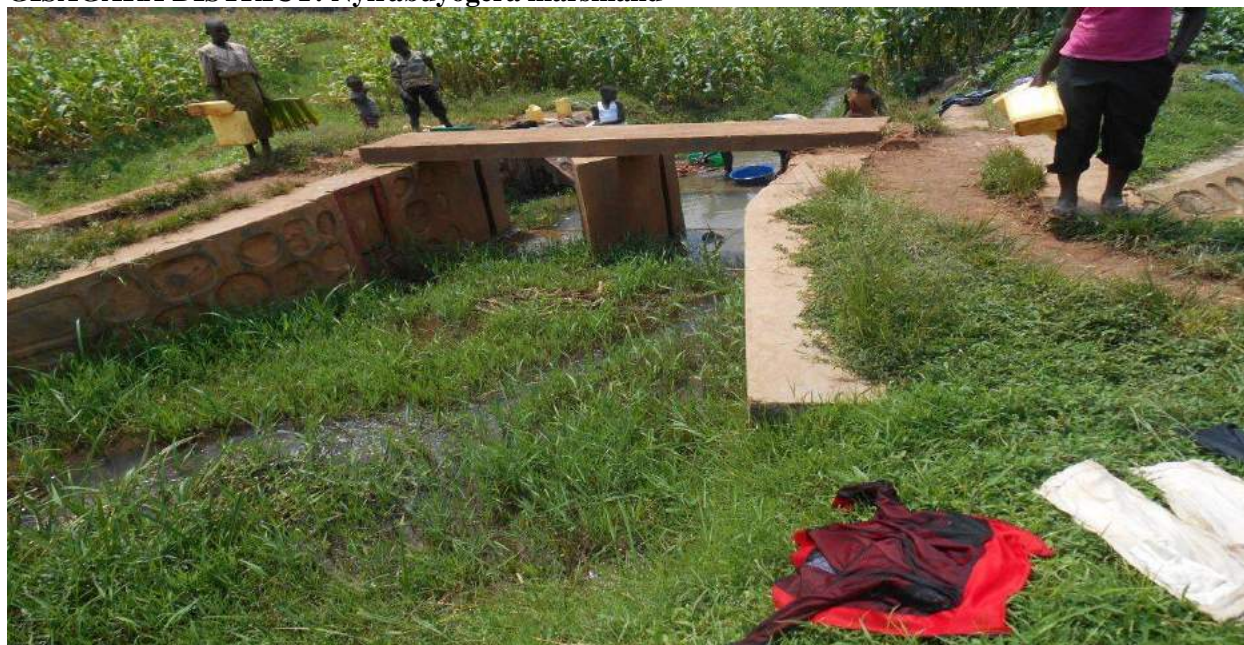
Wooden planks were not inserted in the dam at all. The water level dropped significantly to a level below the red sluice gates. Consequently water could not go through the irrigation canals to the farmland. Photo taken 14th January 2015.

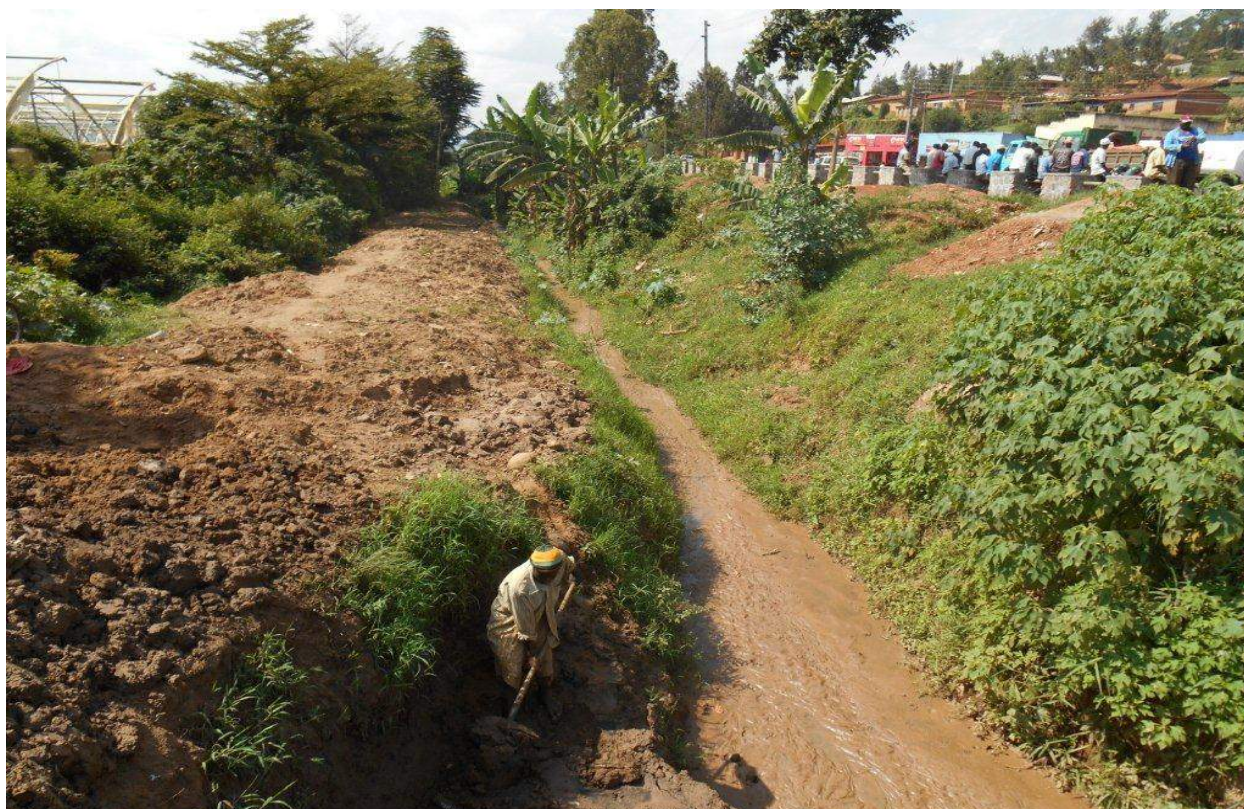
The entire 1 km length of the canal is blocked by mud and is no longer usable. Photo taken on 10th December 2014.

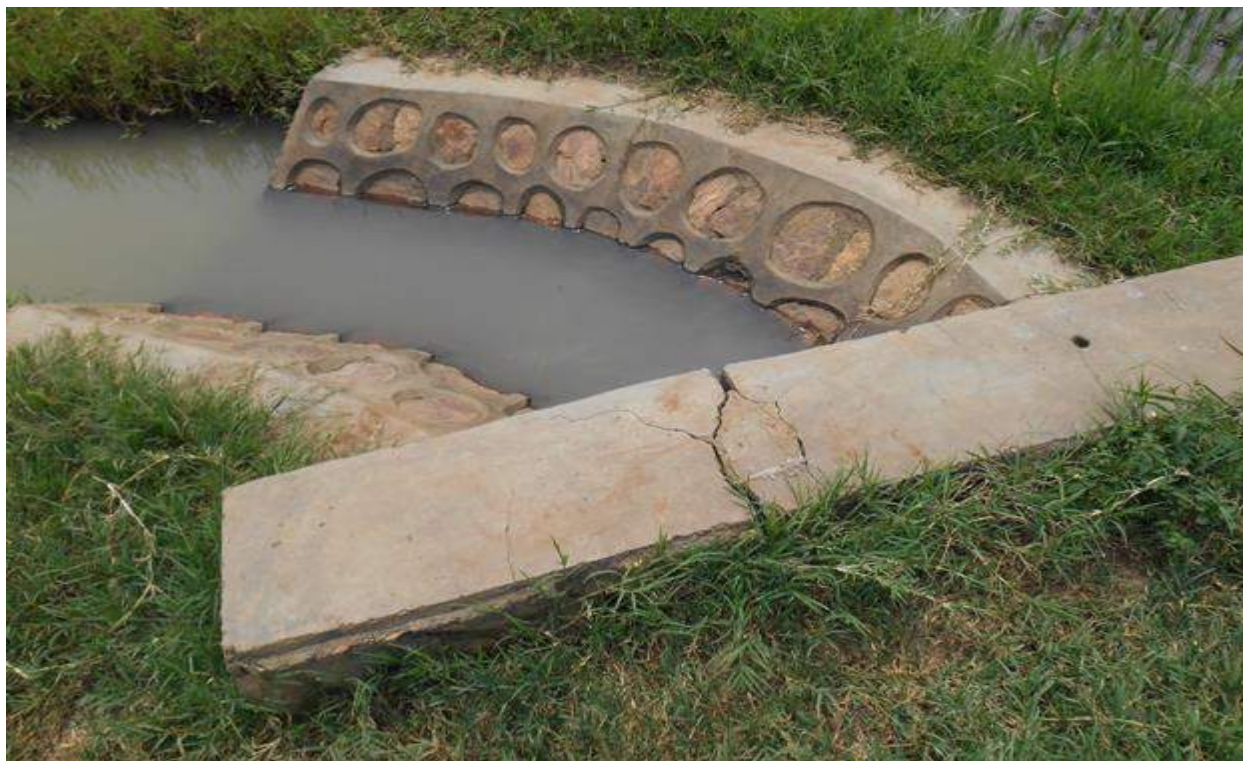
Cracks like this one above are found on many irrigation infrastructure throughout the marshland. Photo taken at Nyiramageni marshland on 19th January 2015.

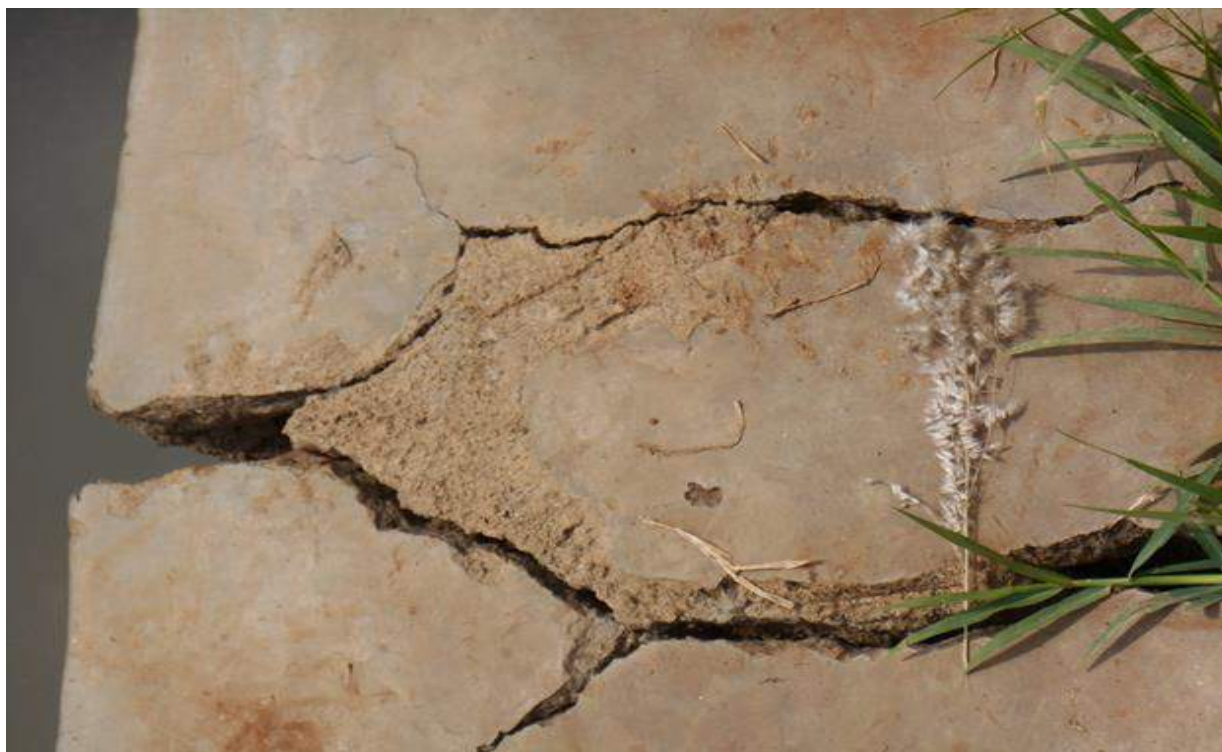
When you get closer, you realize that the infrastructure has big cracks and if not rehabilitated, will eventually fail. Photo taken at Nyiramageni marshland on 19th January 2015.

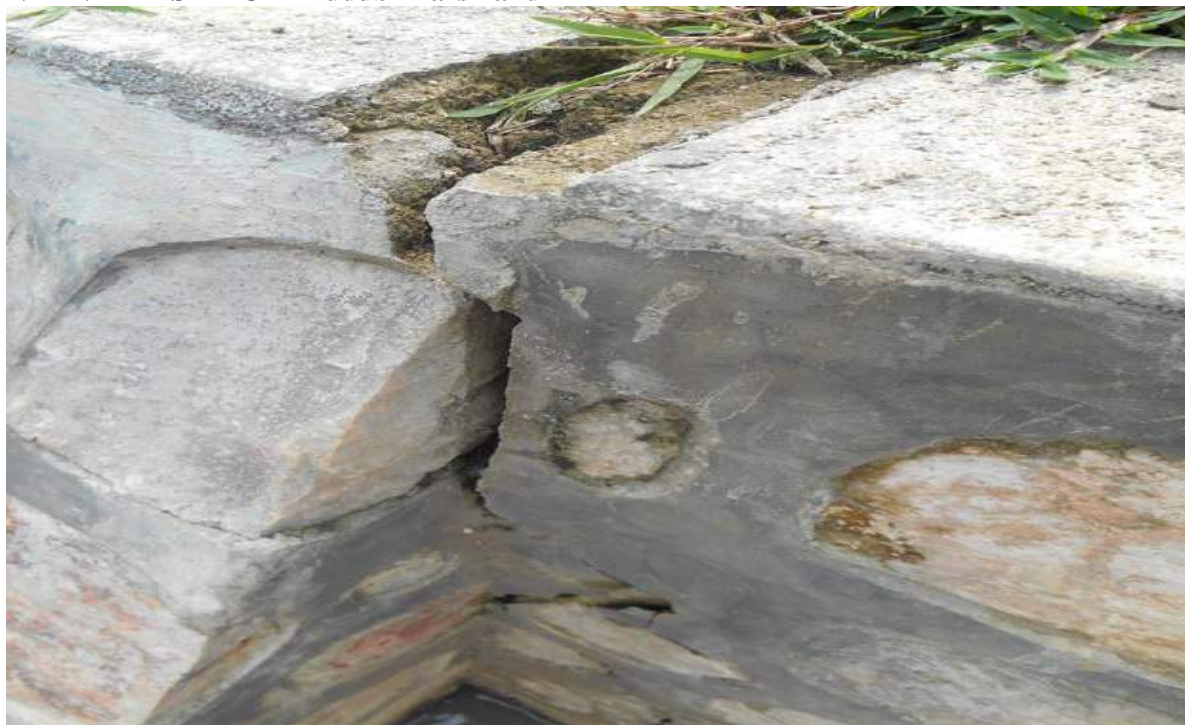
Upper view of the intake dam structure was cracked and if not repaired, can fall down in case of a heavy rain. Photo taken at Budubi marshland on 20th January 2015

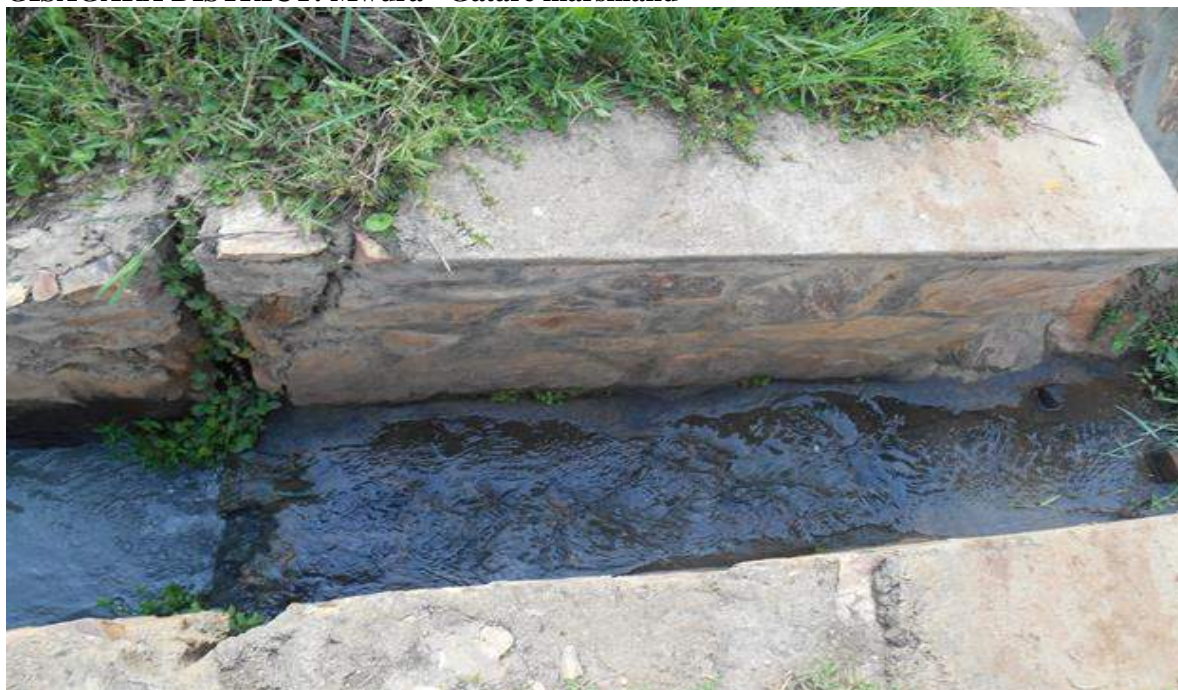
Cracked infrastructure at Mwura - gatare marshland. Photo taken on 15th January 2015.

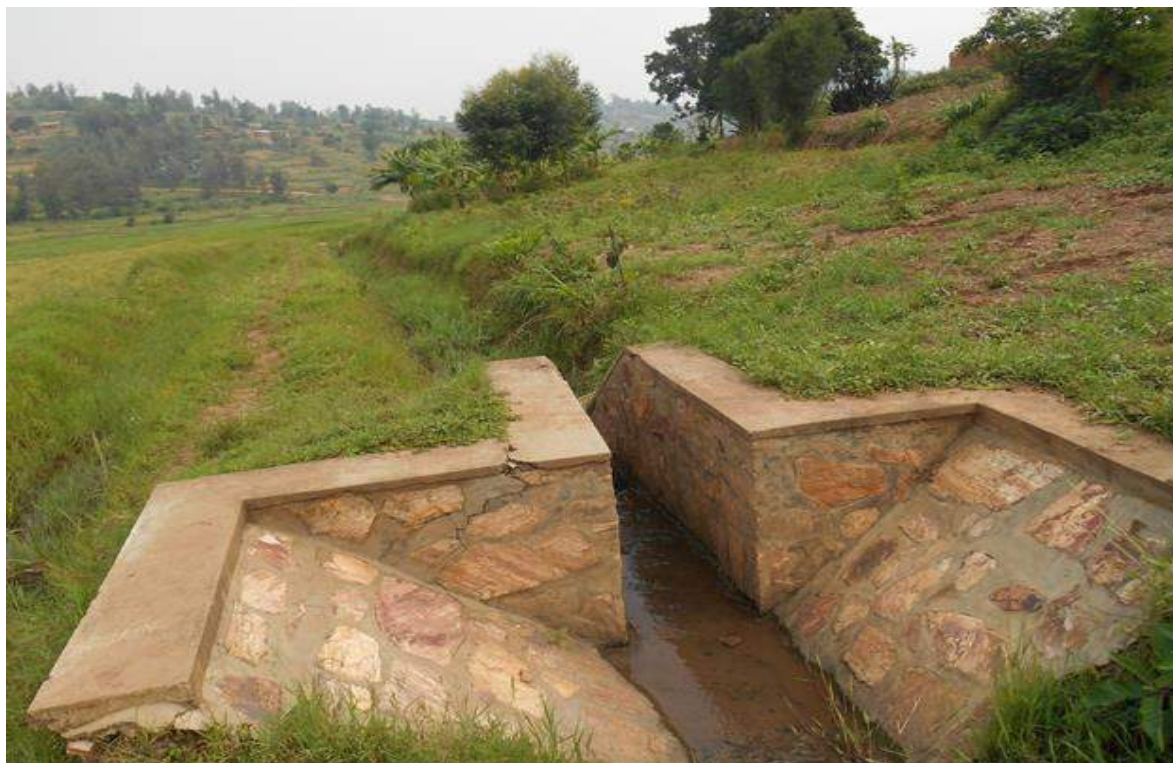
Cracked infrastructure at Mwura - gatare marshland. Photo taken on 15th January 2015.

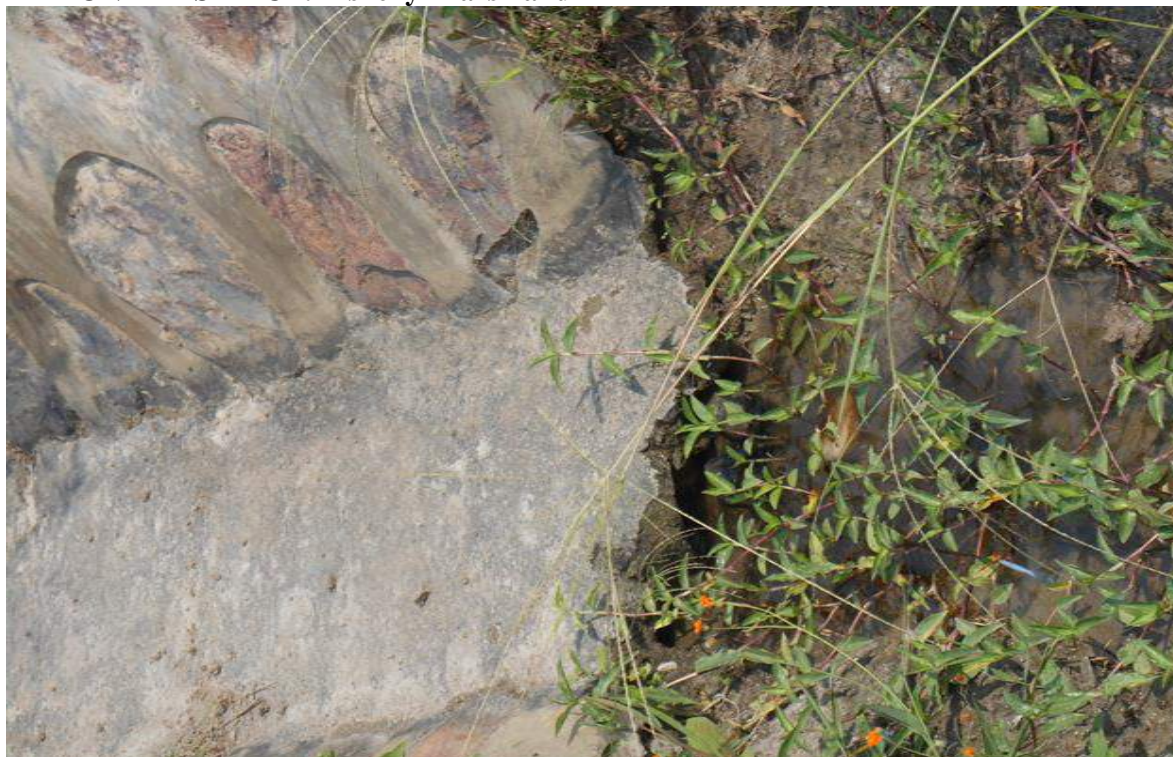
Dilapidated irrigation infrastructure that has been in use for less than a year. Photo taken at Bishenyi marshland on 7th January 2015.

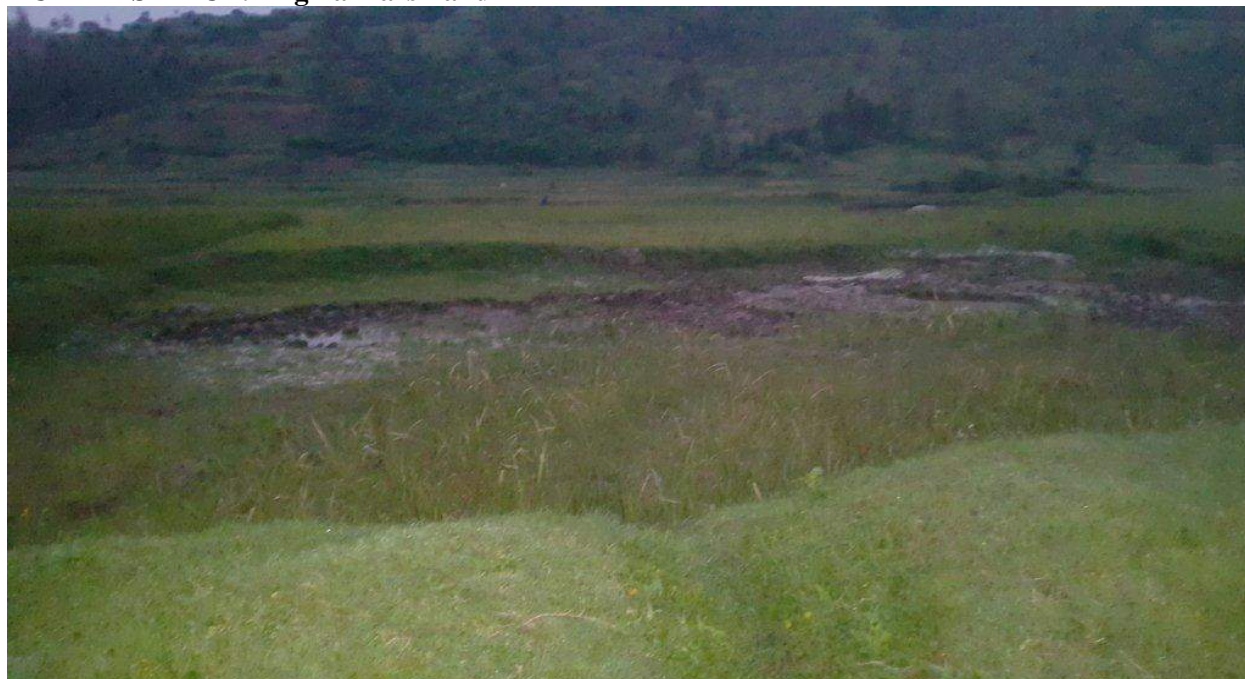
HUYE DISTRICT: Migina marshland

This practice reduces the size of farmland available for cultivation of crops and in some cases has resulted into blockage of the canal meant for distribution of irrigation water to the surrounding fields. This renders the money spent on irrigation project wasteful and creates a risk that the overall project objective of increasing crop yields will not be achieved. See photos below for details.

Farmland converted into a sand mining site in Migina marshland in Huye district. Photo taken on 12th January 2015.

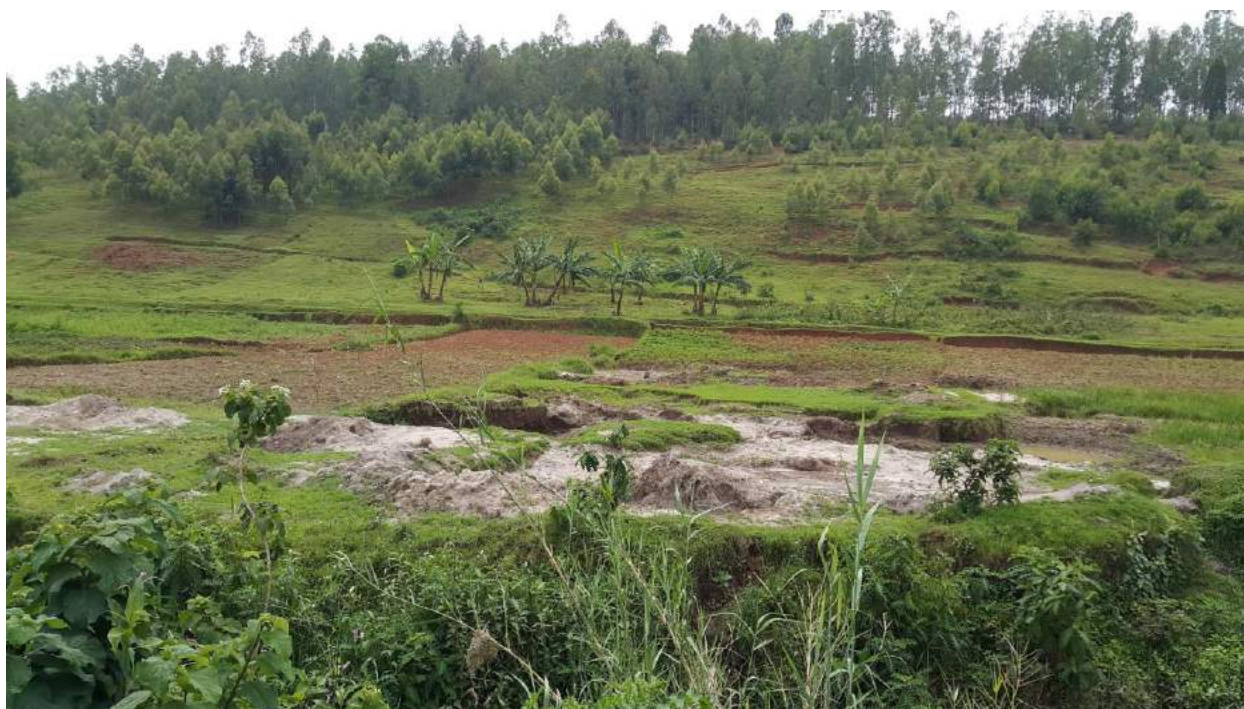
HUYE DISTRICT: Mukura marshland

Farmland converted into a sand mining site in Mukura marshland in Huye district. Photo taken on 13th January 2015.

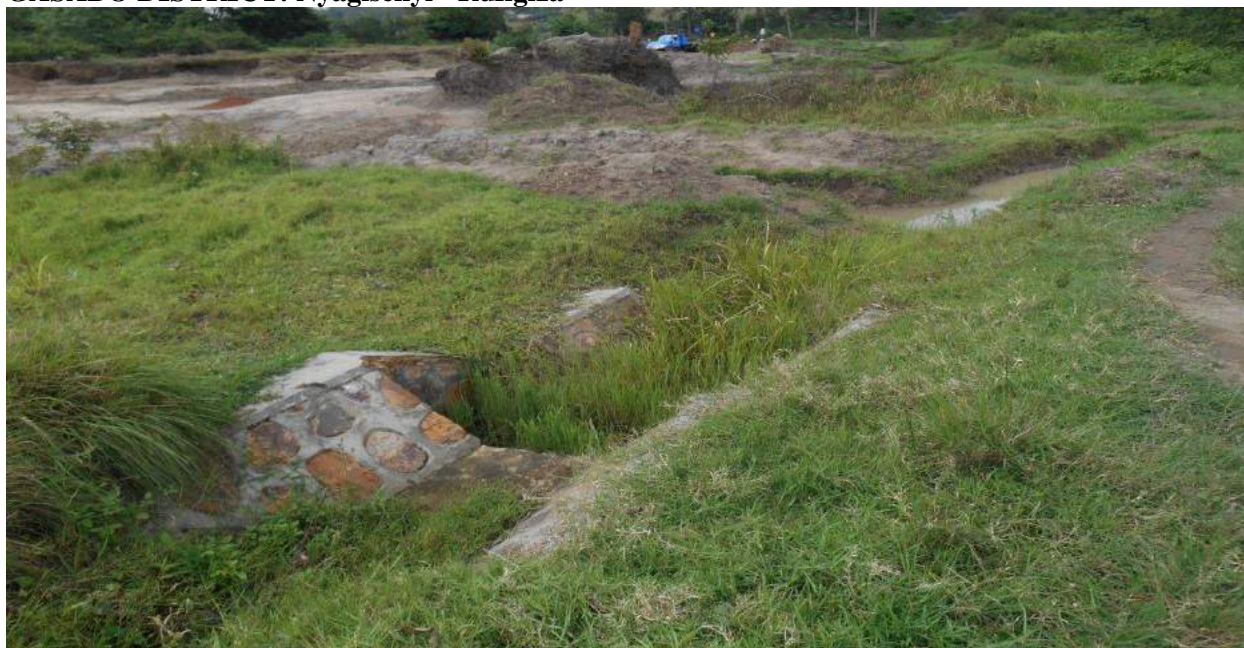
GASABO DISTRICT: Nyagisenyi - Rufigiza

Farmland converted into a sand mining site in Nyagisenyi - Rufigiza marshland in Gasabo district. The mining activity has contributed to the blockage of the irrigation canal. Photo taken on 18th November 2014.

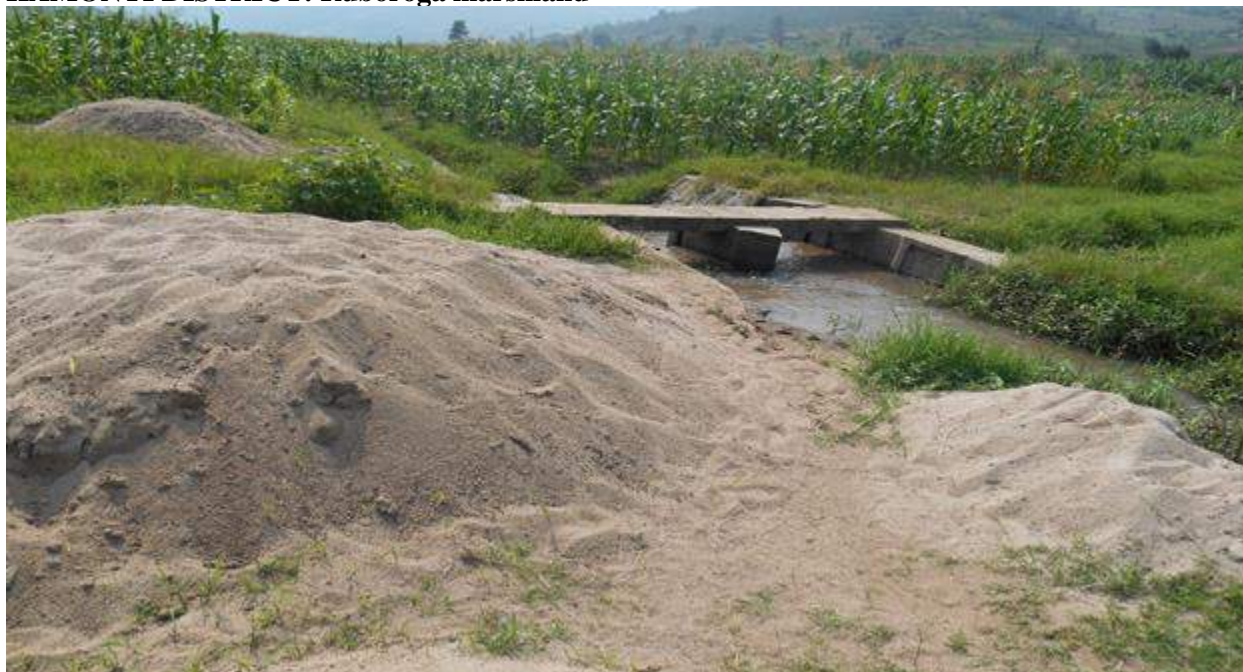
KAMONYI DISTRICT: Ruboroga marshland

Farmland converted into a sand mining site in Ruboroga marshland in Kamonyi district. Photo taken 7th January 2015.

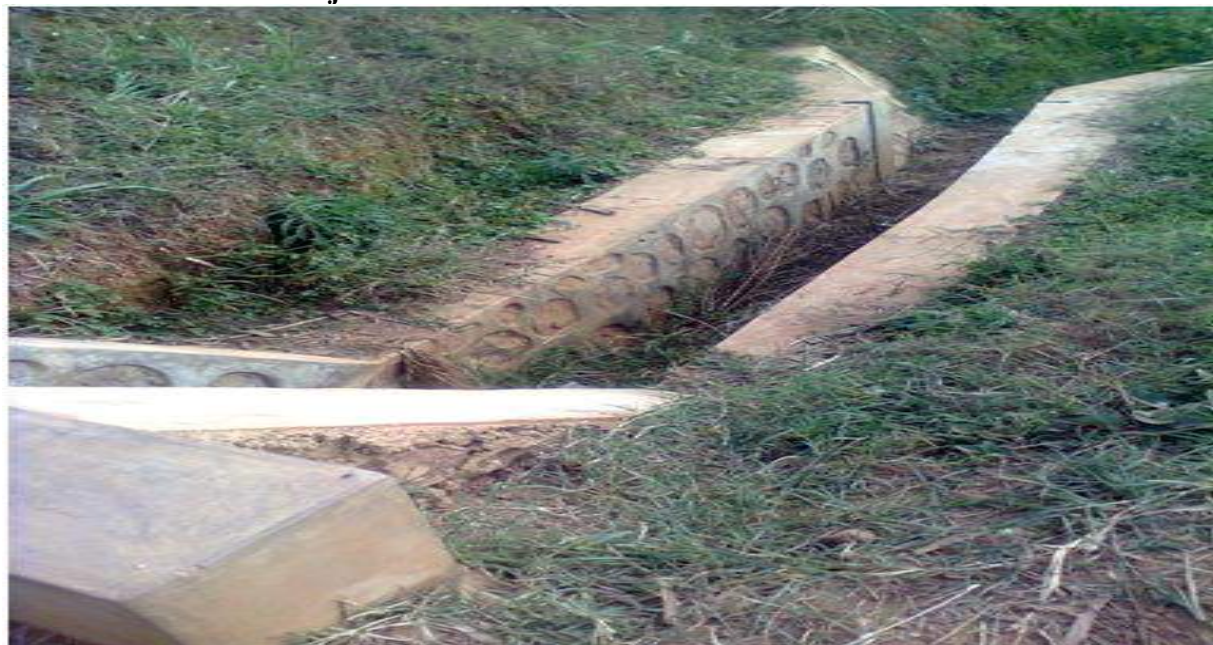
A canal that is not maintained and does not allow flow of water. Photo taken at Kajevuba marshland on 7th August 2014.

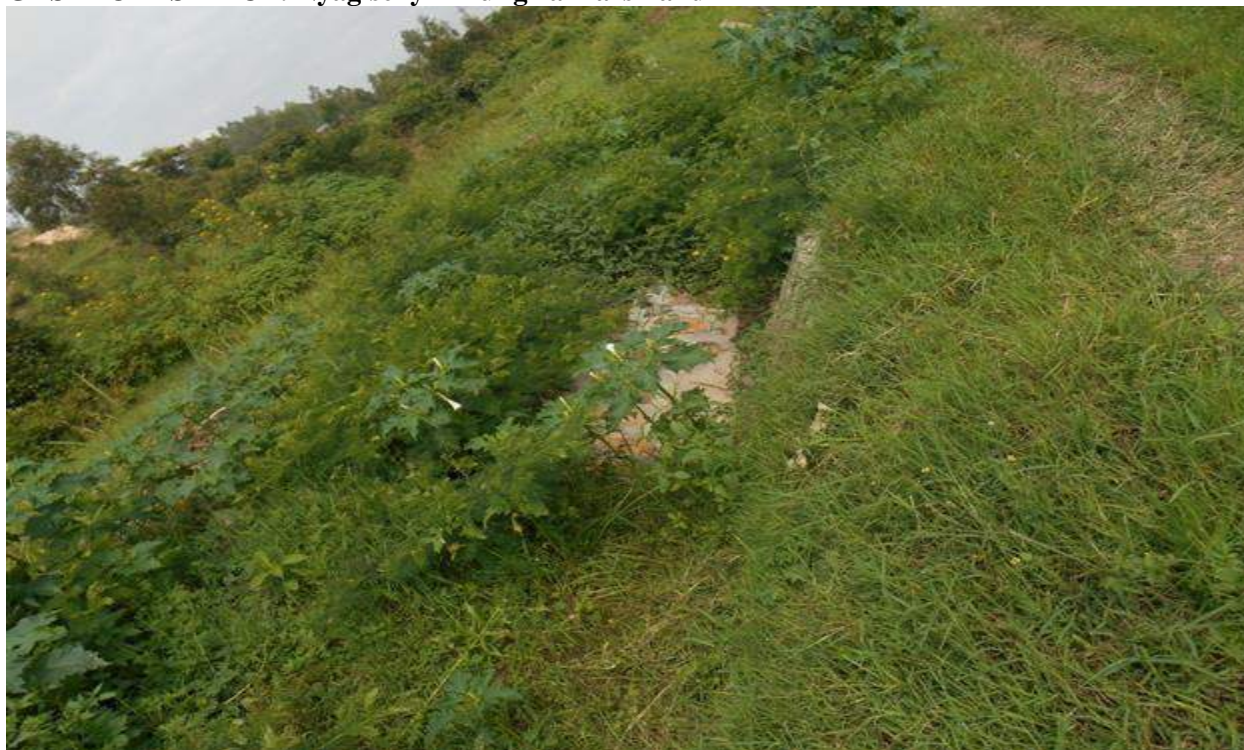
Irrigation canal covered by plant overgrowth rendering it unusable. Photo taken at Nyagisenyi - Rufigiza marshland on 18th November 2014.
