**OFFICE OF THE AUDITOR GENERAL
OF STATE FINANCES, RWANDA**

**PERFORMANCE AUDIT REPORT ON UTILIZATION AND MAINTENANCE OF
IRRIGATION AND MECHANIZATION EQUIPMENT**

May 2015

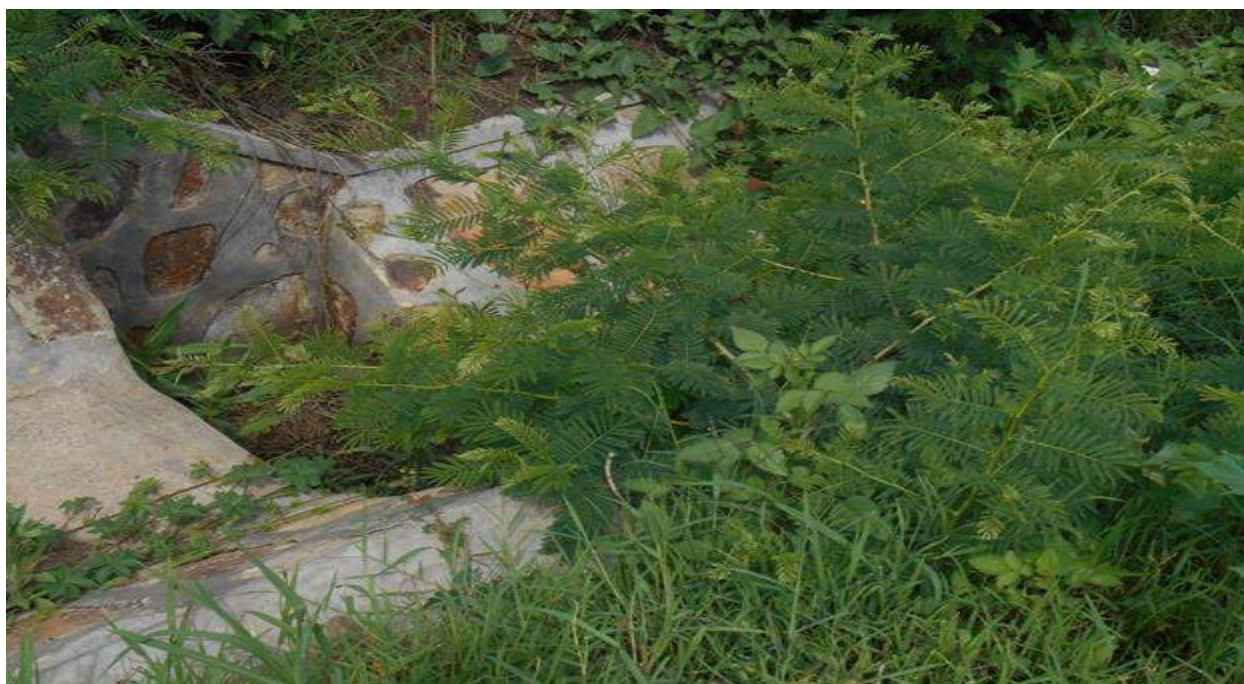
Another irrigation canal covered by plant overgrowth rendering it unusable. Photo taken at Nyagisenyi - Rufigiza marshland on 18th November 2014.

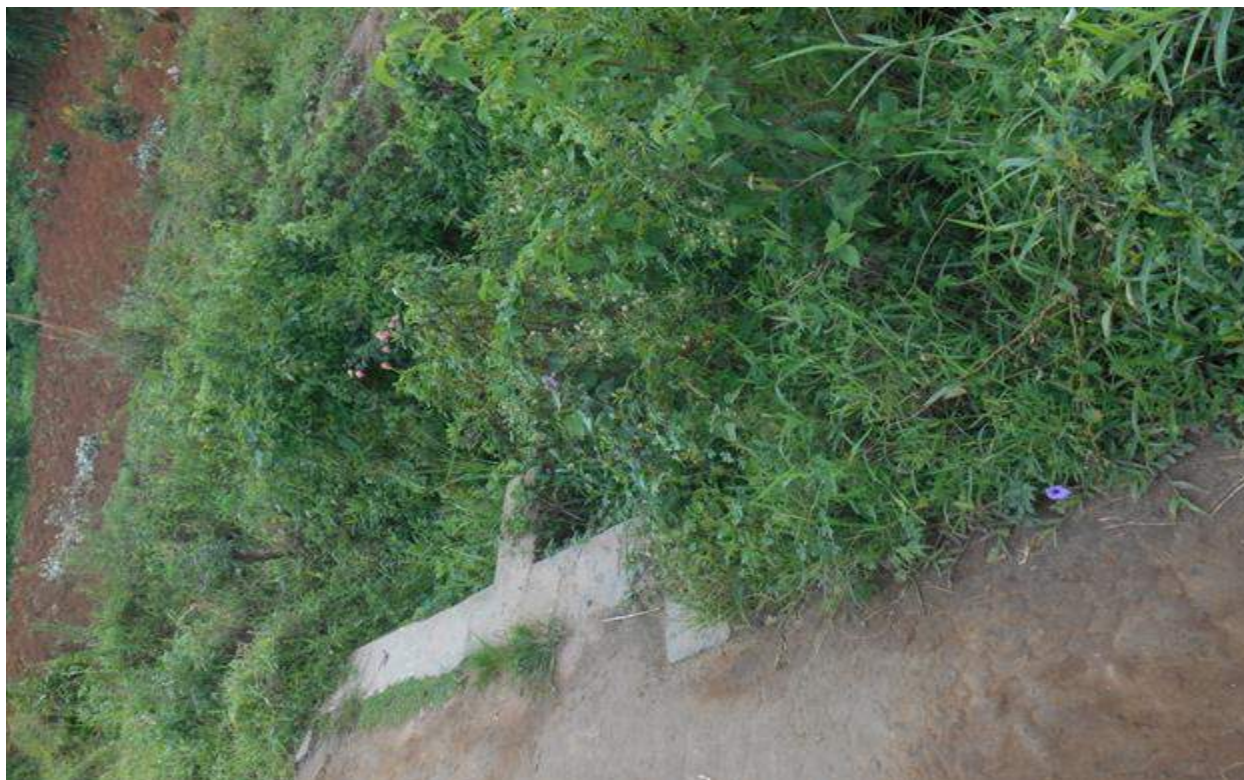
Another irrigation canal covered by plant overgrowth rendering it unusable. Photo taken at Nyagisenyi - Rufigiza marshland on 18th November 2014.

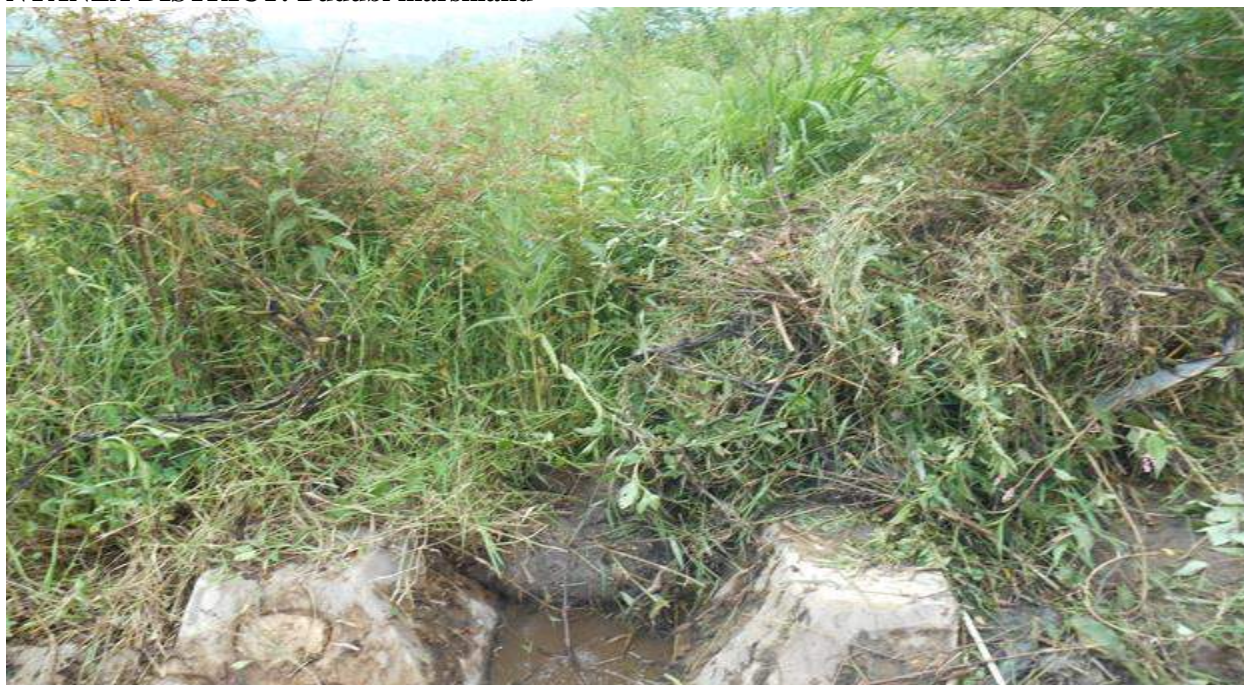
NYANZA DISTRICT: Budubi marshland

Irrigation canal covered by plant overgrowth rendering it unusable. Photo taken at Budubi marshland on 20th January 2015.

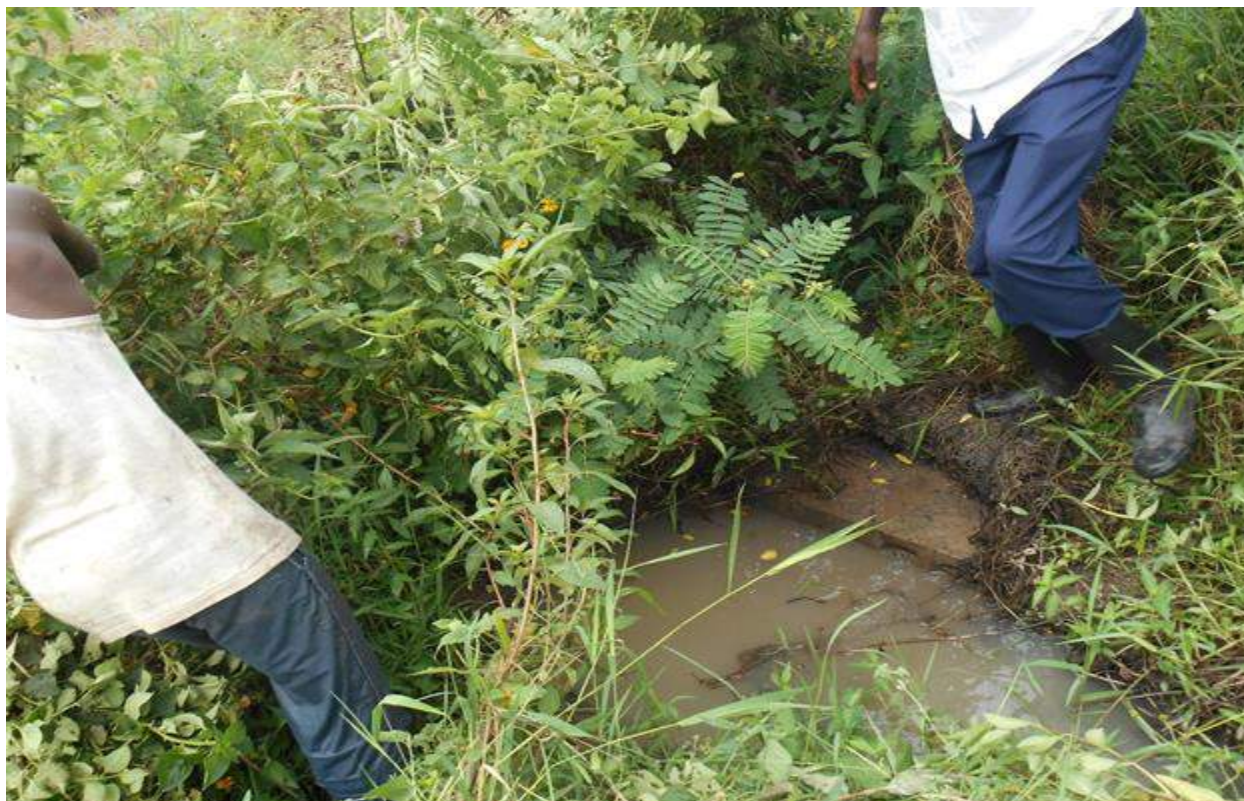
Another irrigation canal covered by plant overgrowth rendering it unusable. Photo taken at Budubi marshland on 20th January 2015.

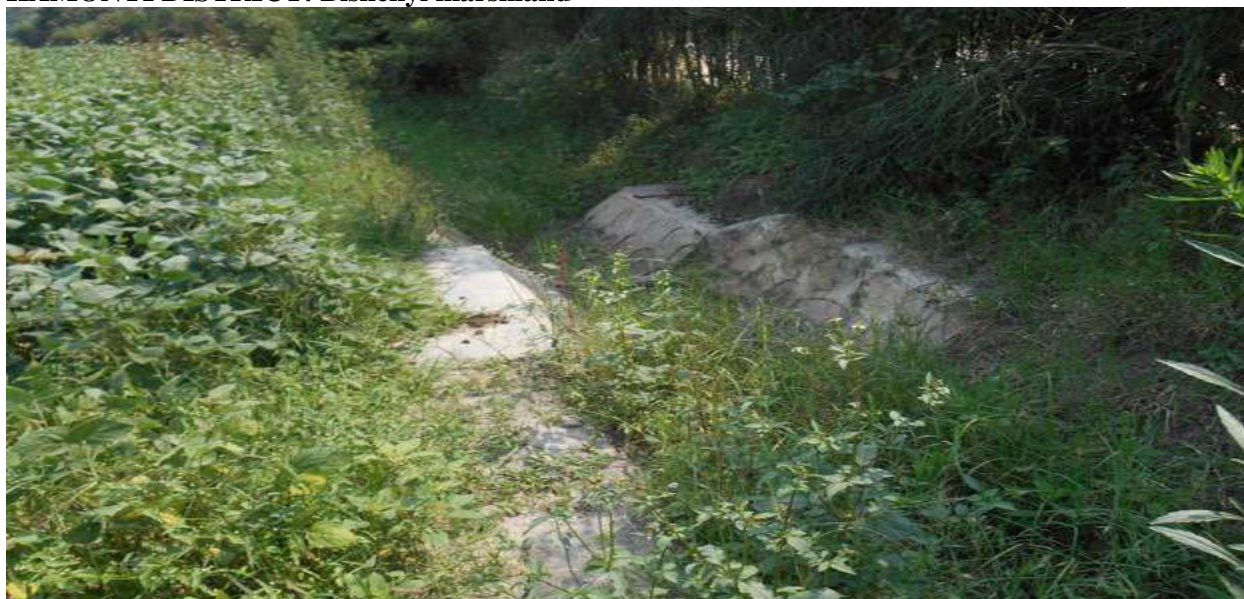
KAMONYI DISTRICT: Bishenyi marshland

Irrigation canal covered by plant overgrowth rendering it unusable. Photo taken at Bishenyi marshland on 7th January 2015.

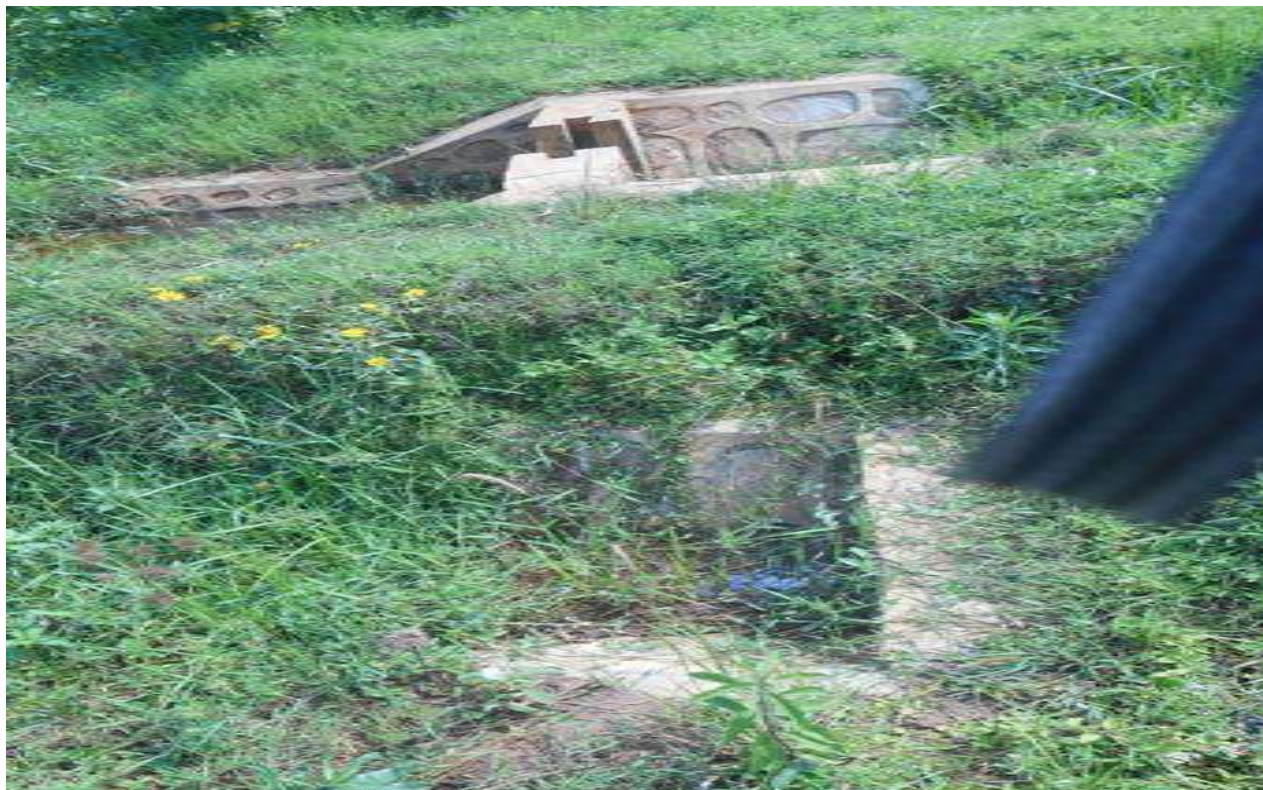
Irrigation canal covered by plant overgrowth rendering it unusable. Photo taken at Gikoro marshland on 9th January 2015.

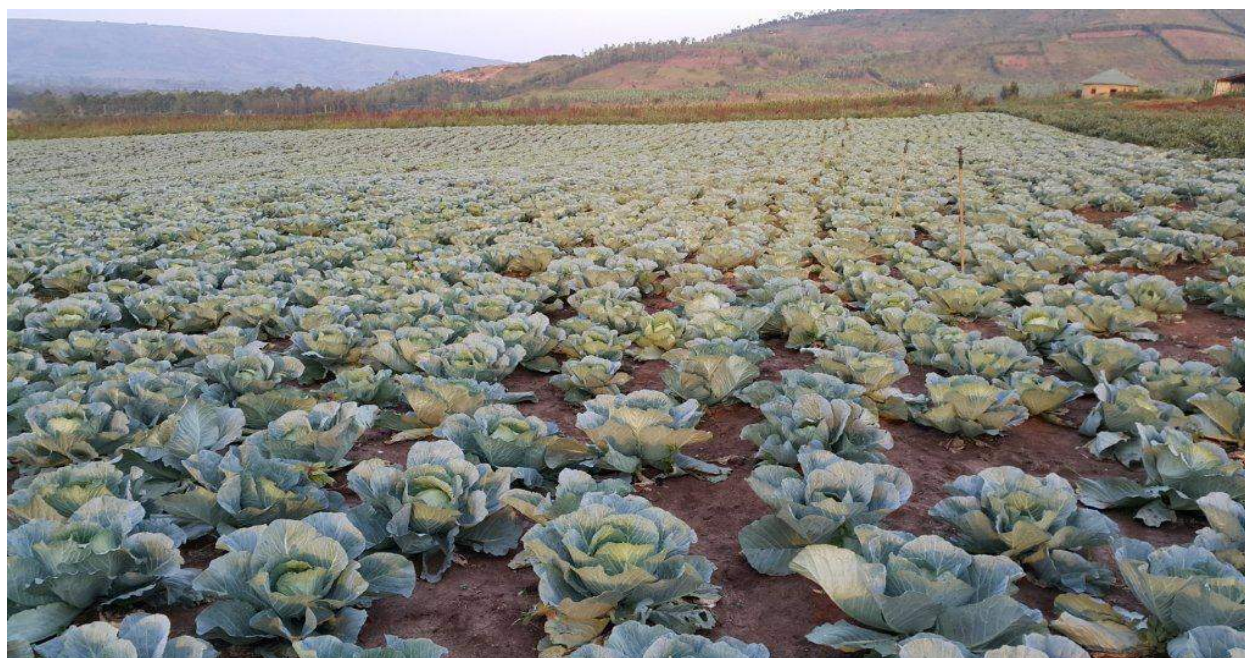
However, during the audit field visit, we noted that the Matimba irrigation scheme is located far from the main road and the access road is in poor condition. This negatively impacts on the ability of traders to access the irrigation scheme and consequently the farm produce. We noted cases where cabbages and eggplants produced in Matimba irrigation scheme were ready for market but there were no ready buyers due to poor road network from the main road leading to the irrigation scheme.

Cabbages ready for harvest but there are few buyers due to poor road network from the main road to the irrigation scheme. Photo taken on 28th January 2015

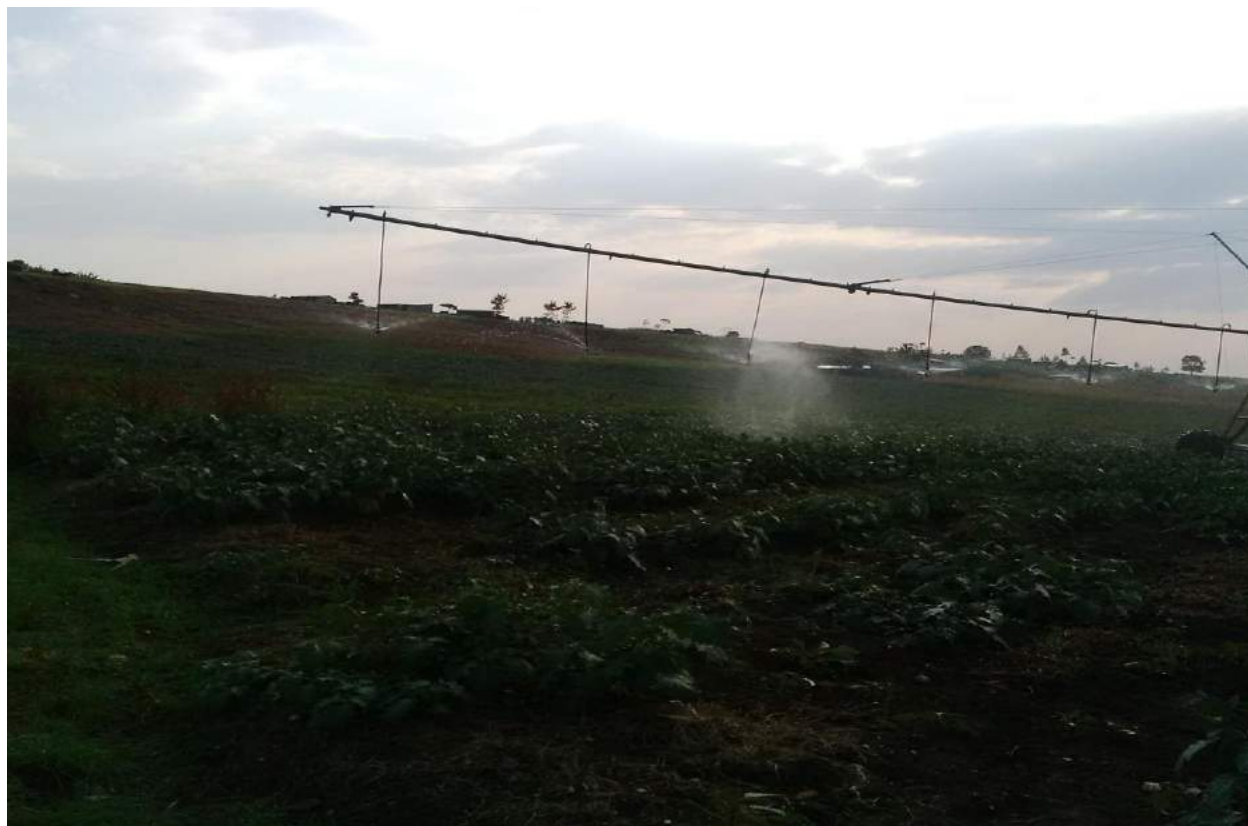
The irrigation water is not uniformly distributed with risk that some crops do not receive adequate water supply. Photo taken at Matimba irrigation scheme on 28th January 2015.

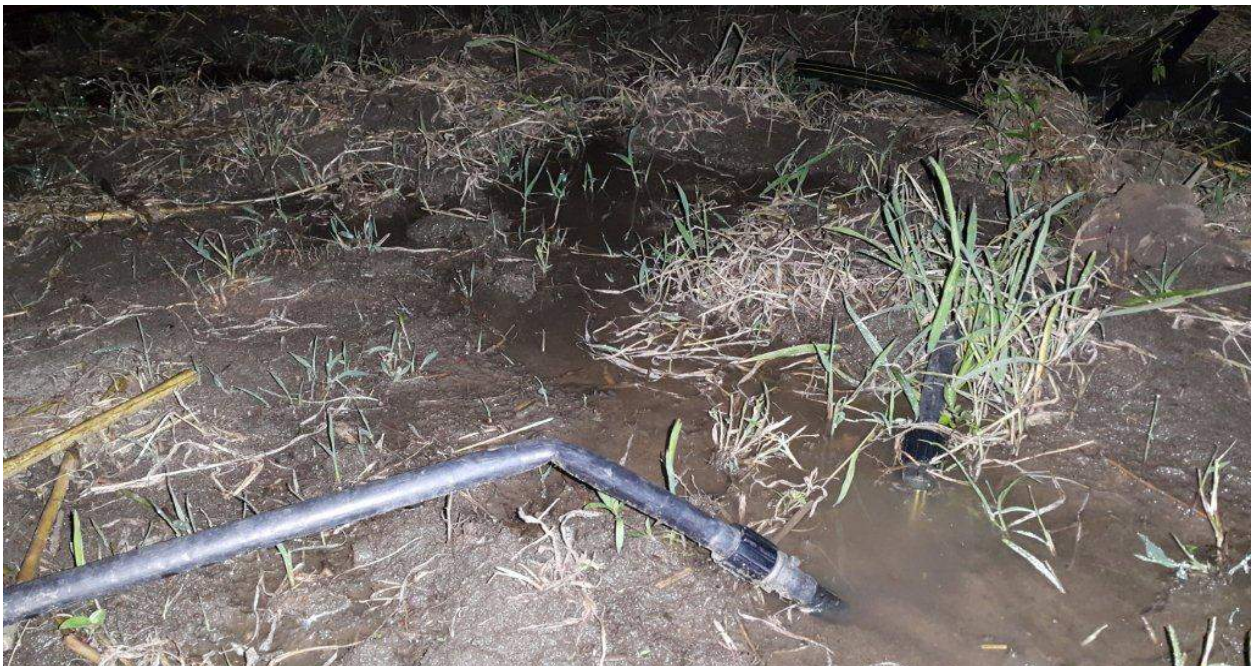
Parts of the farmland are flooded due to excessive flow of water. Photo taken at Matimba irrigation scheme on 28th January 2015.

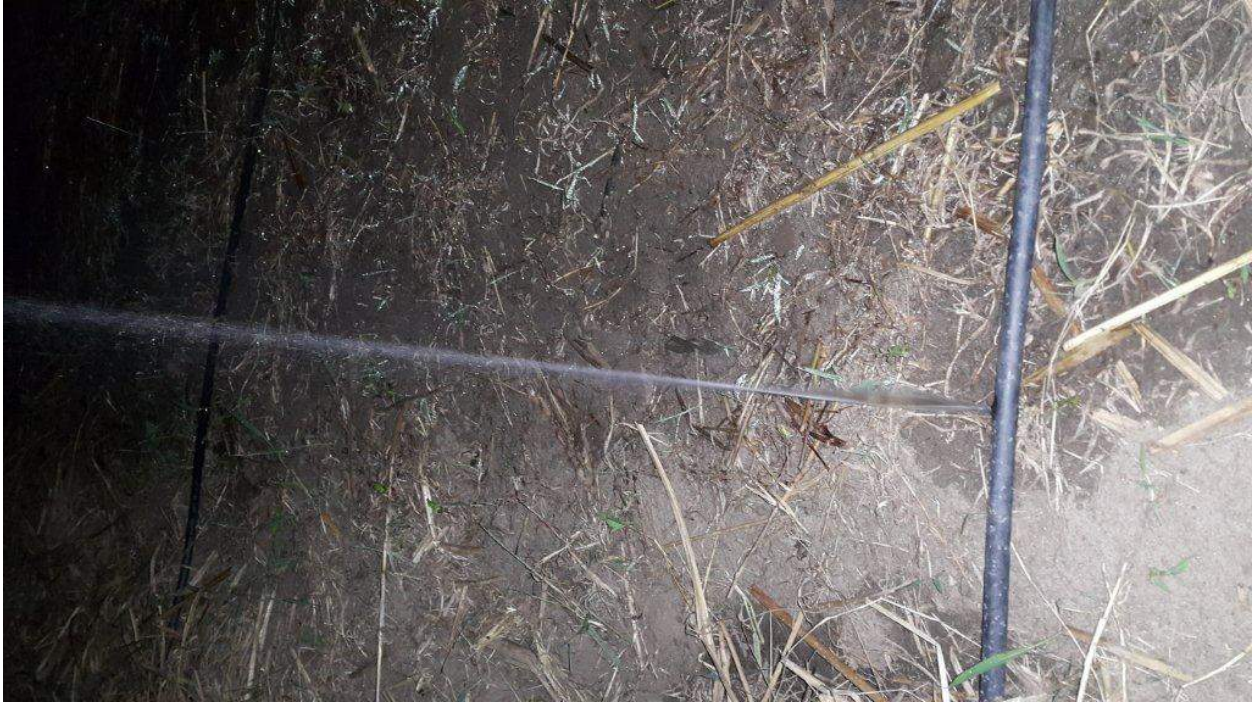
Some drippers have very high flow rates and behave like sprinklers. This leads to non-uniform flow of water in the farmland. Photo taken at Matimba irrigation scheme on 28th January 2015.

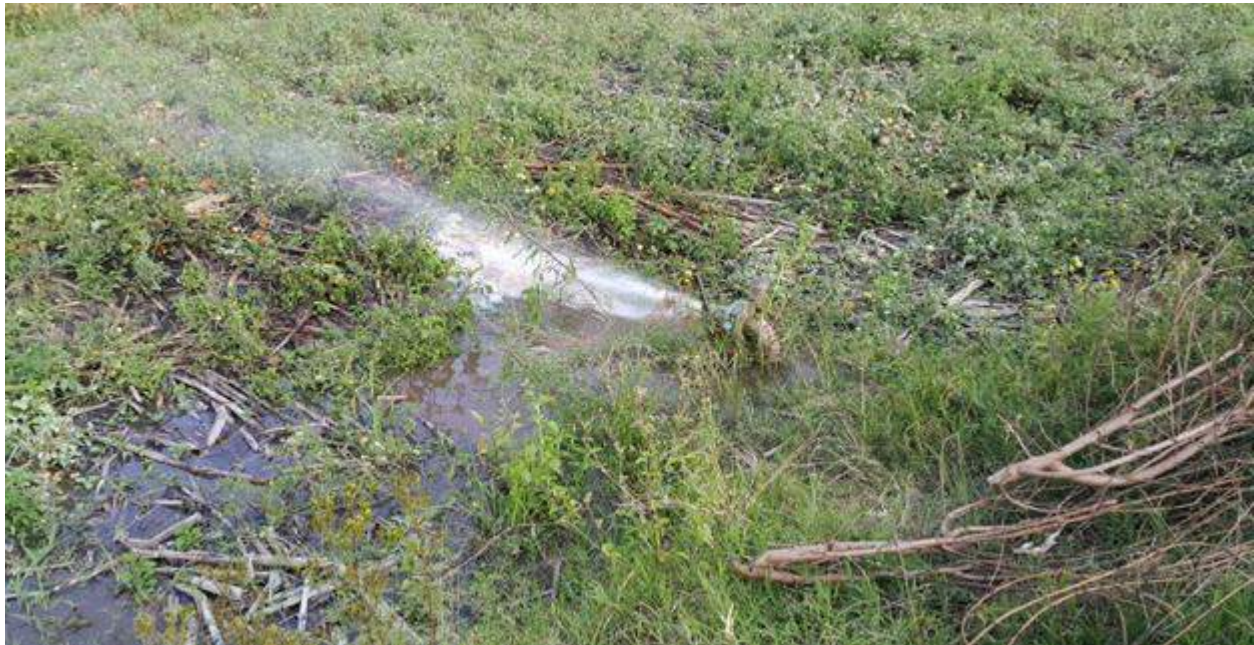
Uncontrolled irrigation is bad for crops. As shown above, mature tomatoes are easily spoilt by excess water. Photo taken at Matimba irrigation scheme on 28th January 2015.

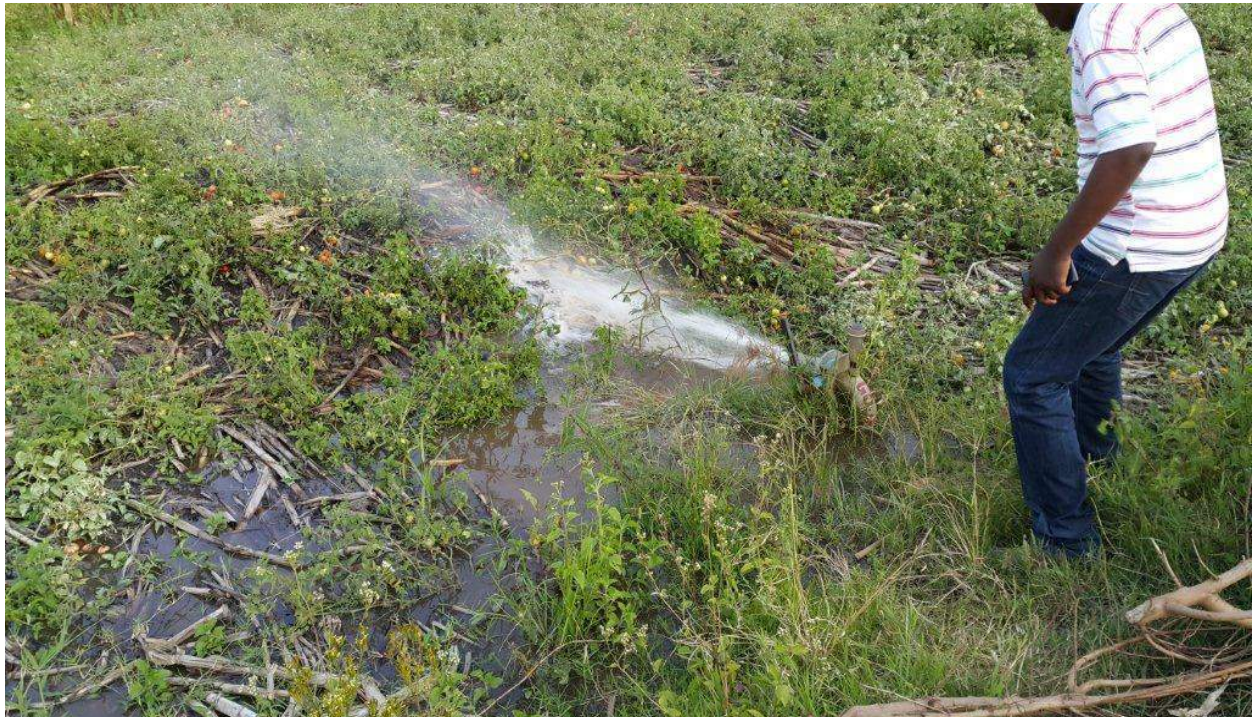
Shown above is the Site irrigation coordinator trying to close off the irrigation hydrant after we found it flooding the tomato farmland. Photo taken at Matimba irrigation scheme on 28th January 2015.
