**PERFORMANCE AUDIT REPORT ON THE MANAGEMENT OF WATER  
PROJECTS IN RURAL AREAS**

**A REPORT OF THE CONTROLLER AND AUDITOR GENERAL OF THE UNITED  
REPUBLIC OF TANZANIA**

**March, 2019**

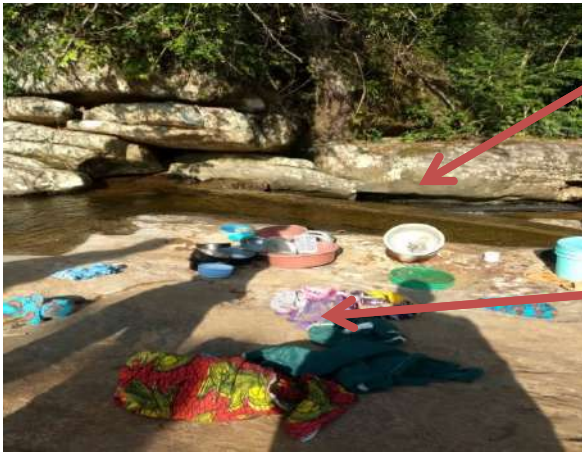
Photo 3.1

Through site visits at Kigugu water projects in Mvomero DC, the audit team found out those members of the community who were washing their clothes exactly at the intake point. The health of the community who were using such water sources were at risk to epidemic diseases like cholera due to pollution of water at the intake point. **Photo 3.1** hereunder shows the activities which were going-on at the intake of Kigugu water project.

Water intake at  
Kigugu water  
project

Washing of clothes  
activities going on at  
intake point

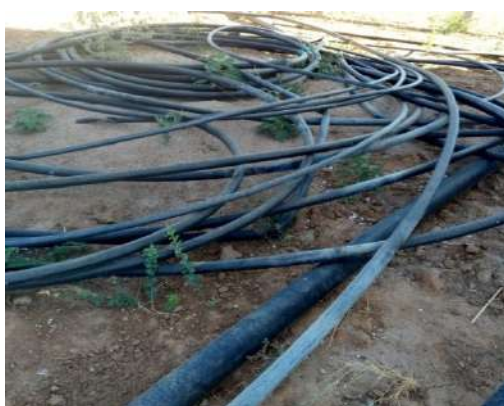
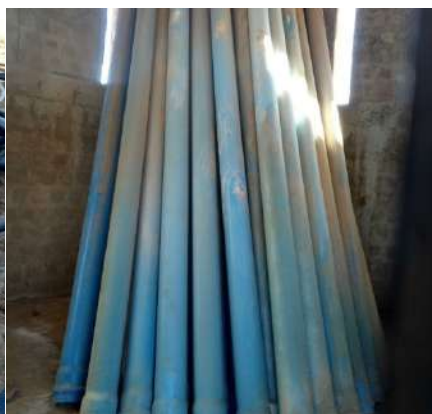
**Photo 3.2 (a) and (b):** Show remained pipes at Londoni water projects in Manyoni DC

Furthermore, neither the accompanied district water engineer nor secretary of COWSOs were able to tell the exact number of excess water pipes available until when they were counted with the audit team. This poses the risk of loss of some of the water pipes. The projects completed in 2014 and no one was monitoring the remaining pipes. Photo 3.2 shows the remained water pipes at Londoni water projects.

**Photo 3.2 (a)**

**Photo 3.2 (b)**

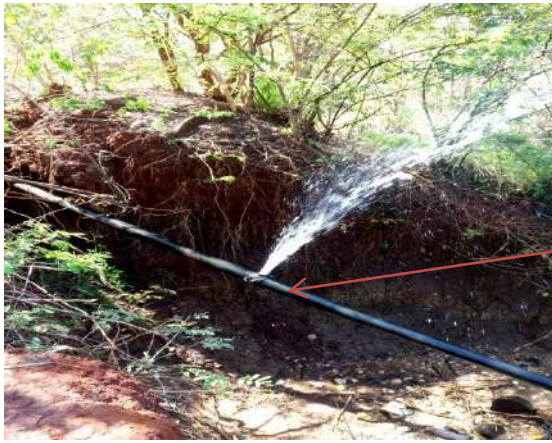
*Photo 3.3: Mlali Kipera water project (Photo was taken on 29/11/2018)*

Moreover, during site visits, it was noted at Mlali-Kipera water projects in Mvomero DC that the pipe which was supplying water from intake to water tank had leakages whereby a lot of water were lost. Photo 3.3 shows main water pipes.

Water leaking from  
main water pipe  
from intake at Mlali  
Kipera water project  
in Mvomero DC

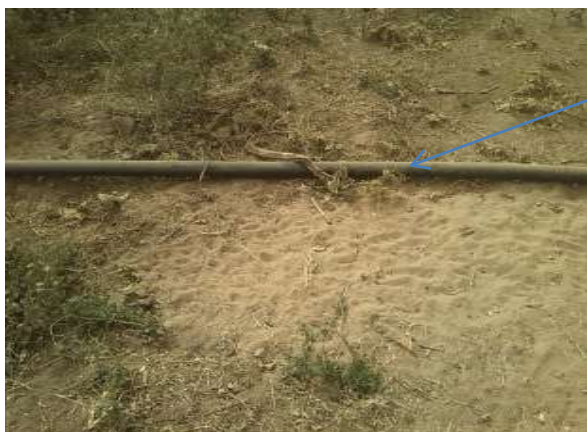
**Photo 3.4:** Pipe laid on the ground instead of being one meter below the ground

This was the result of inadequate supervision since this incident is totally contrary to the BOQ requirements and to the best practices. The contractor did it intentionally since there was no supervision at all and he knew that it was not acceptable and contrary to the requirements of the contract.

**Photo No. 3.4** hereunder showing pipe laid above the ground instead of the required one meter deep. The contractor managed to do this due to lack of supervision from Simanjaro DC

Pipe laid on the ground instead of being one meter below the ground
